Knit Line Failure of a Glass-Filled Polysulfone Pipe Fitting and Fractographic Comparison to Laboratory-Produced Fractures

Ronald J. Parrington, P.E., FASM¹

¹ Engineering Systems Inc. (ESI), Aurora, IL, USA

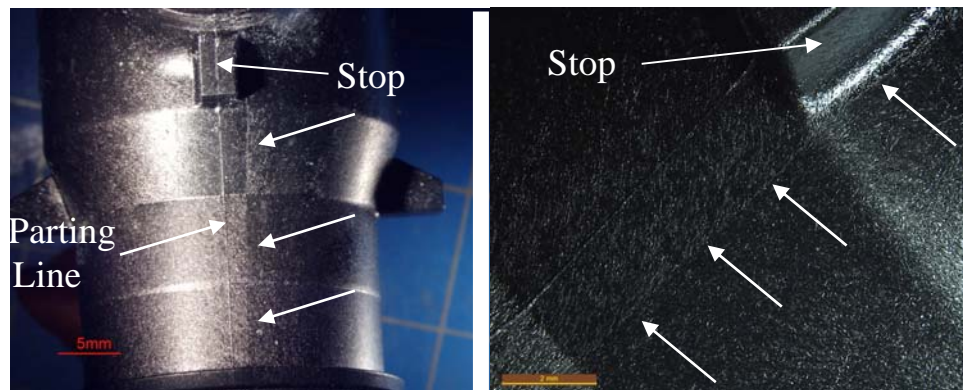
A subtle knit or weld line is visible adjacent to the parting line. A knit line or weld line is created during molding when material flow splits to flow around features such as holes in the part design and then reconverges on the other side of the feature. By the time the two material fronts reconverge, the molten plastic may have already started to skin over and, therefore, the cohesive bonding at a knit line is never as strong as the surrounding material. Furthermore, in the case of glass fiber reinforced plastics, the glass fiber orientation tends to be parallel to the knit line. This creates a plane of weakness as the parallel glass fibers do not strengthen the part in the direction transverse to the knit line. The crack path observed on the failed fitting is similar to the knit line location on the new fitting. The fracture surfaces display smooth, flat areas and rough areas. The smooth, flat areas are consistent with cracking along a knit line. As a rule of thumb, heavily filled and reinforced plastics, such as the failed 20% glass-fiber-reinforced PSU fitting, do not display many (if any) meaningful fracture surface features on both the macro- and microscale. However, the flat surface texture and radial lines suggest that the fracture originated at a corner or shoulder of the fitting, which acts as a stress raiser. Furthermore, the crack path and knit line run along a pipe stop, which also acts as a stress raiser.

Figure 1. Images of the knit line, which runs roughly parallel to the parting line and along the pipe stop.

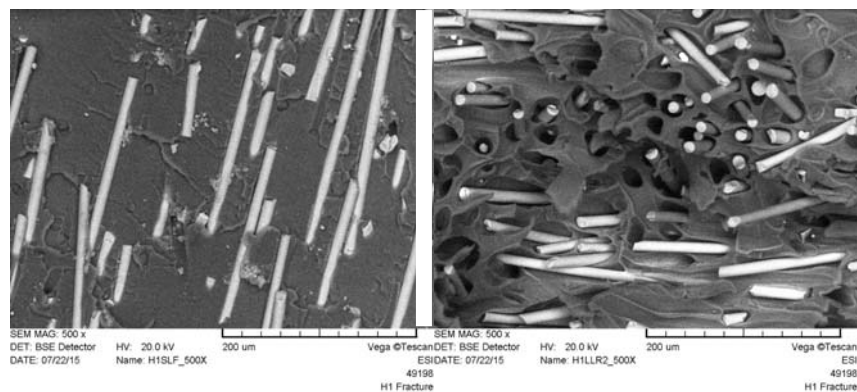
The fracture surfaces of the failed fitting were examined with an SEM. Smooth, flat areas of the fracture surface were compared to rough areas. On the microscale, the rough areas of the failed fitting fracture surface display much more material stretching than the smooth/flat regions. In the smooth/flat regions of the failed fitting, the glass fibers run parallel to the fracture surface and there is much less glass fiber

Figure 2. SEM photomicrographs showing the fracture surface morphology in smooth (left) and rough (right) regions of the failed fitting.
