Impact Fatigue Failure of Ordnance Components

Frederick E. Schmidt, Jr. * and David M. Norfleet*

* Engineering Systems Inc., 3851 Exchange Avenue, Aurora, IL 60504

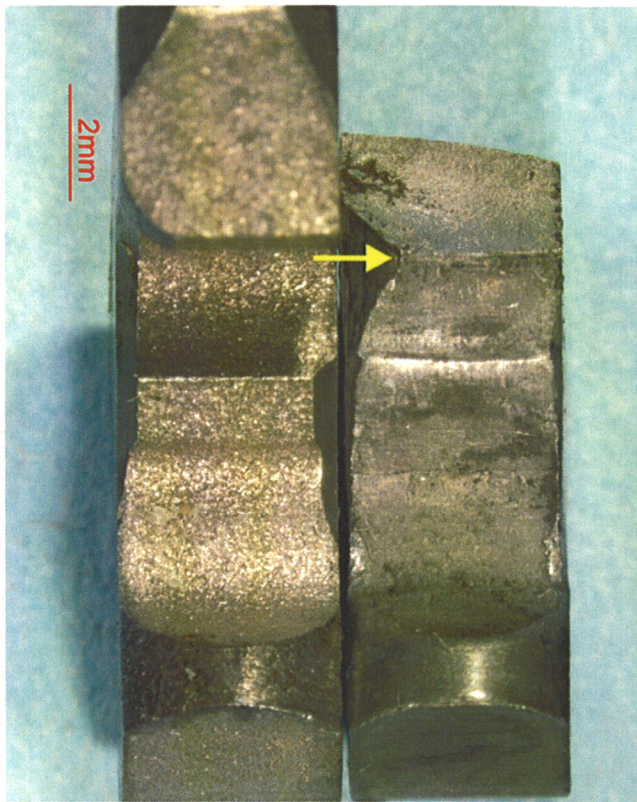
Previous fractographic⁽²⁾ studies performed on ordnance components indicate highly localized stresses develop and under impact loading non traditional macro and micro structure characteristics are observed. Figure #1 shows a side by side view of a new and failed extractor. The actual fracture is at the middle of a large radius fillet (arrow). The new part has a claw which obscures the fillet view. Significant burnishing (wear) has occurred in the fillet area in the failed part, but this polishing actually mitigates the crack initiation stage in impact fatigue. Figure #2 shows a macro view of the fracture path, with many traditional crack arrest indications of progressive fracture. The general fracture surface was remarkably flat and smooth even through to final fracture. Using the SEM it was determined that while some progressive features were observed as shown in Figures #3 and #4 at 500X and 1,250X respectively. In general a ruffled and mottled surface character occurs without any indication of fatigue striations. These components are exceedingly uniform in microstructure and exhibit a hardness level approximately HRC ~ 44 to 51 as determined using Superficial Hardness.

Figure 1 MIM, Fillet (arrow)

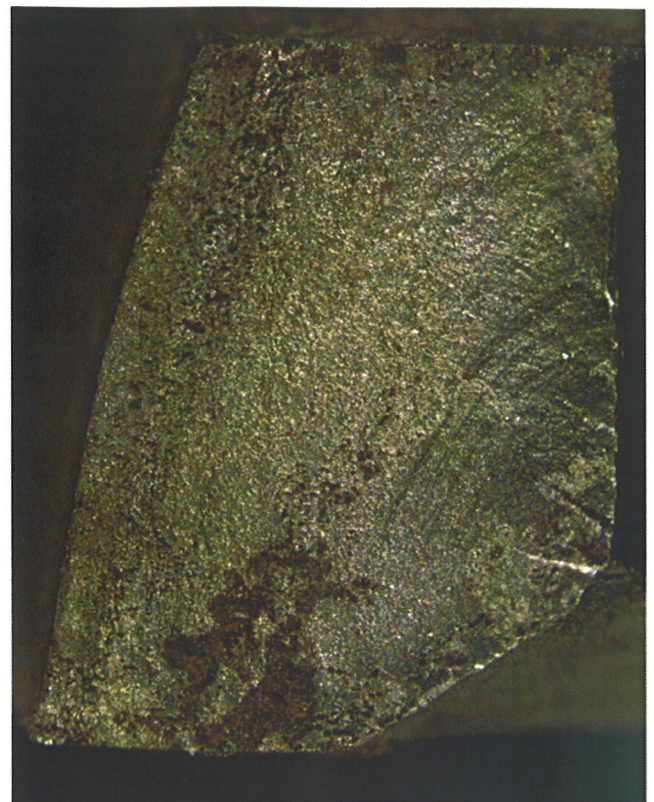
Figure 2 Crack Arrest Lines

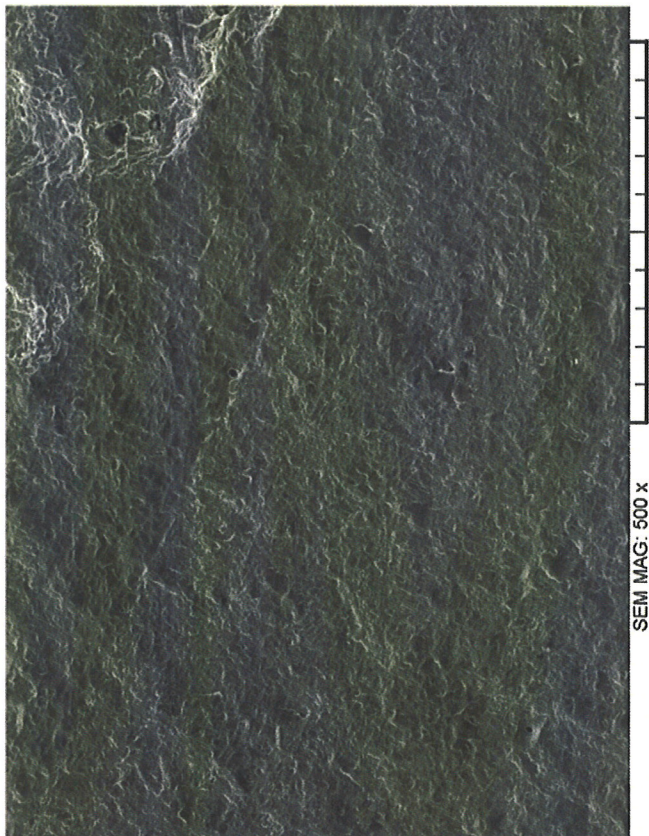
Figure 3 No Striations

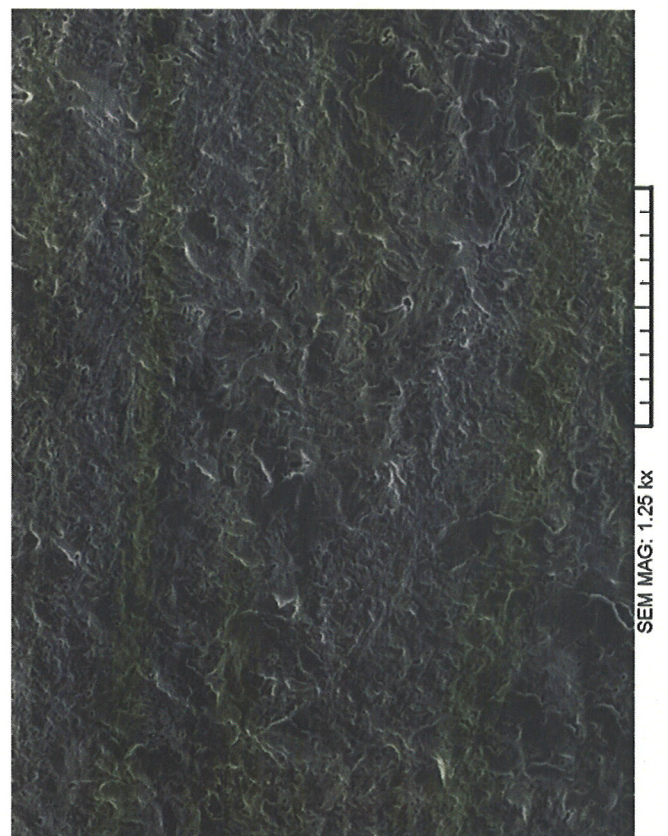
Figure 4 Ruffled/Mottled
