Surface Analysis of Pressurized Water Reactor Steam Generator Tubing Specimens

A. Parsi,* W. A. Byers,* J. Deshon**

* Materials Center of Excellence, Westinghouse Electric Co LLC, 1340 Beulah Road, Pittsburgh, PA 15235

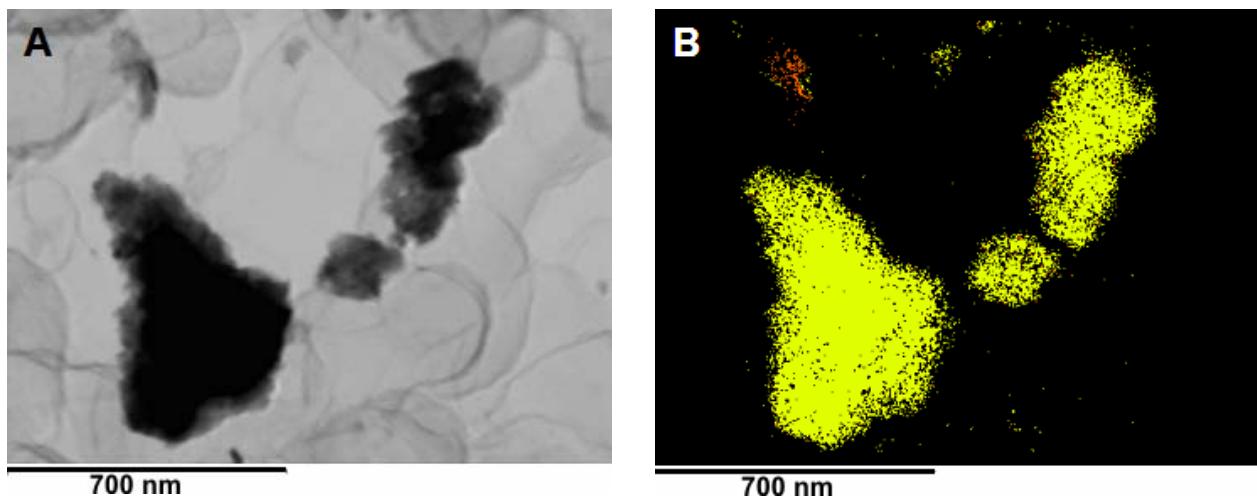
Based on descaling of the corrosion film and analysis using TEM (Figure 1), it was determined that on average, the composition of the corrosion films was close to NiCrFeO_4 (or more precisely, $\text{Ni}_{0.9}\text{Cr}_{1.0}\text{Fe}_{1.1}\text{O}_4$). This indicates that the Ni released during corrosion is quite significant relative to Cr and Fe. The observation that the iron content in the corrosion film is distributed toward the coolant interface and is roughly equal to the chromium suggests that although Alloy 600 and Alloy 690 steam generator tubes release Ni while capturing Fe. Iron constitutes a major component of core crud, and in many axial offset anomaly (AOA) cycles, it was the dominant constituent. If steam generator tubing is not a source of iron release during the cycle, then stainless steel components within the RCS or components of the chemical and volume control system must be responsible for much of the core crud inventory. Establishing which components contribute significantly to iron release will be important for future crud control efforts.

FIG. 1. (A) Bright-field TEM a sample of Diablo Canyon 1 EOC7 descaled corrosion film. (B) The XEDS phase map highlighting clusters with approximate composition of NiCrFeO_4 in yellow.

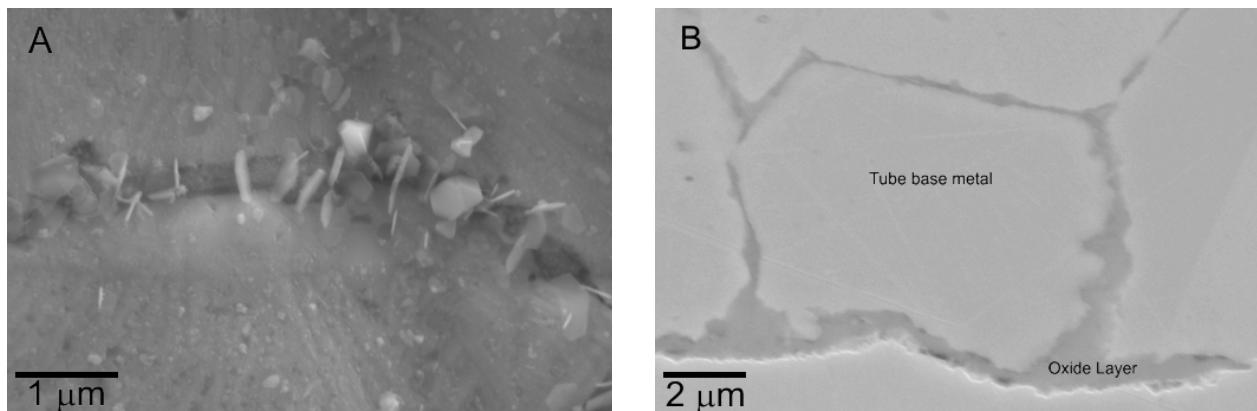
Limited SEM data show that localized attack at grain boundaries and surface defects is likely a significant cause of corrosion product release. Figure 2A shows formation of hexagonal crystals at a Cr-rich grain boundary of Alloy 690, and Figure 2B shows a cross sectional view of a Vogtle 2 tube with extensive corrosion at the grain boundaries at the surface of the tubes. More detailed study using a larger and more diverse sample population is needed.

FIG. 2. (A) Top-down SEM of Oconee 2 Alloy 690 tube showing the formation of corrosion products at the grain boundaries. (B) Cross-section SEM of Vogtle 2 Alloy 600 tube showing significant corrosion at the grain boundaries near the tube surface.

If localized corrosion at grain boundaries and surface defects controls steam generator corrosion product release, then releases from new steam generators can be controlled by optimizing heat treatments and surface finishing. Additional studies of localized corrosion on steam generator ID surfaces may help to determine what constitutes the best grain boundary conditions and surface

finishes. The localized nature of corrosion should also be considered when optimizing chemistry for in-service steam generators.
