Sliding Component Failure Due to Vibration Damage

Lisa A. Deibler and Donald F. Susan

Sandia National Laboratories, Albuquerque, USA

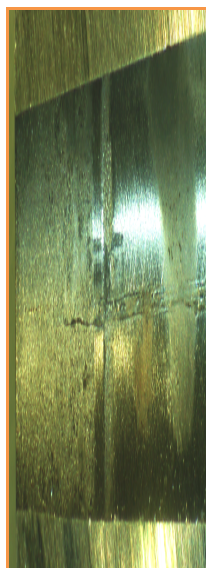
To determine the cause of the lock-up, housings were cut open to remove the pins and surfaces were visually inspected for signs of damage caused by vibration. Figure 2 shows an example of the type of extensive damage visible in a typical housing. A matching pattern of surface wear damage was also observed on the pins. The areas outlined in yellow, red, and purple in Figure 1 were areas of concern for wear damage. The area outlined in yellow near the tip of each pin where they interlock was found to have the most severe damage.

SEM inspection of the wear scars on both the housing and the pins showed the presence of oxide particles, which are indicative of fretting [1]. During fretting, which is often seen on parts subject to vibration, the passive layer on the stainless steel breaks down. This breakdown leads to oxidation and the much harder oxide particles accelerate the wear.

Figure 2. Photograph of wear damage on interior of housing

It was concluded that more mechanical design changes were needed to reduce the tolerances and pre-load the pin connection in order to avoid vibration damage of the sliding interfaces.

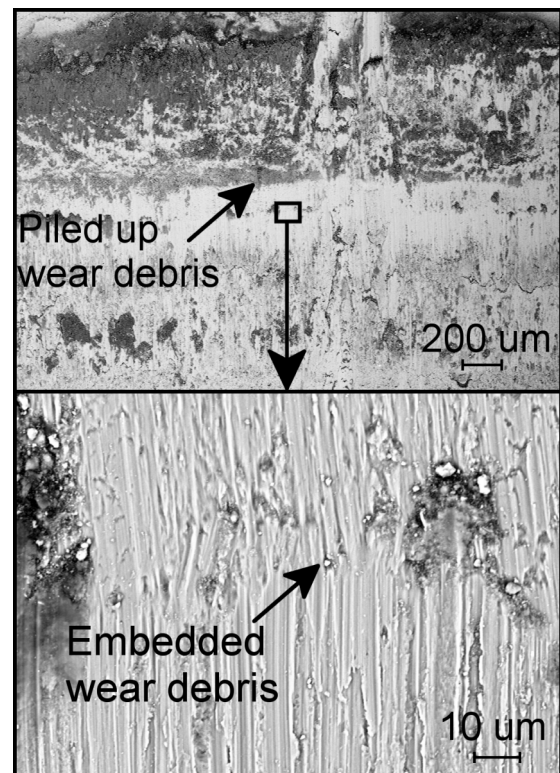
Analysis of the wear scars on both the pins and the housing was performed to determine whether the vibration causes the pin to bond to the sleeve, or if there is an effect of the pulling operation combined with the vibration damage that causes the lock up. SEM images of housings near the top of the lower pin showed evidence that the oxide particles caused by fretting had been smashed into the surface of the housing (Figure 3). The fretting debris was also piled up at the end of a long furrow, indicating that the presence of the wear debris during the attempt to pull out the pin caused the corner of the pin to dig into the housing, which caused the lock up. Once the outside corner of the pin begins to dig into the housing, the geometry of the interlocking pins causes it to lever outwards, digging further into the housing as more force is applied to the pin. In normal operation when there is no wear debris present to cause the outside corner of the pin to begin to stick, the geometry of the interlocking pins would not present any barrier to pull-out.

Figure 3. SEM images of piled up and embedded wear debris on housing surface.
