## Crack Tip Plastic Zone Formation during Pipeline Hydrostatic Testing

Jian Li, M.Elboujdaini and P.Liu

Materials Technology Laboratory, CANMET, 568 Booth St. Ottawa, Ontario, Canada, K1A 0G1

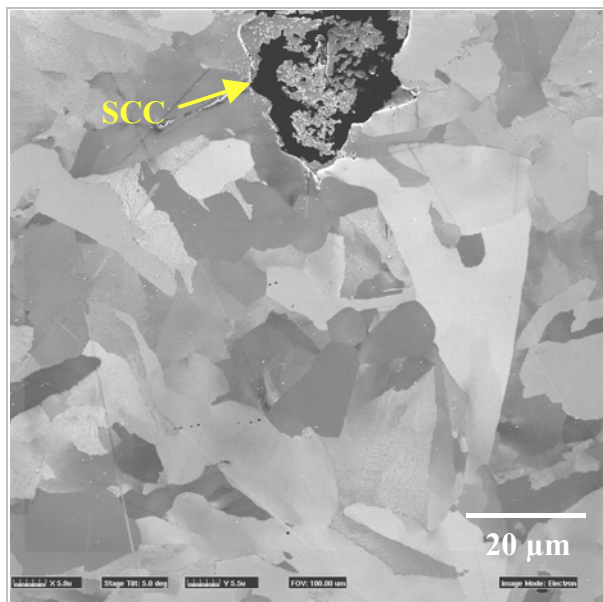
Figure 1 shows a typical FIB image taken at an SCC crack-tip from a sample that had not been subjected to hydrostatic testing. The crystallographic orientation contrast indicated no apparent plastic zone ahead of the crack tip. Figure 2 shows a crack tip from a pipe subjected to hydrostatic tests; this sample shows a plastic zone near the crack tip. The existence of deformed substrate near crack tips could promote further SCC propagation. Figure 3 shows a montage of a section of a long crack. The top portion of this crack is much wider and transformed to a distinctively thinner crack. Apparent plastic zones exist at both the transition zone and the thin crack tip. It can be deduced that the thicker SCC existed prior to the hydrostatic test in 1994 and became inactive for a period of time (dormant crack before 1994 hydrostatic testing). Signs of hydrotest in 1994 are marked by the plastic deformation in the transition zone. This SCC became re-activated and started to propagate again after the 1994 hydrostatic test, and the 2004 hydrostatic test created the second plastic zone at the crack tip.

Figure 1. SCC tip from a sample with no hydrostatic test.

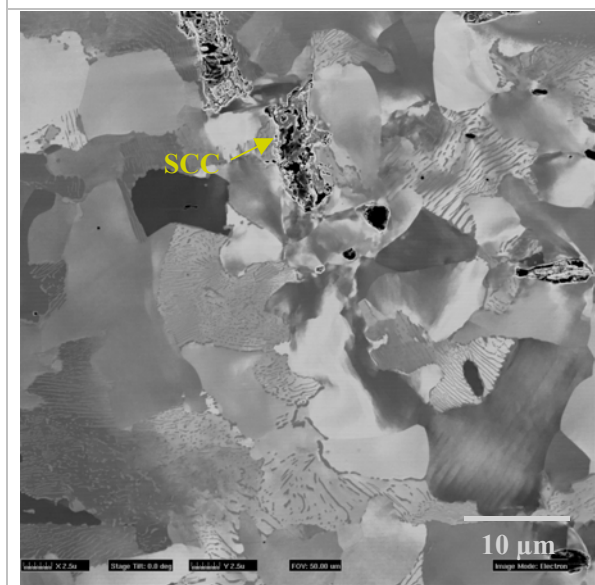
Figure 2. Plastic zone at a large SCC tip resulting from hydrostatic testing.

The FIB SE imaging provides new insights into the effect of hydrostatic tests on steel pipelines. The current microstructural features indicate that caution should be exercised when planning for hydrostatic testing since it may re-activate some inactive SCC. These plastic zones are not detectable by either optical microscope or SEM. A detailed study will be published elsewhere.

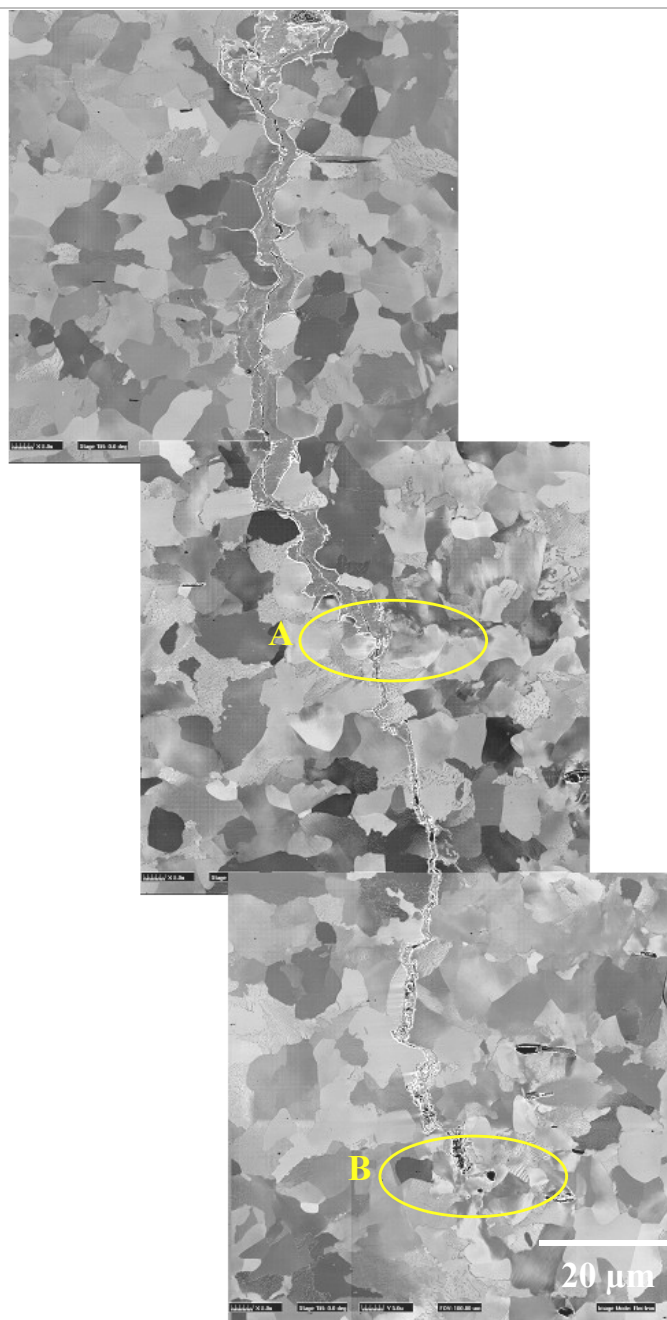
Figure 3. Montage image of a large SCC showing the SCC re-activation and propagation from the earlier hydrostatic test. **A**: Plastic zone at the SCC tip due to 1994 hydrotest, **B**: SCC tip and plastic zone resulting from the hydrotest in 2004.
