Three Pipe Corrosion Failure Cases

Andrew Havics

pH2, LLC, Avon, IN

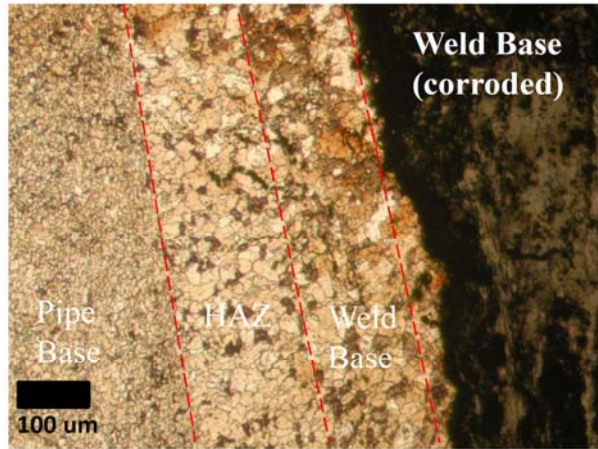
In Case 1, a glycol-based cooling system leaked. Examination of the pipe revealed extensive corrosion on both the exterior (very unusual) and interior of the piping. The microstructure was consistent and there no signs of microbially induced corrosion (MIC). A review of electrochemical potential testing revealed the most likely cause was galvanic action with the fluid.

Figure 1. Photomicrograph of etched pipe cross section from Case 1 through left half of the weld. It includes the pipe base metal, heat affected zone (HAZ), weld base metal, and corroded (missing) weld metal.

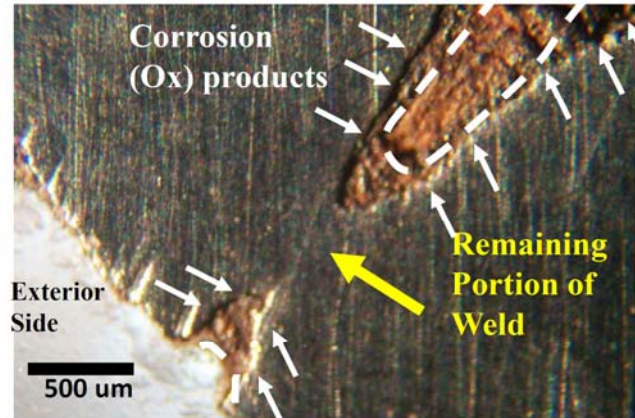
Figure 2. Photomicrograph of a ground but unpolished pipe cross section from Case 1 showing corroded weld on exterior and mid-interior surface.

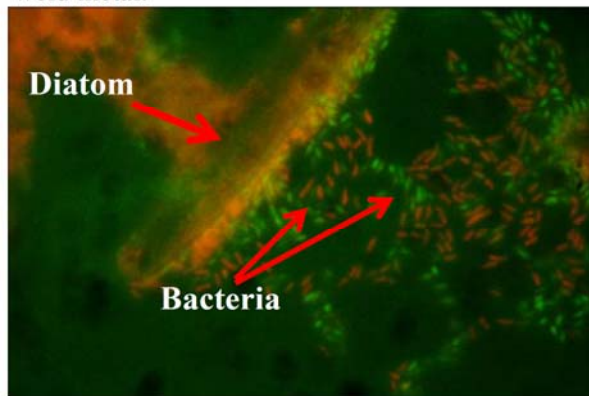
Figure 3. Photomicrograph of filtered water sample from Case 2. Biomaterials (biofilm on a diatom and bacteria) are stained with Acridine orange (AO) and viewed via epi-fluorescence.

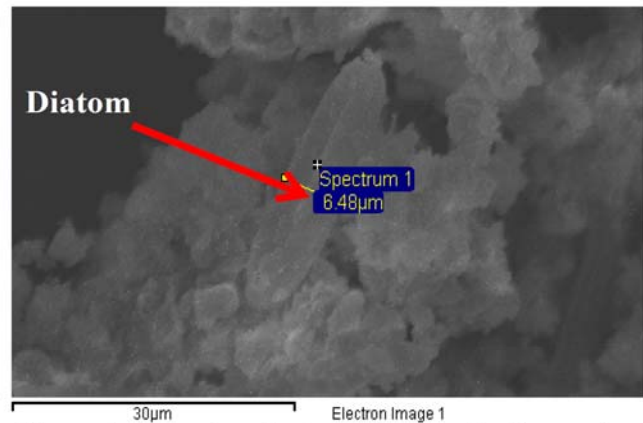
corrosion materials, clearly and strongly implicate poor water quality control. Poor water quality control was secondarily supported by the presence of Chlorine (Cl) in corrosion products evaluated by SEM-EDS, generation rate of tubercles, as well as water pH and conductivity variability. Overall, the corrosion and subsequent pitting were attributed to poor water quality control.

Figure 4. Scanning electron micrograph of corrosion product on interior side of pipe sample with a diatom embedded in the corrosion layer.

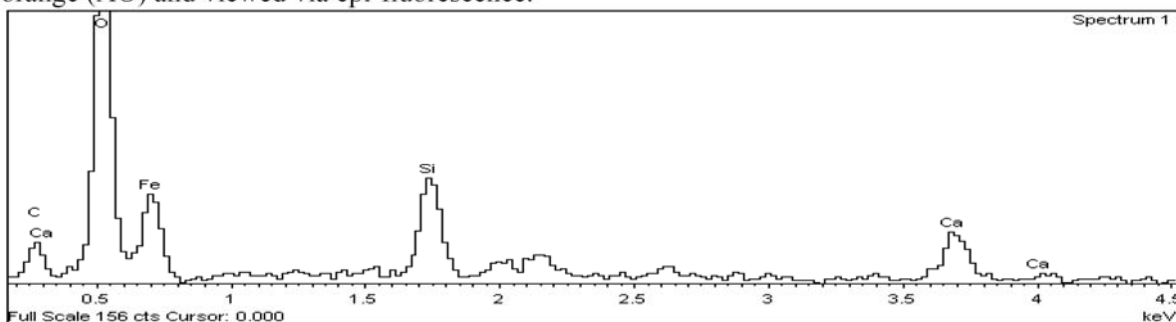
Figure 5. EDS spectra from diatom shown in Figure 4, where the diatom is composed of Si & O, whereas the Ca and Fe are from the water deposits and corroded pipe, respectively.
