Cross-sectioning Sub-millimetre Sized Defects in Ornamental Chrome-plated Component

A.J. Lockley¹

¹ Canadian Nuclear Laboratories, Chalk River Labs, Chalk River Ontario Canada

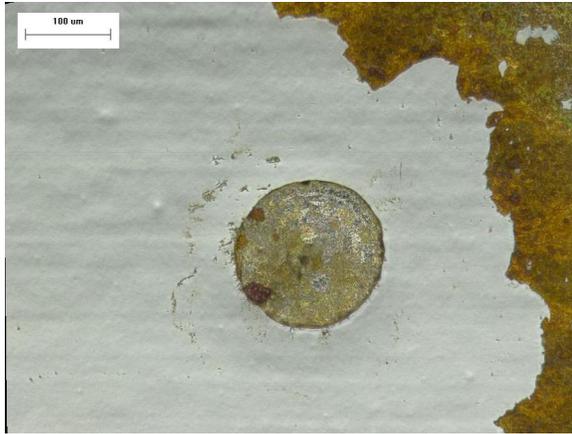
Figure 1 Digital Microscope image showing a circular defect with surrounding rust-coloured staining on a chrome plated surface.

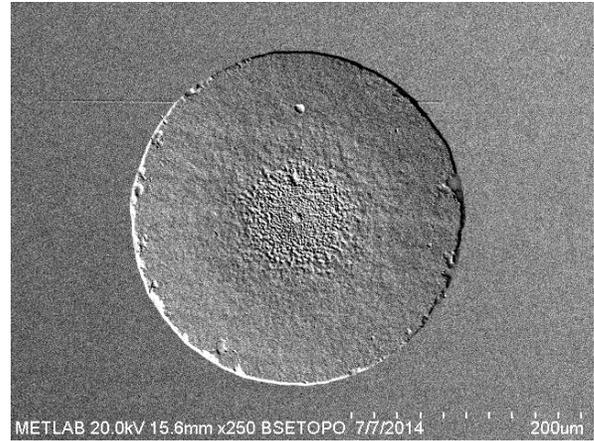
A digital microscope (DM) in conjunction with a Scanning Electron Microscope (SEM) was a synergistic tool set effective in locating and imaging small surface defects. The DM is a recent evolution of the optical microscope that was particularly useful for its ability to scan wide fields of view at lower magnification with the ability to zoom to higher magnification without having to change objective lenses while maintaining superior depth of field compared with standard optical methods. This instrument proved invaluable for the detection of small circular defects frequently associated with surface stains as seen in Figure 1. Circular defects were examined using the SEM to obtain higher resolution images as seen in Figure 2. The circular defects ranged in size from about 100 μ m to 200 μ m in diameter.

Figure 2 An SEM image showing detail of one of the circular defects.

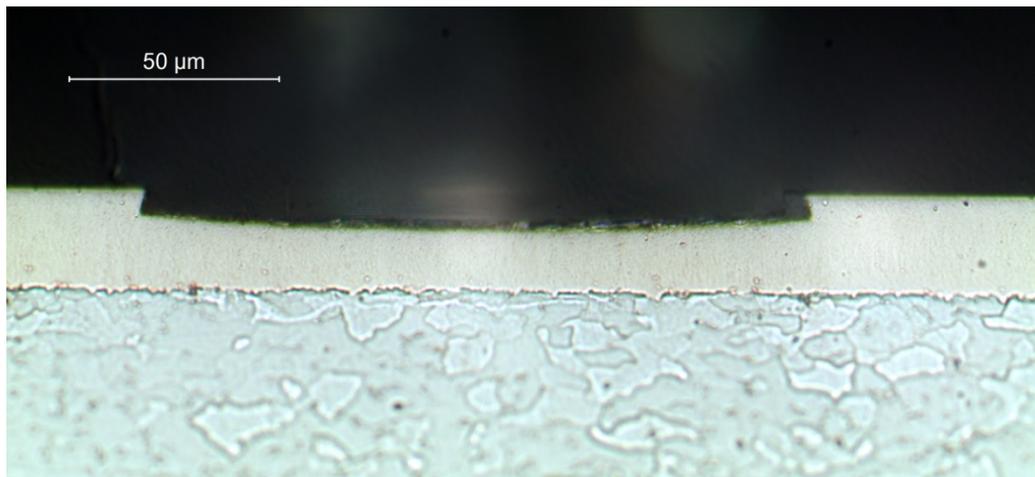
Figure 3 Cross-section of the profile of a circular defect in the nickel plate on a steel substrate.

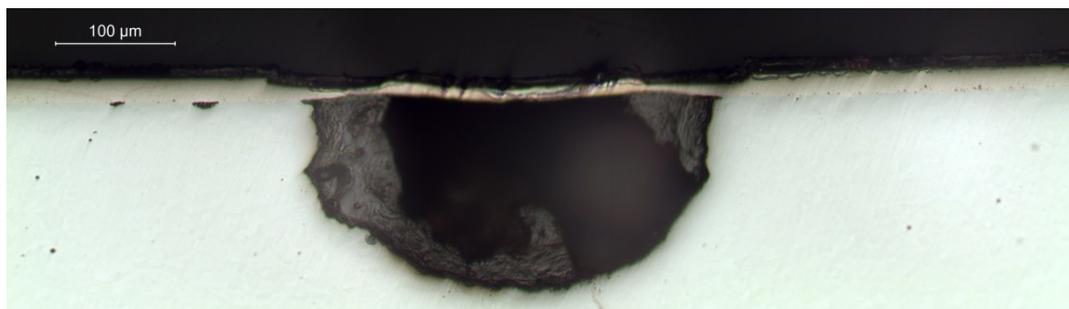
Visually aided serial-sectioning was successful in producing metallographic cross-sections through the centre of the circular defects. This revealed that circular defects tended to be isolated to the outer surface of the nickel plating and if they occurred in a region where the nickel plate was sufficiently thick the defects had limited depth as seen in Figure 3. However, in regions where the nickel plate was relatively thin, a pit in the steel substrate was commonly observed as seen in Figure 4. The circular nature of the defects suggest they result from the presence of gas bubbles that prevented a uniform coverage of the surface. Corrosion to the steel substrate would occur in areas where nickel plating thickness was inadequate to provide corrosion protection. As corrosion progressed the corrosion by-products seeped out of the pit and stained the chrome surface.

Figure 4 Cross-section through a circular defect with a corrosion pit beneath.
