Embrittlement of Mild Steels during Hot Dip Galvanization

Michael Panzenböck¹, Patric Schütz¹

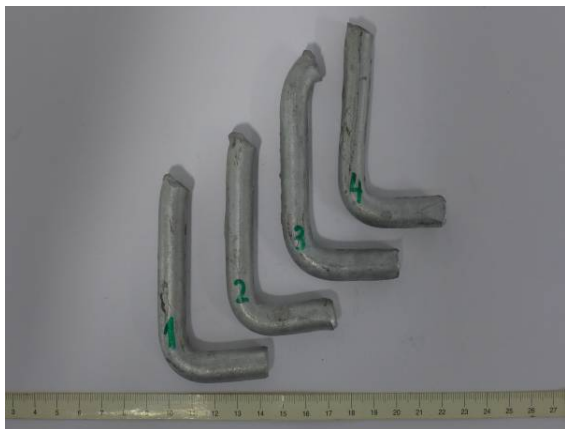
Figure 1a. Macroscopic overview of four parts of broken hangers. Arrows mark the fracture surface.

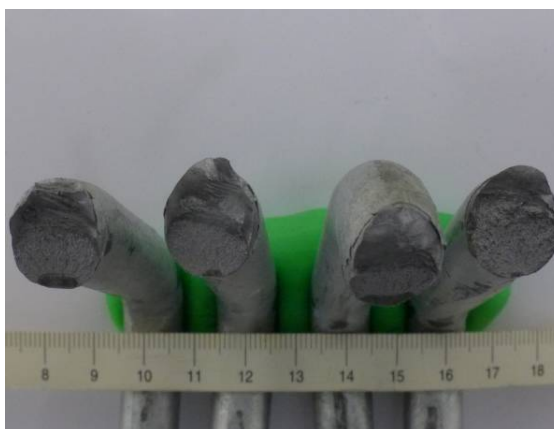
Figure 1b. Macroscopic overview of the fracture surface. Arrows mark regions of crack initiation (dark spots).

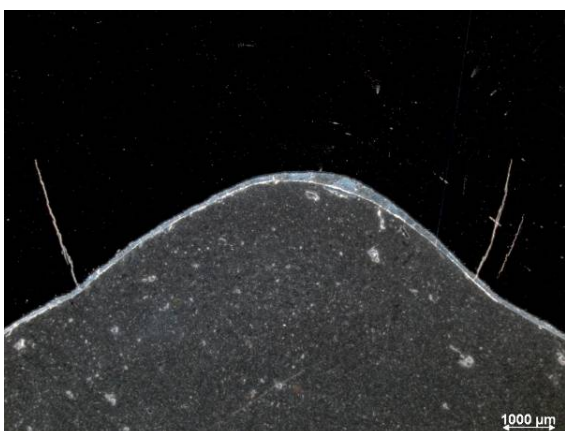
Figure 2a. Metallographic cross section through the bended wire (dark field). Cracks are clearly visible as white lines.

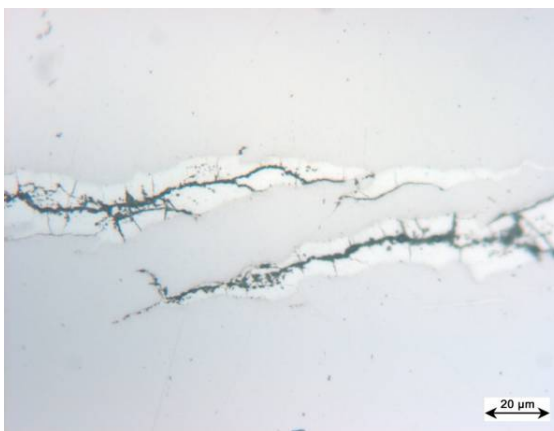
Figure 2b. Detail from Fig. 2a (crack 1). Main crack and crack branches are covered with zinc.

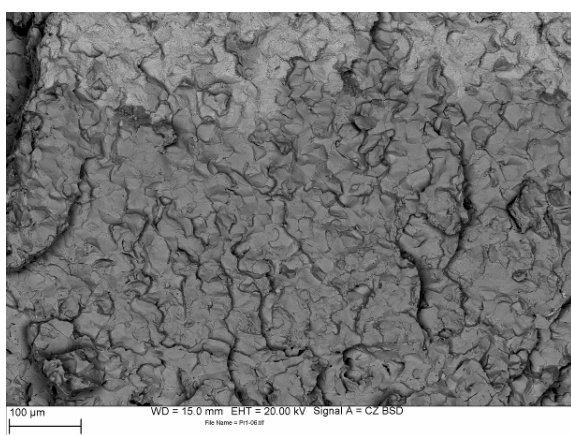
Figure 3a. Fractographic investigation of the fracture surface (dark spot). The inter-granular fracture zone is covered with zinc.

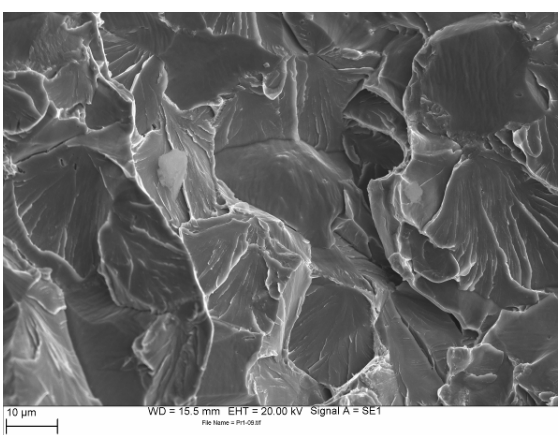
Figure 3b. Fractographic investigation of the fracture surface behind the dark spot. Cleavage fracture is prevalent.
