Failure Analysis and Design of Cu-Be Alloy Clips

Frederick E. Schmidt, Jr. *

* Engineering Systems Inc., 3851 Exchange Avenue, Aurora, IL 60504

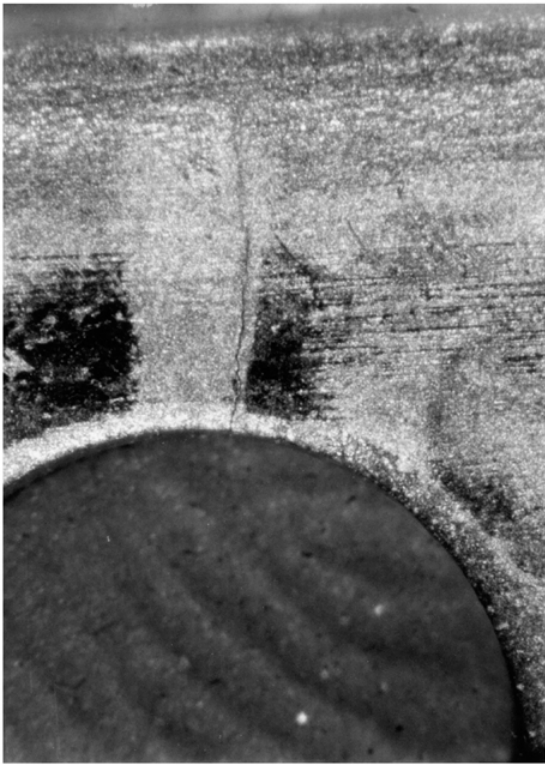
An investigation of clip failures attributed mainly to premature corrosion fatigue, has been made on Cu - 1.92% Be alloy (CDA-172) case clips. The failures were determined to be caused by three factors: (a) excessive localized tensile stresses in the fork area between spring tines, Figure A; (b) microstructure and over-aging of the associated heat treatment, RHC 38-42, Figures D, E, and F for various aging conditions; and (c) crack initiation locations (side and fork regions), Figure B, and fractography, Figure C. Improvement of each of these three factors eliminated the very short service life. Design modifications were made that resulted in a significant cost reduction, and illustrates the value added of a complete design review in addition to simply conducting a root cause failure analysis.

A - Initial Crack, 20x

Modified Clip Design – After correcting the aging treatment to 625°F for 2 to 2.5 hours, clip life doubled from 200 to 250,000 cycles. A stress analysis calculation indicated that concentrated tensile stresses were being focused at the center of the fork, and the twisting action of case release promoted side wall fatigue crack initiation. It was decided to reduce the cross-sectional area of the tuning fork clips by 25% and 50% by removing the middle of the tine. This had the advantage to reduce the resistance to twisting as the component casings were extracted from the conveyor clips. The actual shape of the tines was changed from straight to hour glass shaped. The hour glass shape change reduced the fork stresses and stress levels in the tines to less than ~40,000 psi.

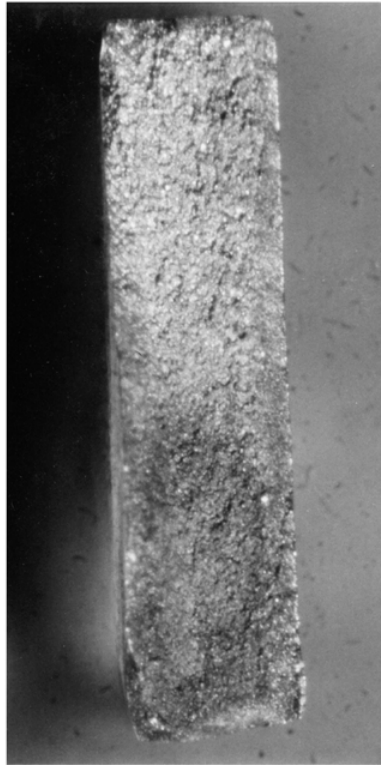
B - Fracture, 40x

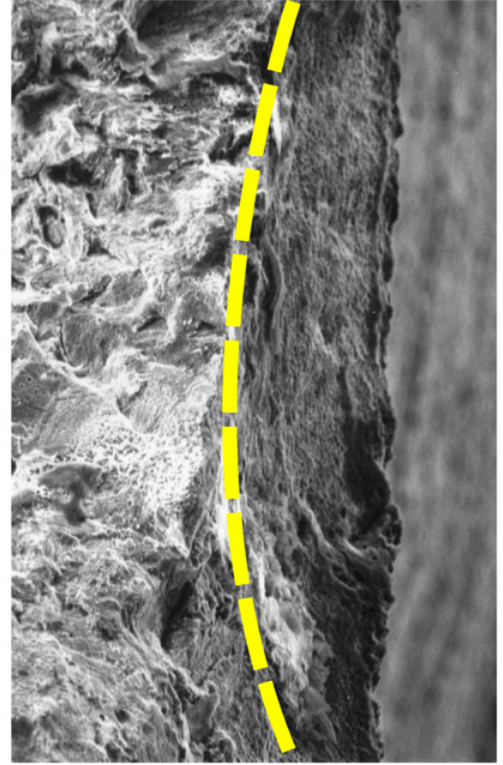
C - SEM - Fatigue, 372x

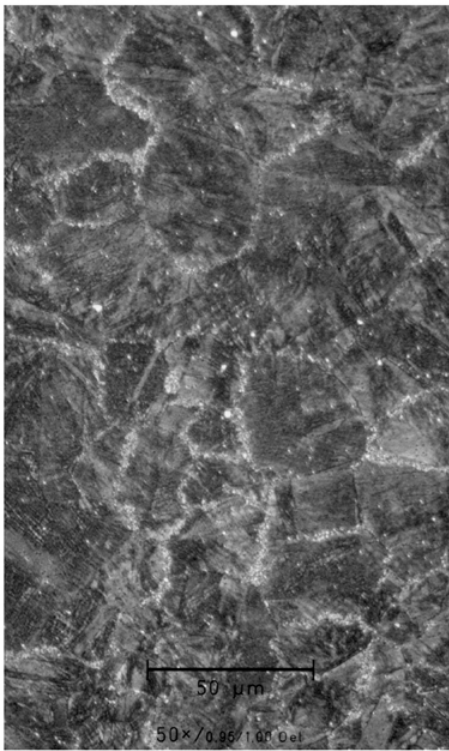
Quantitative Hardness, HRC Values – Hardness measurements for aging at 1.5 hrs. @ 750°F indicated that both new and over-aged clips ranged from HRC from 37.3 to 38.8 average, while improved clips ranged from HRC from 39.9 to 40.5 after 2.5 hrs. @ 625°F. The associated microstructures are shown in Figures D, E, and F. Clearly, the lower temperature aging condition was beneficial in that massive precipitates were no longer forming at the grain boundaries to the extent that corrosion assisted fatigue was dominant.

D - Overaged, 500x

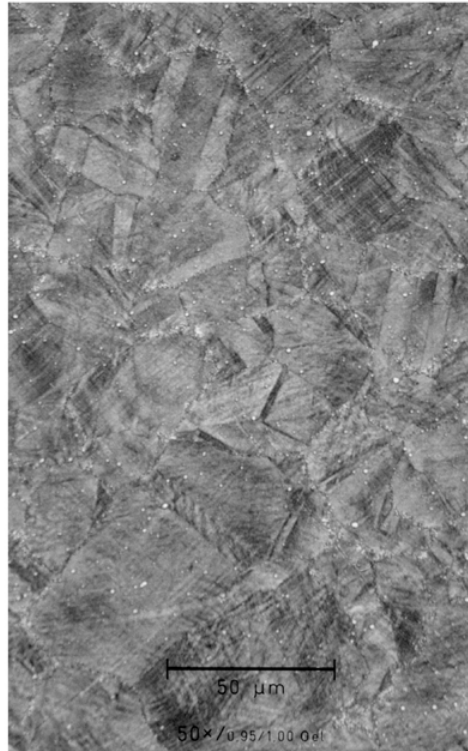
E - 1.5 hrs @ 700 F, 500x

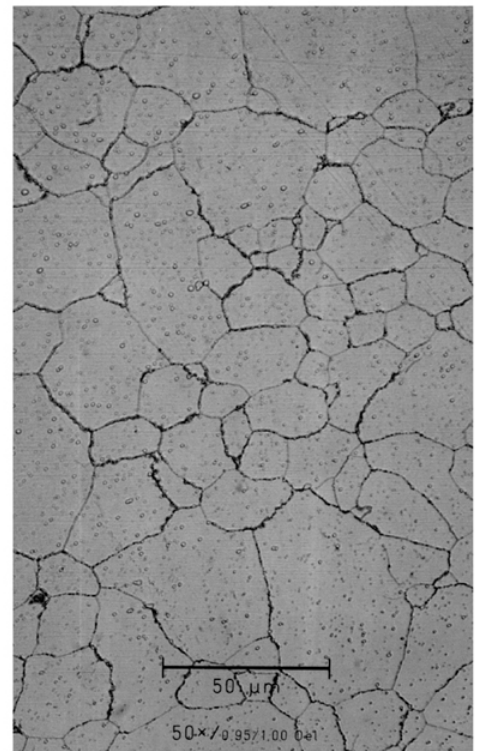
E - 2.5 hrs @ 625 F, 500x
