Failure Analysis in FeCo Magnetic Alloys through Electron Channeling Contrast Imaging Defect Characterization

Julia Deitz¹, Tim Ruggles², Philip Noell¹, Donald Susan³ and Joseph Michael¹

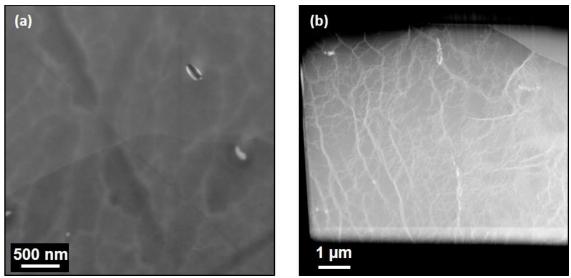
A heat-treated Fe-Co-2V alloy is investigated using electron channeling contrast imaging (ECCI), and this shows only specific grains towards the outer edges of the sample have defect content. These defects are shown in Figure 1(a) and appear consistent with anti-phase domains; if they exist, this would be indicative of ordering in the sample. These grains were further investigated with STEM shown in Figure 1(b) which show that these defects continue throughout the entire grain. HR-STEM and EDXS will be performed to conclusively determine the type of defect present in these grains. Only the grains with these defects show magnetic domains – shown with Lorentz TEM in Figure 2 – thus confirming the relationship between these defect structures and the magnetic properties of the FeCo alloy. In-situ strain ECCI will be shown to investigate the role these defects play in ultimate fracture. Understanding the role of structural defects in FeCo alloy fracture will help to mitigate their effects.

Figure 1. Figure 1. (a) ECCI image of a heat treated FeCo alloy sample showing structural defects and (b) correlated STEM image showing these defect structures continue throughout grain.
