## Scanning Electron Microscopy study of the standard sterilization procedure applied to dental instruments

M. L. Redígolo,<sup>\*</sup> P. G. R. Cardoso,<sup>\*</sup> M. B. S. Posso,<sup>\*</sup> and S. Koury<sup>\*</sup>

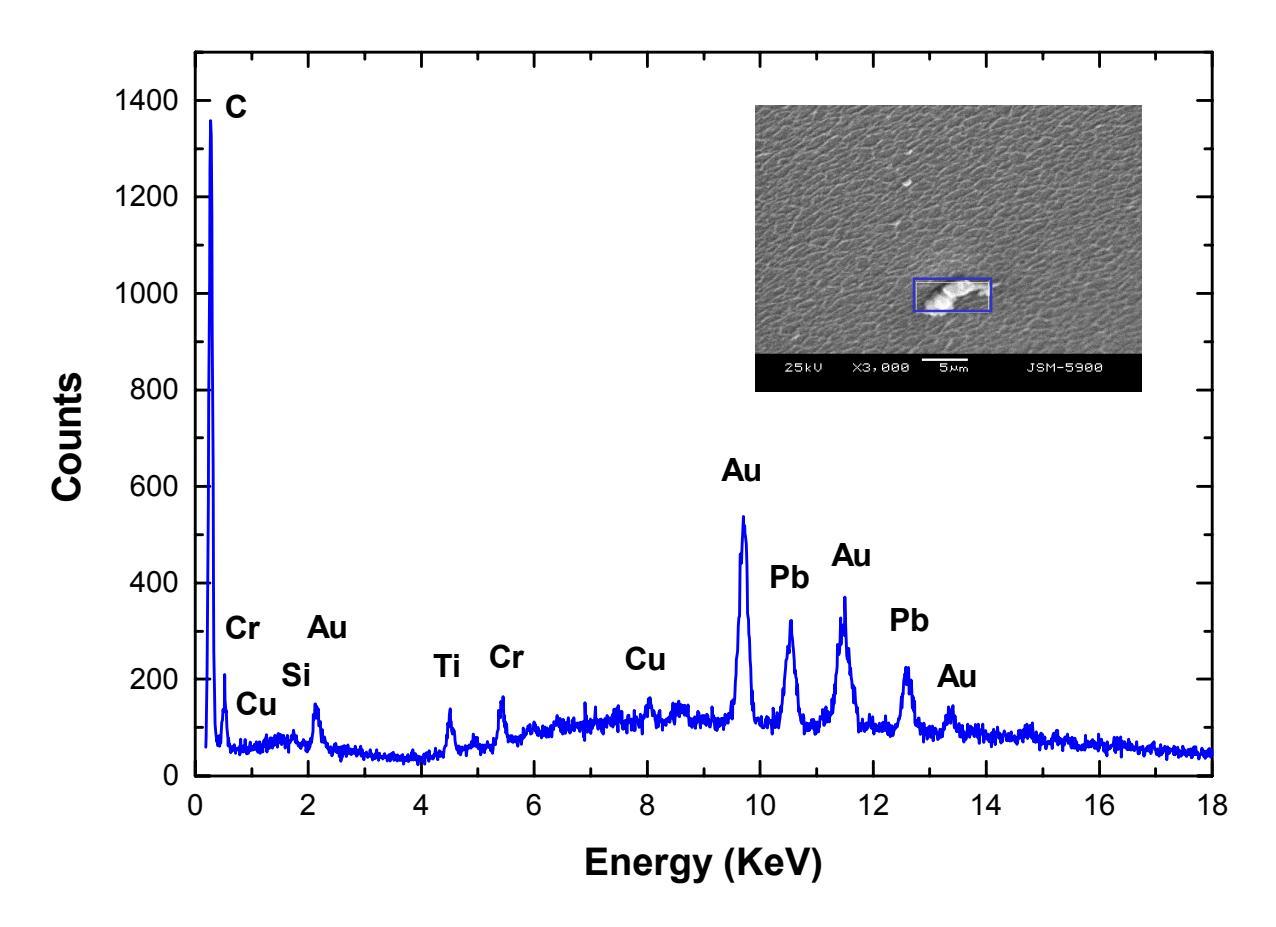
This work analyzes the sterilization conditions of ultra-high-speed air turbines through scanning electron microscopy (SEM) observing the internal parts of the dental handpiece ducts searching for points of corrosion and biofilms. The electron microscopy was performed with a JSM-5900 LV microscope (JEOL) under 15 kV and 25 kV, at the Brazilian Synchrotron Light Laboratory. The samples were also submitted to Energy Dispersive Spectroscopy (EDS) to check for specific proteins characteristic of bacteria activity.

FIG. 1. EDS analysis of the marked region presented in the SEM photomicrograph (x 3000; 5  $\mu$ m bar)

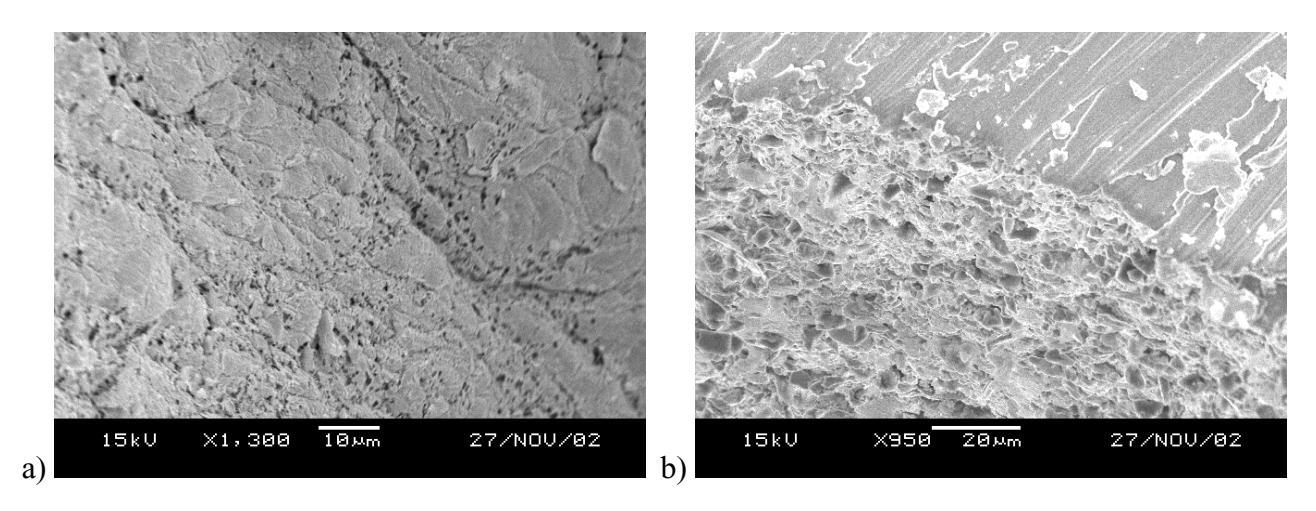
For this study, three dental handpieces were analyzed. The first one was submitted to 1000 sterilizing cycles during its 5 year period of use. The second one was submitted to only 30 cycles of sterilization process. A brand new handpiece that was not submitted to any use or sterilization procedure represents the control sample. The standard sterilizing procedures here adopted include a cleaning process in enzyme detergents using an ultrasonic device with distilled water. Then the handpieces were submitted to a lubrication process with an aqueous solution (Premix ®) and to standard autoclaving (121 °C during 30 min) in steam sterilizers. Through the microscopy and a bacterial culture analysis, no biofilm was detected. While these procedures are effective in preventing the formation of the biofilm they are also considerably aggressive contributing to the handpieces corrosion process. Figure 1 shows the EDS results for debris found inside the handpiece air duct presenting traces of Chromium and other elements. The most used handpiece analyzed in this experiment presented a deteriorated internal surface for the water duct due to the corrosion process (figure 2b) differently from the aspect observed for the control handpiece (figure 2a).

FIG. 2. SEM photomicrograph of the inner surface of the water duct for (a) the control sample (x 1300, 10  $\mu$ m bar) and for (b) the most used handpiece (x 90; 200  $\mu$ m bar).
