Investigation of failure mechanisms in ion irradiated X-750 Ni-based superalloy using transmission electron microscopy

Zhongwen Yao¹ and Pooyan Changizian²

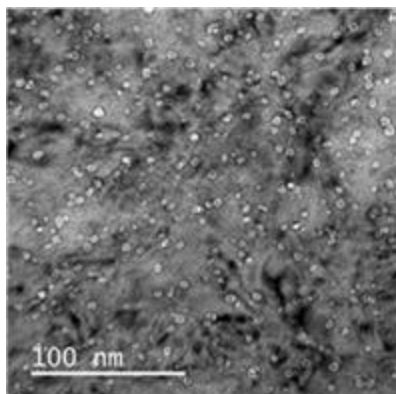
Figure 1. Figure 1. After helium ion implantation, the bright field micrograph showing the cavities.

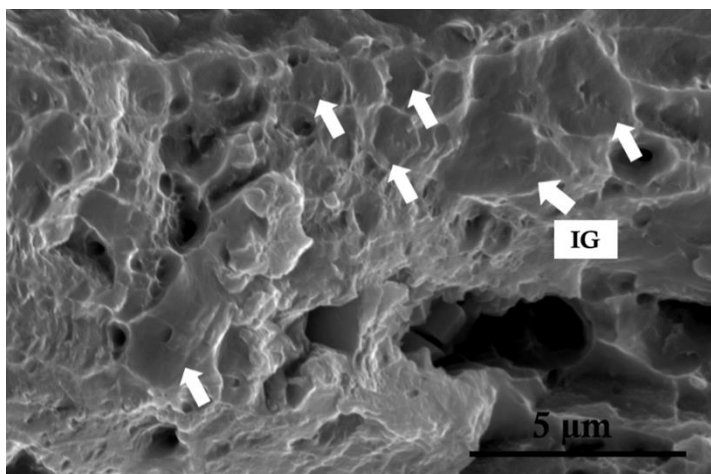
Figure 2. Fig. 2. The SEM fractography on helium-implanted sample shows the grain facets which indicate the intergranular fracture.
