ICD Lead Dislodgement and Inappropriate ICD Shocks

Pablo Blanco, MD*

A 16-year-old girl with a history of peripartum cardiomyopathy and implantation of a cardioverter-

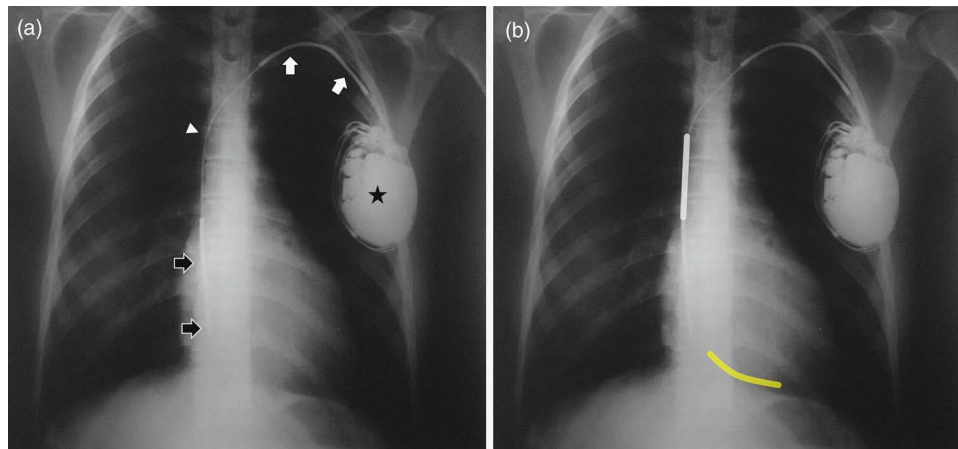
Figure 1. (a) Chest radiograph showing the ICD generator (black star), ICD lead (arrowhead), and the two coils (arrows) for providing the electric shock. The superior vena cava coil (white arrows) is displaced into the left subclavian vein and the right ventricular lead (black arrows) is displaced into the right atrium, directed toward the region of the inferior vena cava (IVC). (b) Same chest radiograph of (a) indicating the proper position of the shock coils into the superior vena cava (white line) and right ventricle (yellow line).

left infraclavicular region, with some tenderness on palpation. A normal sinus rhythm was recorded on the surface electrocardiogram. A subsequent witnessed ICD shock was not related to any arrhythmia detected on cardiac monitor. A chest radiograph demonstrated a single-chamber ICD and lead dislodgement, with the resultant misplacement of both ICD shock coils (Figure 1). Transthoracic echocardiogram also confirmed the lead displaced into the inferior vena cava (Figure 2a). A magnet was applied over the ICD generator and device firing was abolished (Figure 2b).

Inappropriate or unnecessary ICD shocks commonly occur as a result of changes in device sensing due to alterations in lead integrity, improper lead position (as in this case) and supraventricular tachyarrhythmias.^{1,2} In order to eliminate this life-threatening ICD

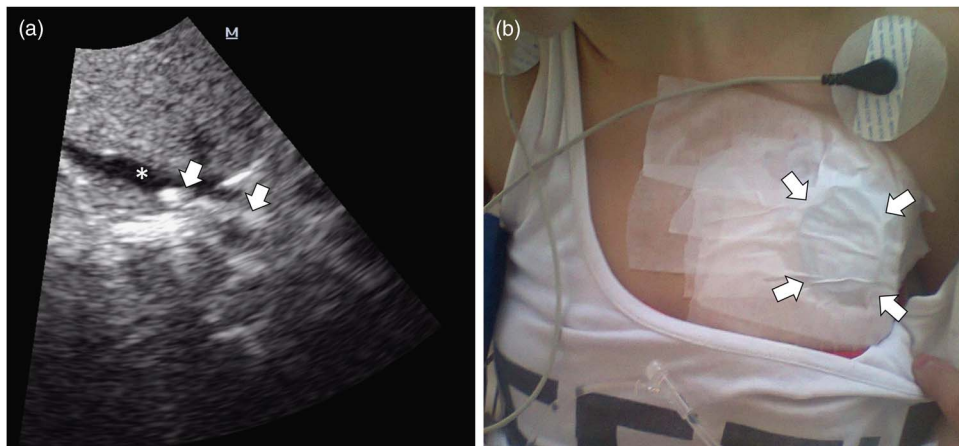
Figure 2. (a) Transthoracic echocardiogram demonstrating the tip of the ICD lead and RV coil (white arrows) entering into the IVC (asterisk). (b) A magnet (white arrows) is placed over the ICD generator and is secured with tape to maintain the inactivated status.

complication, a magnet should be positioned over the device to temporarily suspend tachyarrhythmia intervention until ICD problems are identified and resolved,^{1,2} and thus it should be required to have a magnet available in all EDs.
