Correlative 3D X-Ray, Laser Ablation, and SEM/EDS Mapping Establishing Access Point for FIB Tomography of Defects in Multi-Layer Ceramic Capacitors

J Favata¹, V Ray¹ and S Shahbazmohamadi¹

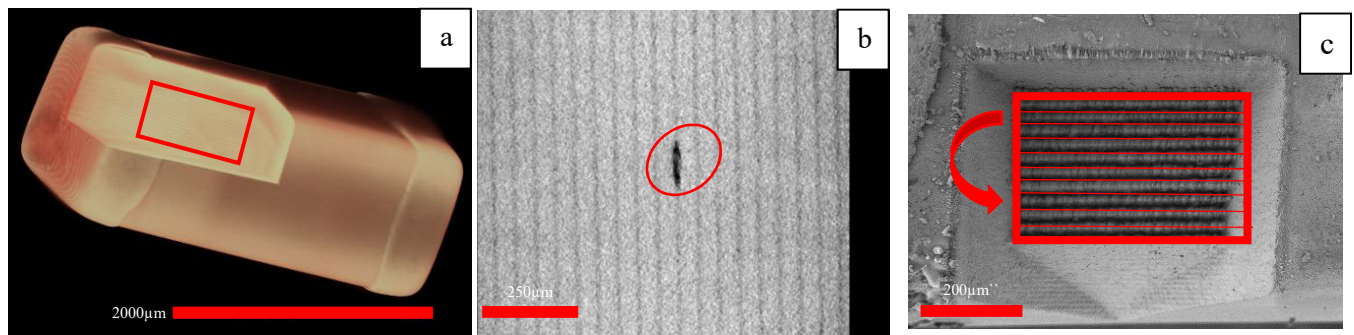
Figure 1. 3-D X-ray tomography volume rendering of MLCC (a), high-resolution cross-section of suspected defect area (b), and laser raster pattern with direction of incremental line rotation (c).

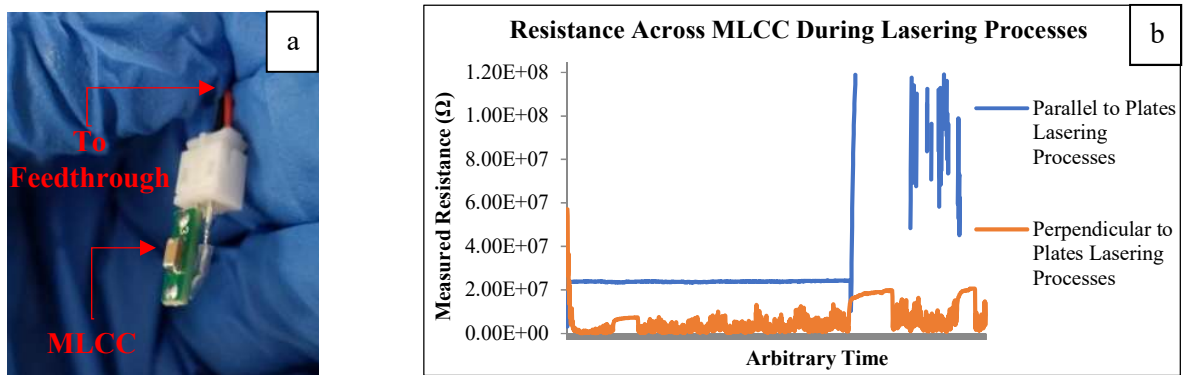
Figure 2. Sample-end in-situ monitoring configuration (left); Resistance measurements across MLCC during lasering processes; Breaks in blue graph represent infinite resistance, corresponding to no detectable leakage (right).

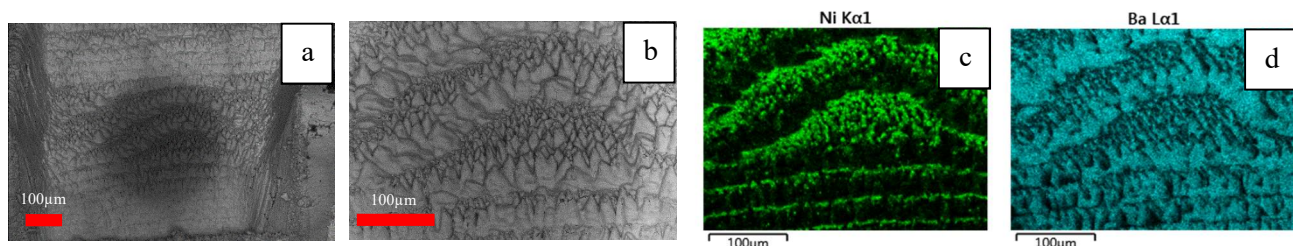
Figure 3. SEM images of access point to region of suspected defect (a and b) and respective EDS maps showing distinct BaTiO₃-dielectric and Ni-conductive plate regions (c and d) after laser milling.
