# The Role of Microscopy in Indoor Air Quality Investigations

R.B. Simmons  
Georgia State University  
rsimmons@gsu.edu

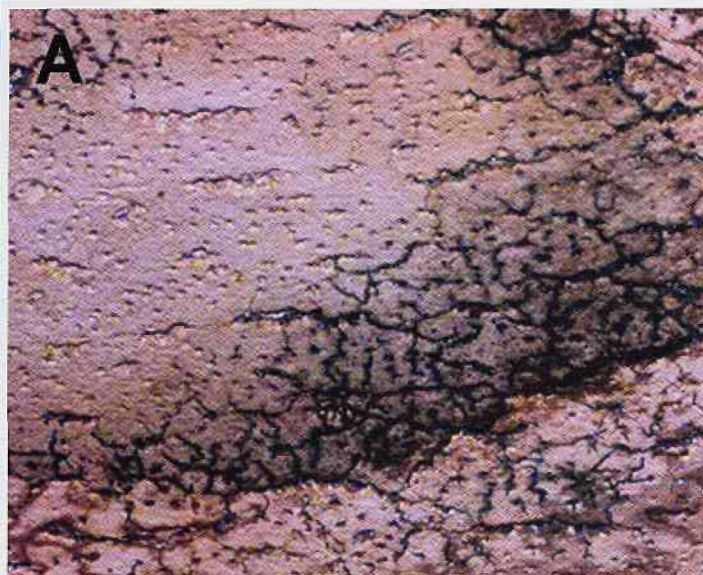
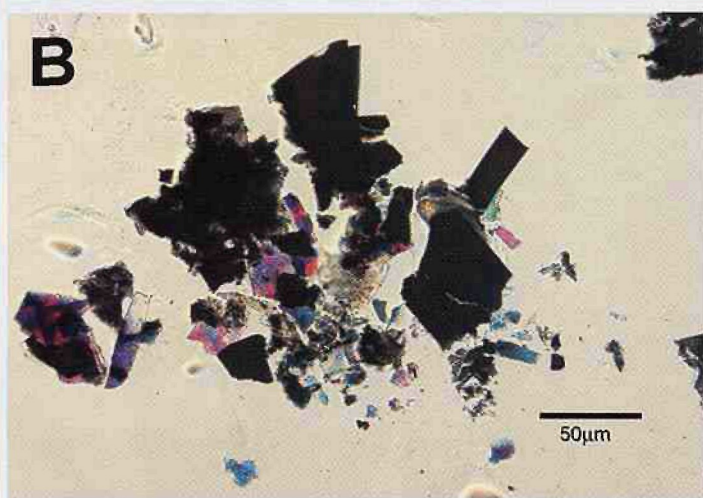
**Figure 2.** A. Textured black and red stain as observed on a water damaged cellulose fiber ceiling tile. B. Mineral deposits identified by light microscopy. No fungi were detected. Scale bar = 50  $\mu$ m.

Many different species of fungi look similar on natural substrates to the unaided eye. Light microscopy of samples collected on clear polypropylene adhesive tape (clear packing tape will do) often gives a quick answer to the question of what groups of organisms are actually growing on a surface, or if the suspect surface features are not biological in origin. Scanning electron microscopy of materials will show surface features in great detail. Figure 1 shows examples of 'black mould' on wall coverings from 2 different sites. Visual inspection might lead to an identification of *Stachybotrys* at both sites. However, the sample on the left shows the presence of *Alternaria* and *Fusarium* (both potential, but rare pathogens) whereas the material on the right shows *Stachybotrys*. Figure 2 shows a colorful stain on a water damaged ceiling tile, which, under microscopic examination is actually a mineral deposit. Microscopic examination of a similar stain from another ceiling tile shown in Figure 3 clearly demonstrates the presence of the fungus *Stachybotrys*.

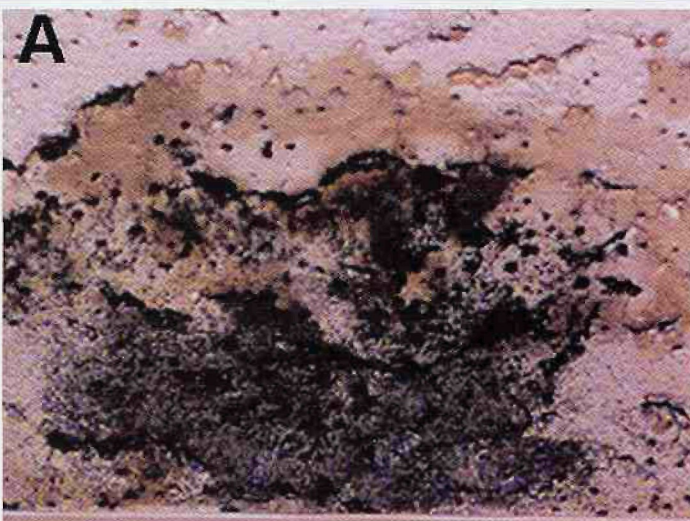
**Figure 3.** A. Textured black and red stain as observed on a water damaged cellulose fiber ceiling tile. B. Light micrograph showing conidia and conidiophores of *Stachybotrys chartarum*. Scale bar = 20  $\mu$ m. C. Scanning electron micrograph of the ceiling tile surface showing mature *Stachybotrys* conidiophores with conidia. Scale Bar = 3  $\mu$ m.
