# AN UNUSUAL ICE FORMATION ON THE OTTAWA RIVER

By L. W. GOLD and G. P. WILLIAMS

(Snow and Ice Section, Division of Building Research, National Research Council,  
Ottawa, Canada)

**ABSTRACT.** An unusual humped formation of floating ice, about 10 m. high, 100 m. wide and 1,200 m. long, was observed on the Ottawa River, Canada. Some characteristics of this formation are described. The cause of the humps was found to be frazil ice deposited in a trench about 90 m. wide, 90 m. deep and 1,200 m. long. The frazil ice was formed in rapids up-stream from the humps.

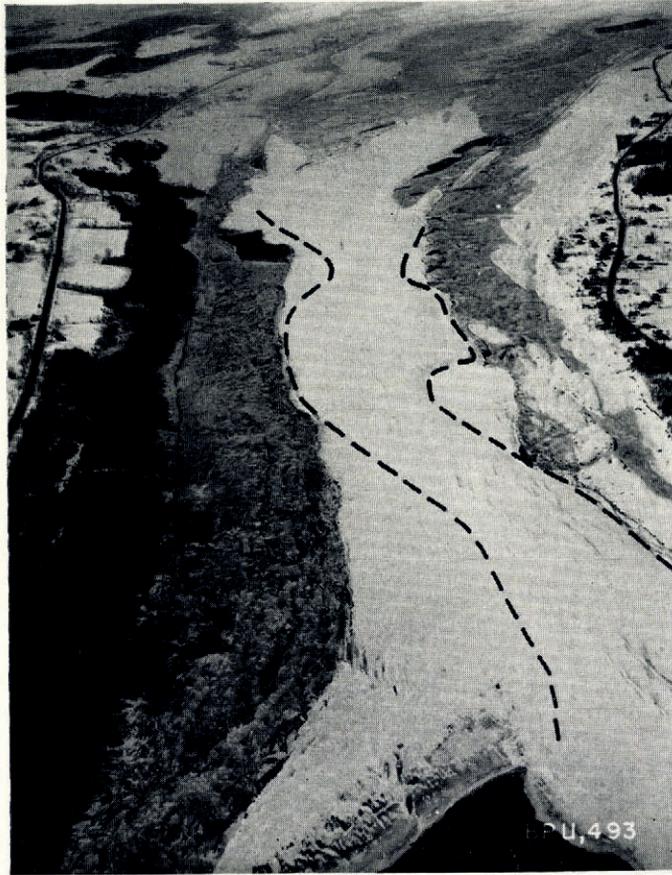
*Fig. 1. Aerial view of ice humps at Greece's Point taken from an altitude of about 600 m. Greece's Point and the highway are seen on the right. The dashed lines outline the humped region*

The disturbed area of the ice cover was about 1,200 m. in length and at a site where the river narrowed from about 550 m. to a little under 300 m. Within this area were two very large humps between 450 and 600 m. long and about 150 m. wide (Fig. 1). In the photograph, the river flows from the top to the bottom. Figure 1 shows to a limited extent the widening of the river above and below the site of the humps.

At the top of the humps were several large longitudinal cracks (Fig. 1), up to a metre in width. Although the cracks were usually snow-filled, at some places the upper part of the humps was exposed in profile as shown in Figure 3. It could then be seen that the surface of the humps consisted of a layer of clear river ice some 25 cm. thick overlain with snow. Beneath the clear ice was a porous ice deposit which had a density of about one-third that of normal ice.

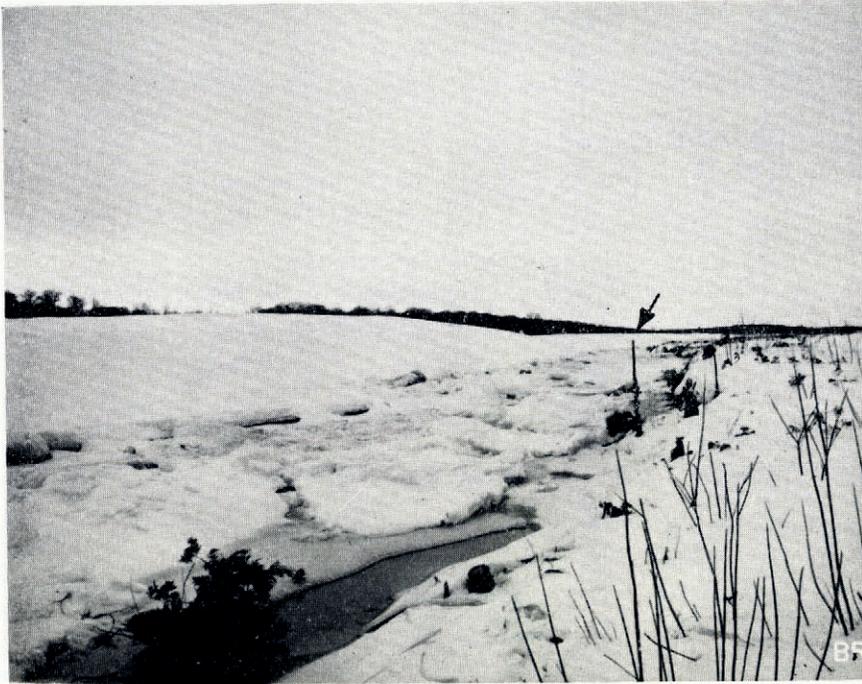
*Fig. 2. The ice humps photographed from the north shore of the Ottawa River. Ice pans and water can be seen between the rock face at the shore and the edge of the ice humps. The arrow locates the up-stream hump*

Each hump rose gradually to a height between 10 and 12 m. above the water surface. This can be seen in Figure 2 where part of the down-stream hump is shown in profile. The up-stream hump can be seen in the background.

down-stream. Only about 0.5 m. of the top of the rock face was above water. The ice humps had risen as well showing that they were floating. The shape of the humps could now be seen clearly against the background of trees on the opposite side of the river. The space between the shore and the hump edge was filled with ice pans and water was visible at some locations. This, as well as the edge of the rock face, can be seen in Figure 2.

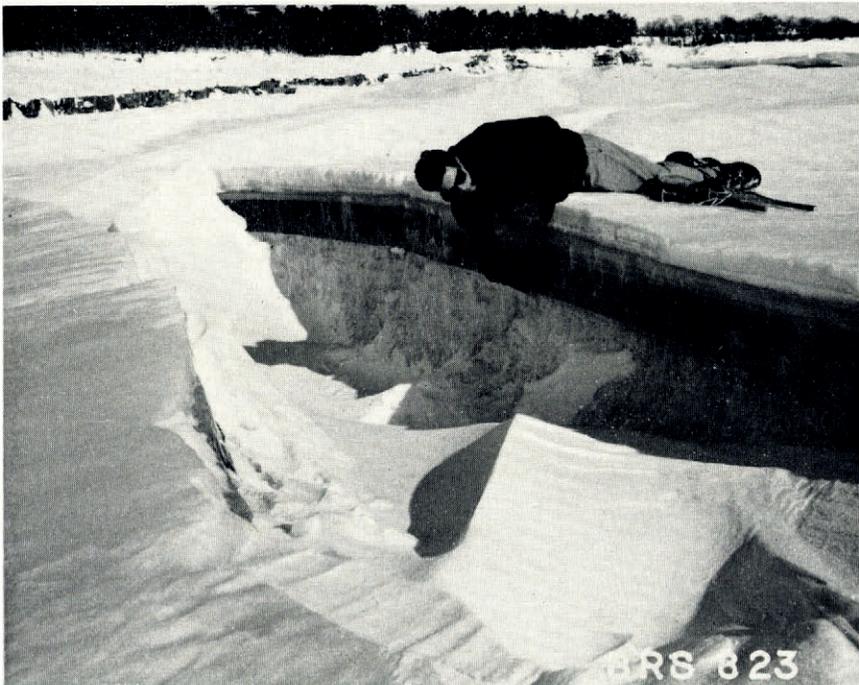
*Fig. 3. An exposure of the upper part of one of the humps by a longitudinal crack. Note the 25 cm. of clear river ice underlain by porous ice*

Two trips were made to the site of the humps during the winter of 1961-62. At the time of the first visit, there was an almost vertical rock face about 9 m. high on the north side of the river at the shore edge. The upper part of the face can be seen in Figure 3. The top of the humps was about level with the top of the rock face. At the time of the second visit the water level had risen about 9 m. due partly to spring run-off and partly to the closing of a new dam
