SUTTON HOO: RE-IMAGING THE SHIP AND CHAMBER

Valerie Fenwick, FSA

Information dispersed in the definitive publication is correlated and developed. Digital 3D imaging of the ship's iron fastenings are used here to extrapolate curved lines of missing rivets and superimpose them on the burial chamber plan. A digital roof reconstruction is also presented.

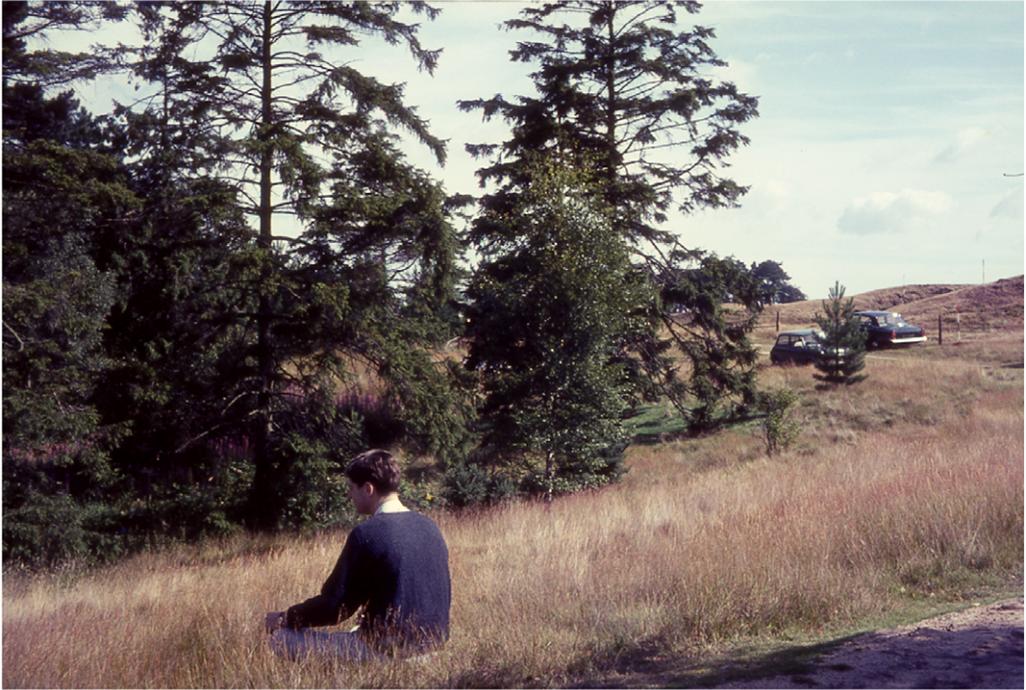
Fig 1. a) the southern combe in 1965 showing its proximity to Mound 1 (right); b) lifting the rivets in 1967. A portion of the stem post remains in the trench cut in natural banded sand.

The author’s involvement in Sutton Hoo began in 1964. Upon joining the then huge Department of British and Medieval Antiquities, she was tasked by Rupert Bruce-Mitford with setting up, firstly, the Sutton Hoo research programme in an annexe of the British Museum, and the re-excavation of the ship impression to begin the following year (fig 1).⁶

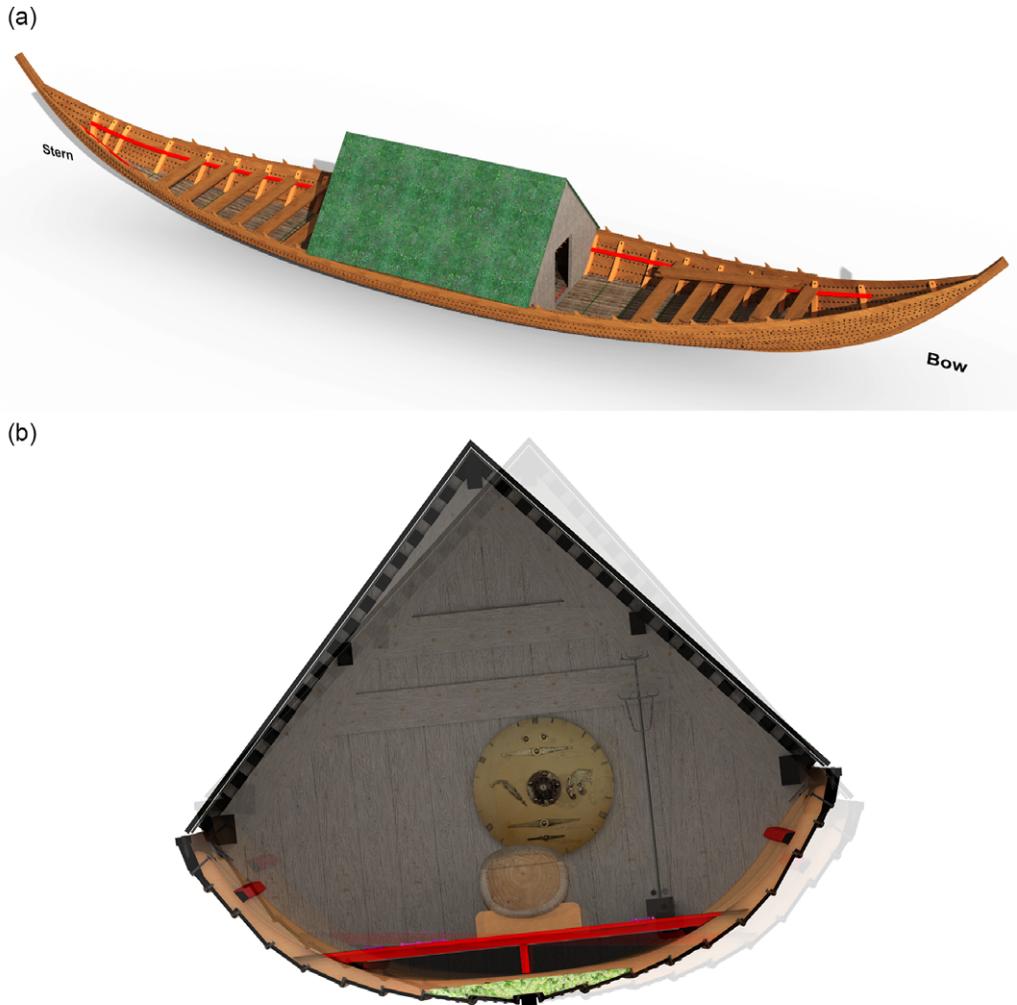
Fig 2. a) the ship as reconstructed with a turf-covered chamber accessed from the foredeck; b) section of the chamber reconstructed to show the subsequent tilt. *Images:* © Pat Tanner.

An opportunity for new research was facilitated by the reconstruction of the Mound I ship. In 2016 the Riverside Trust initiated the project. A sister charity, the Sutton Hoo Ship's Company, was given a brief to use the original materials and contemporary technology. Accurate plans of the hull were essential, and a thorough expert reappraisal was commissioned. Pat Tanner and Julian Whitewright were confronted with disparate information, comprising a photographic record and paper reconstructions. The solution they adopted was to plot each rivet in three dimensions to create an adjusted digital image of the hull.⁹ Their brief required assessment of missing information, such as propulsion, displacement, rowing geometry and performance capability. That data underpins the new 3D reconstructions created for presentation here, namely, internal ship structure, the space amidships, the deck level and the chamber roof. The recorded tilt of the ship is shown.

The tilt is patent in the photographic coverage, measured during the Science Museum survey and recorded in our re-excavation. It was sufficient to impact the grave goods (fig 2b and 5). It caused some objects to slip southwards. Others appear to have slid or toppled from furniture or supports. Examples of tipped items are: the inverted pile of silver bowls and pair of spoons; bucket 2; the gold and garnet rod; the iron stand; the Coptic bowl with the angons gripped by one of its handles; the pottery bottle; and the lamp. This was the first of three movements that can be detected.

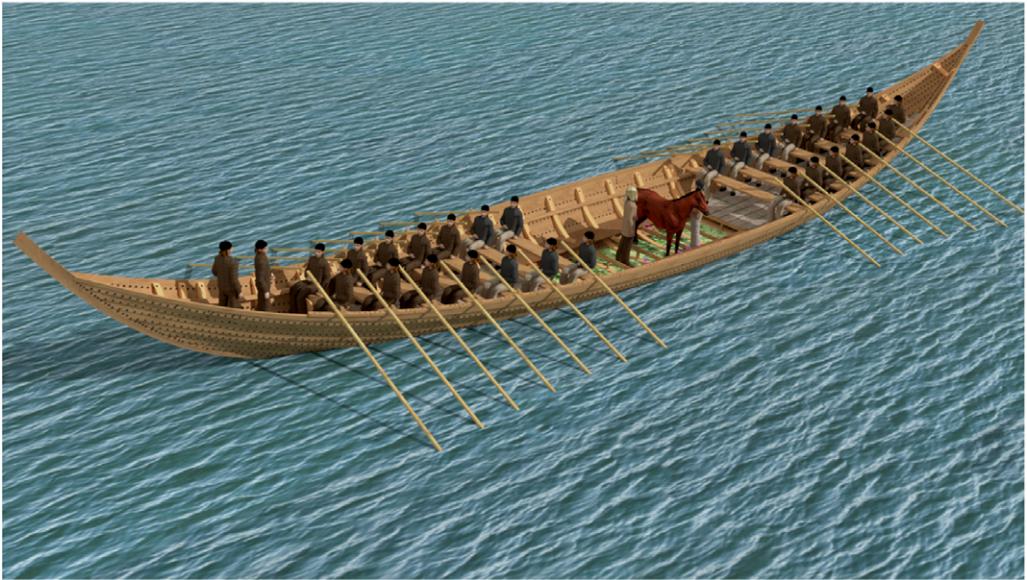
Fig 3. The Mound I ship reconstructed with twenty-eight oarsmen: a) the open hold here used to accommodate a rider and fourteen-hand horse standing on dunnage; b) another view.

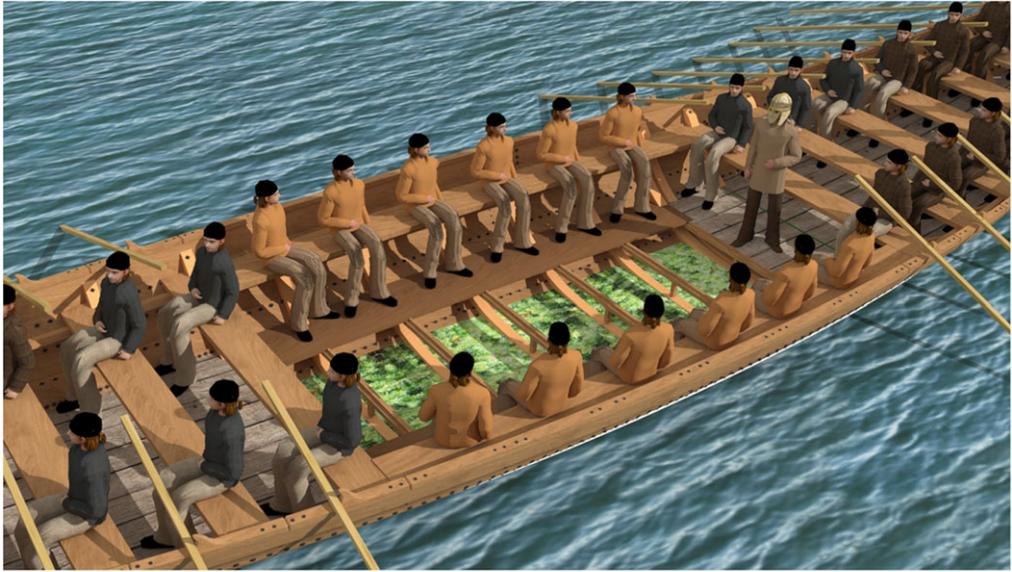
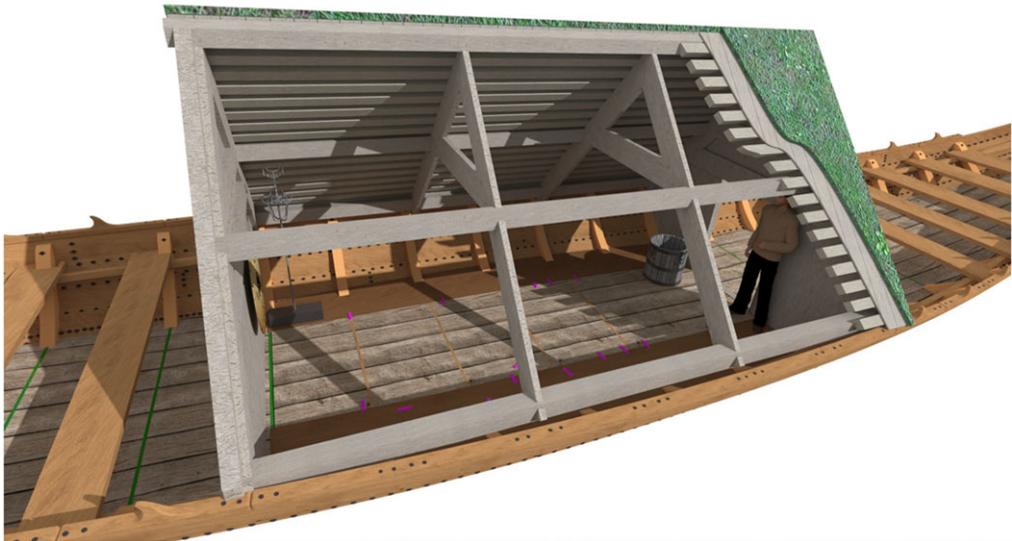
Fig 4. Tentative reconstructions amidships: a) gangways connect decks and accommodate passengers; b) cutaway of the burial chamber with a platform inserted in the open space between the gangways. *Images:* © Pat Tanner.

higher percentage of *Calluna sp.* compared with the adjacent old ground surface.²¹ This is a clue that the decayed vegetable matter may have included heather dunnage, a bedding of choice, on which passengers, gear and animals could be transported (fig 3). In addition to lowering the centre of gravity, the bottom of the vessel provided some shelter from the elements. The Bayeux Tapestry depicts horses stalled low down in galleys under sail.²² The images remind us that there may have been similar accommodation in the Sutton Hoo galley. Flanking gangways would have facilitated the crew movement fore and aft (fig 4a).

at each end were found unevenly disposed 700–800mm distant from the centreline of the keel (fig 4b, 5)²⁴ In Phillips' view they possibly fastened the platform. Varying numbers of cleats are associated with coffins or beds in Anglo-Saxon and continental cemeteries.²⁵ Such crude devices are at variance with the standard of contemporary joinery.²⁶ They are best seen as improvisations by funeral undertakers to strengthen or fasten coffins or reinforce a bed sufficiently to transport a corpse. Cleats have the obvious advantage of not requiring a burial party with carpentry skills.

In the ship the cleats have been interpreted as evidence for a giant coffin, or 'body-bearer'.²⁷ However, the sixteen located specimens, and a further four with no individual find-spot, resist identification as coffin fittings because all were lying horizontally. Additionally, the evidence of textiles on the upper surfaces of three shows that their nails pointed downwards.²⁸ Phillips' and Bruce-Mitford's original idea of a platform still stands. However, they were unable to suggest a part of the ship to which it was secured. As no internal structural elements survived, the minimum is suggested here, namely, planks resting on deck-beams (which incidentally would have strengthened the framing) with thwart risers and stringers (longitudinal elements), which would help to resist racking (twisting) in a hull without a backbone (fig 6).²⁹ On this hypothesis, partial decks, or gangways, could provide a function for cleats securing the infilling planks (figs 4b, 6).

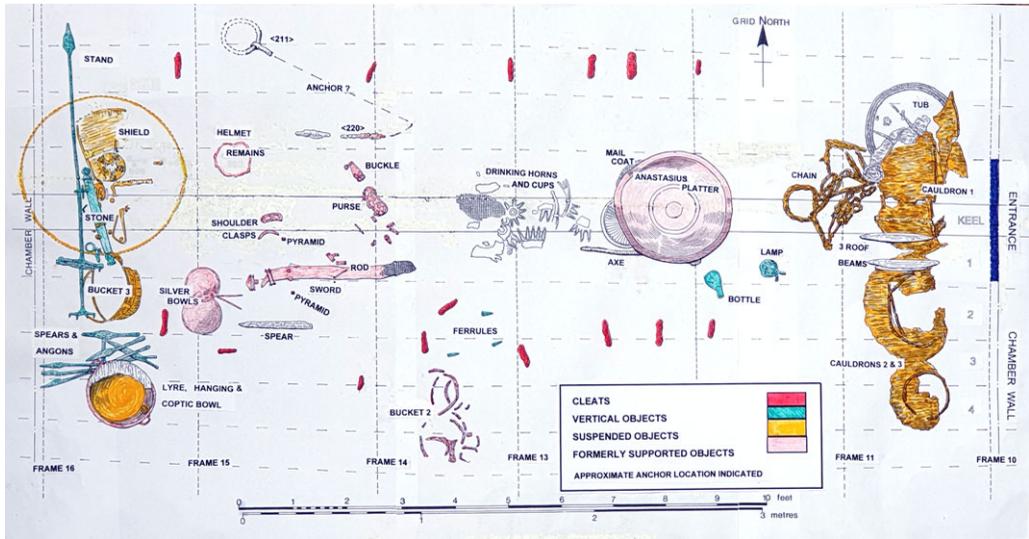
Fig 5. Plan of the burial chamber coloured to show the movement of objects. The strakes and presumed entrance are indicated. *Drawing:* Author's additions to published plans.

There is evidence that a wooden structure the size of a modern garage was built over frames 10 to 16 (fig 5) with the apex of a pitched roof about 2.95m above the keel. The height of presumed vertical objects precludes a horizontal roof (fig 7). The tiny portion of remaining

Brown had also probed the deposit, removing wood traces. Three pieces of oak were left in place (fig 5). They were recorded as ‘pegs’ by Stuart Piggott. Later termed ‘stakes’, their function remained opaque. However, <230a-c> are patently neither pegs nor stakes, but eroded portions of substantial oak timbers locally preserved by proximity to the corroded cauldrons. Their elevated position suggests close-set purlins and key evidence for the roof. Fig 7, proposed here, is based on the need for any reconstruction to conform with the recorded evidence. The unsophisticated digital images are intended to indicate the structure, but joints and scantlings are open to debate.

Fig 5 indicates the planned position of <220> and described position of <211>. They may once have formed part of an anchor lying in the apparently emptier northern part of the chamber with space for organic materials, such as coils of rope. Part of an iron ring, <211> lay between frames 13 and 14. It was of 15mm section and approximately 200mm in diameter. A hoop of the same thickness with flattened ends was connected. The length overall was about 120mm, but the tips were broken and showed signs of flaring. It was very badly corroded, but Bruce-Mitford speculated that it represented the top of a heavy wooden anchor, ‘iron fittings from the fluke or stock could well have been unrecognized amongst the mass of fragmentary pieces of iron excavated in 1939’.⁷⁶

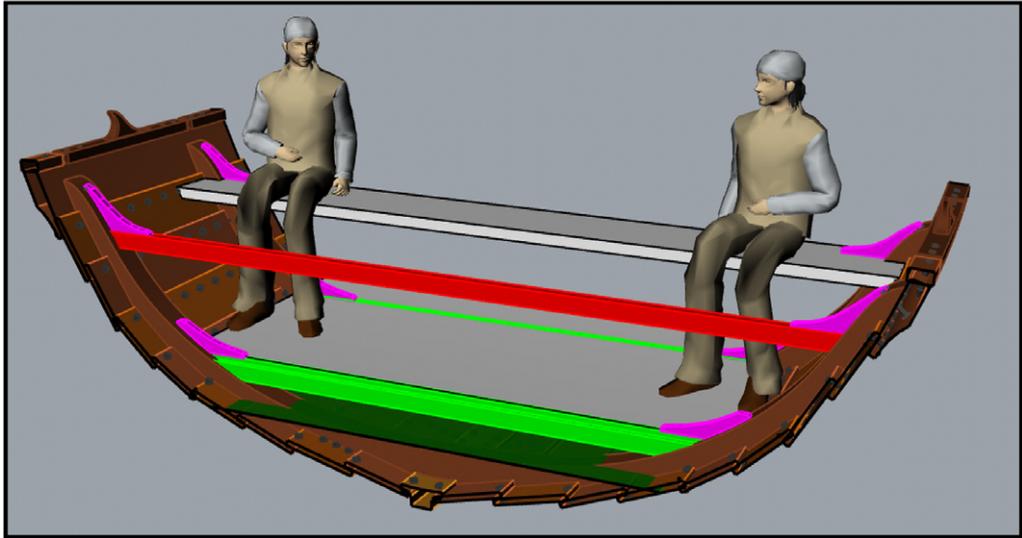
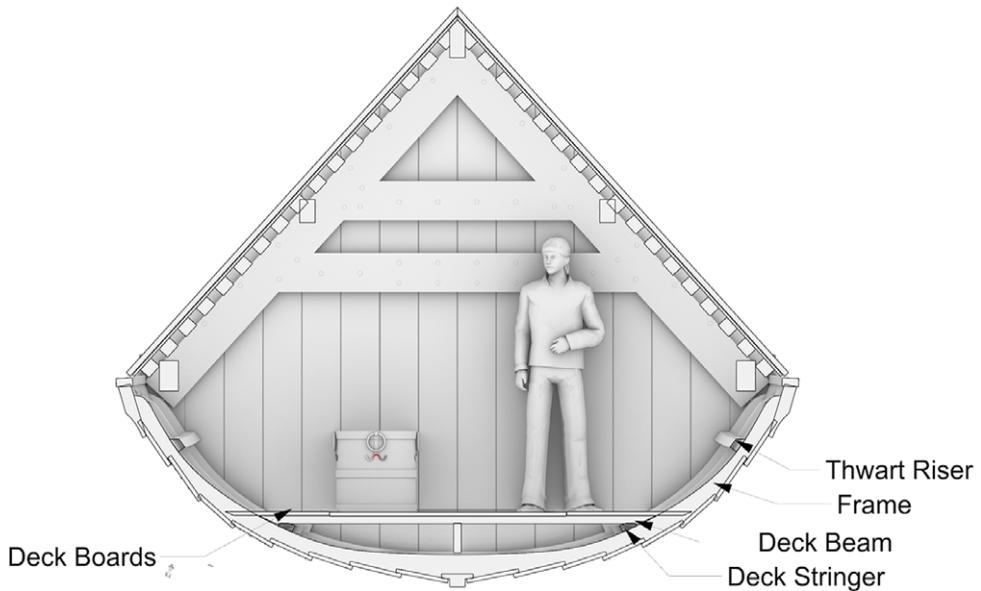
Fig 6. a) the rowing positions of seated oarsmen can be used to determine the height of thwarts and deck, variously supported; b) the deduced deck level is a clue to the height of the burial chamber platform. *Images:* © Pat Tanner.

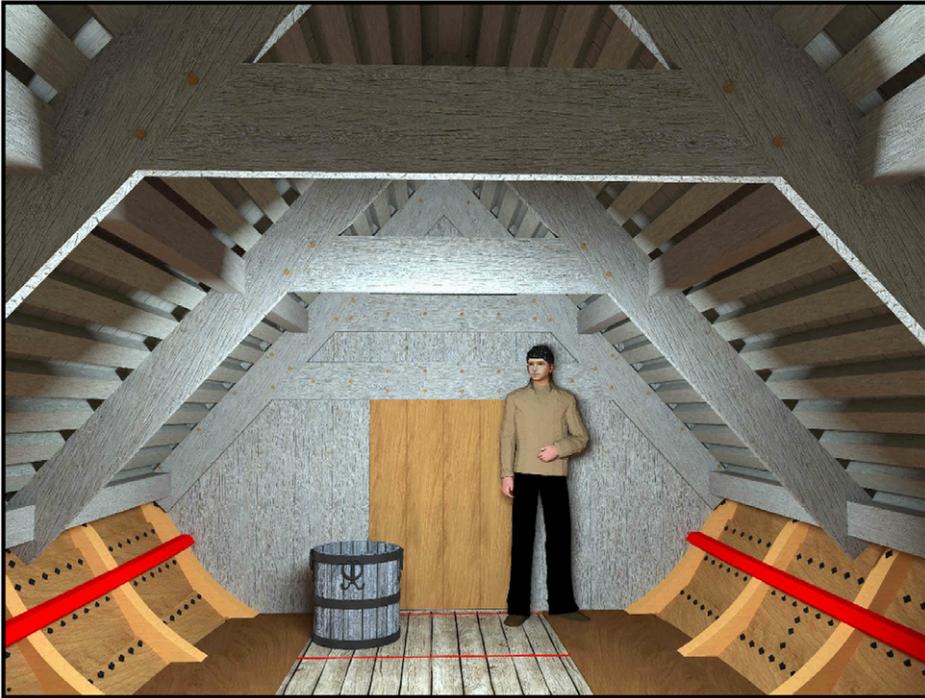
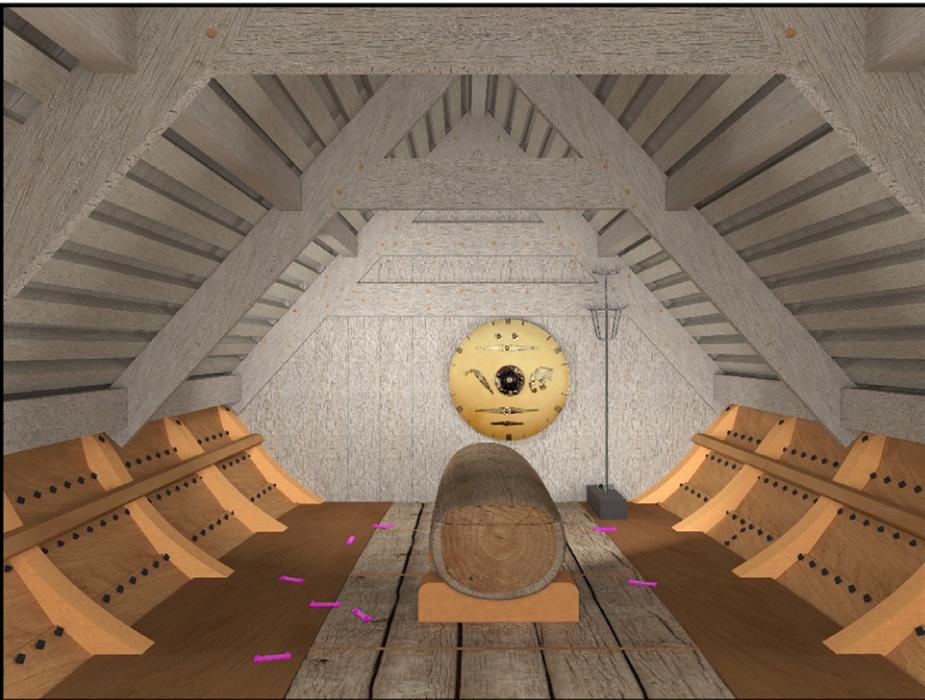
Fig 7. Two views of the reconstructed interior of the burial chamber showing: a) proposed opening in the east wall and thwart supports (red); b) relative positions of cleats (purple). *Images:* © Pat Tanner.

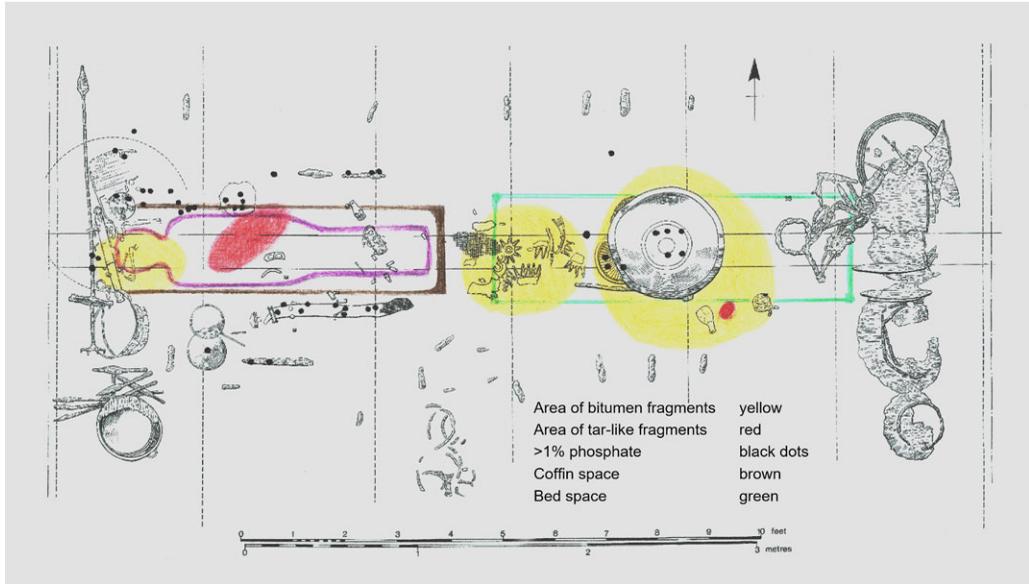
Fig 8. Plan of the burial chamber coloured to show the distribution of residual phosphate, bitumen and 'tar', and proposed positions of a coffin and bed. *Drawing:*

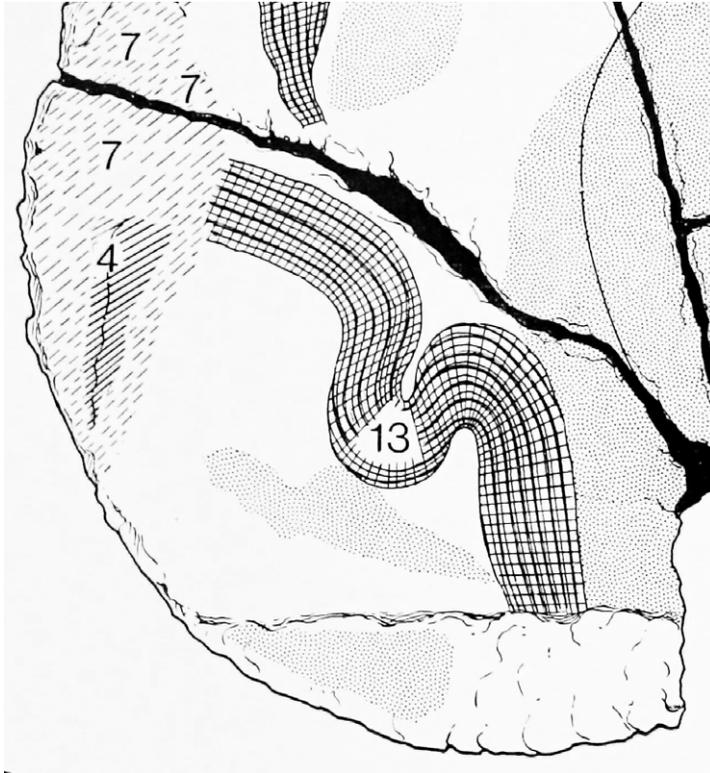
Fig 9. Tape <13>. Impression of parallel lengths preserved on the corroded mail coat.
Drawing: Eric Eden © Trustees of the British Museum.

In contrast to the unused coils, apparently used tape was mineralised by proximity to the rusted mail coat where two types occurred.⁴⁷ There was estimated to have been as much as 10m of tape <13> (fig 9). It had no obvious function and appeared to be parallel or folded lengths. The same tape was recorded elsewhere with the comment, ‘appearances suggest a spare supply for various purposes’.

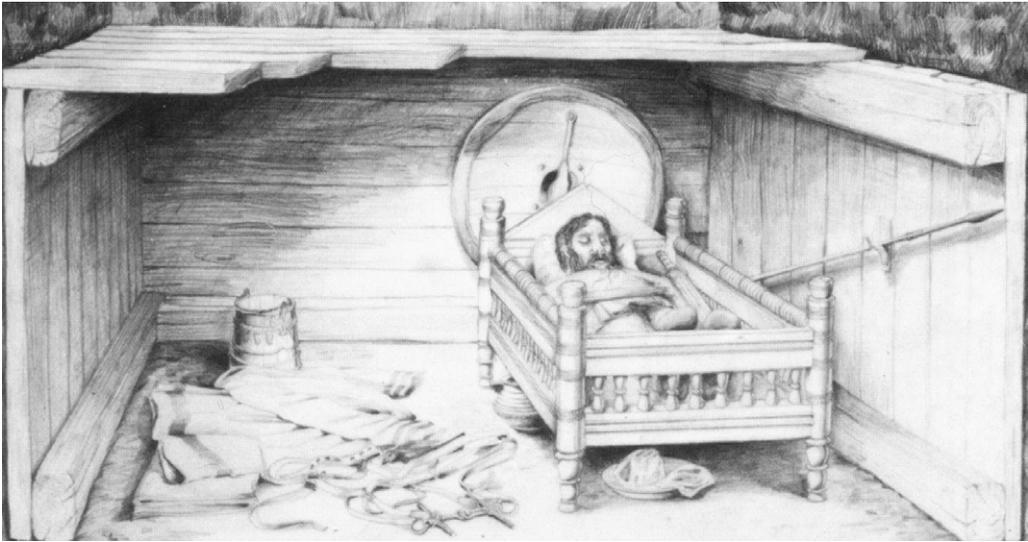
Fig 10. Basel-Bernerring grave 33. Reconstruction of the bed.
Drawing: After Moosbugger-Leu 1982.

Contemporary beds of this design have been found in well-preserved Alamannic male graves. Dimensions are a guide to what may be postulated in the body space. Reconstruction of Basel-Bernerring grave 33 shows that beds of this type existed in this period.⁶⁹ It demonstrates that the axe and chain mail could lie under a bed, with the hanging bowls, silver dish, clothing and other items on the bedding (fig 10). Overall, the silver platter could be supported by laths laid across the bed rails.⁷⁰

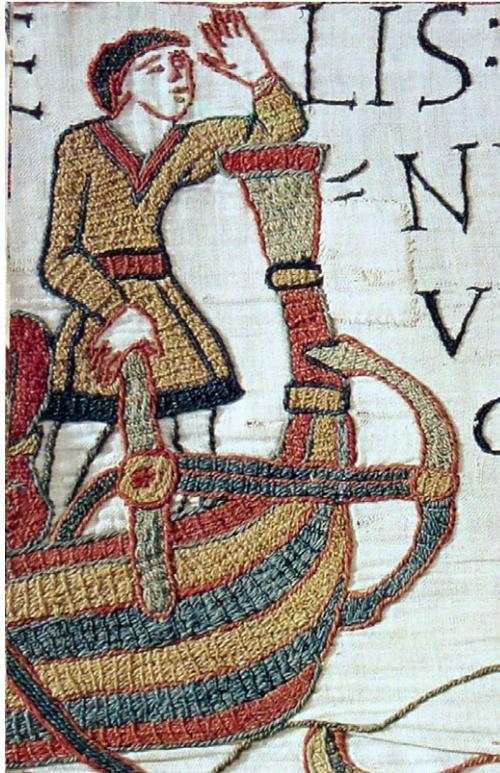
Fig 11. Composite anchor resting on the gunwale of an English ship. *Image:* Official Bayeux Tapestry digital representation, City of Bayeux, DRAC Normandie, University of Caen Normandie, CNRS, ENSICAEN.

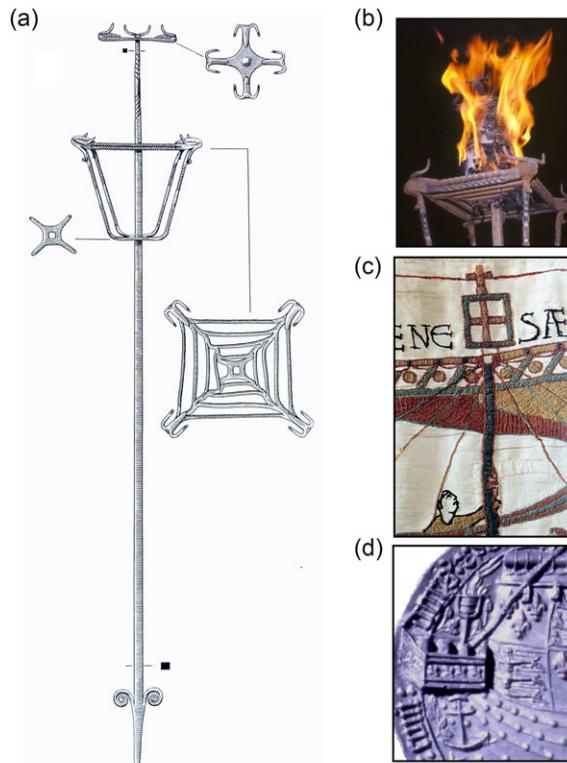
Fig 12. Possible ships' 'cressets': a) the Sutton Hoo 'stand' as restored and b) replicated and fired; c) unlit at the mast head of Duke William's flagship (Bayeux Tapestry); d) flaming on the forecastle of a Plantagenet flagship. Detail of seal impression. *Original drawing:* a) Author. *Photographs:* b) and d) © Author. *Image:* c) Official Bayeux Tapestry digital representation, City of Bayeux, DRAC Normandie, University of Caen Normandie, CNRS, ENSICAEN.

In 1988 the author returned to the original identification by Phillips. A replica was mortised in an oak block based on the dimensions of an oak beam <231> found near it in the burial chamber.⁸⁰ Its weight served to wedge the point tightly. A rope coated with Stockholm tar was wound around the upper shaft and secured with fine wire above the grille. The clear flames lighting a dark night were, as expected, dramatic (fig 12b). The anticipated risk of burning from falling fragments did not materialise. Trials showed that it could be moved in a strong wind without becoming a fire hazard. The all-iron construction made sense in that no part was combustible.

Adams.⁸¹ It is a small step farther to argue for naval use. Throughout history there has been a need for a fleet to maintain contact by day and night in all weathers. Pennants, signal flags, smoke by day and light by night, were employed. The Bayeux Tapestry depicts Duke William's invasion. It is daylight and pennants are being flown (fig 12c). One mast head has a fitting described by David Wilson as an elaborate frame topped by a cross.⁸² In the absence of an alternative identification, it seems likely to represent an unlit 'cresset' of Sutton Hoo type. Cressets, as we know them, antedated enclosed lanterns. Richard of Gloucester's seal shows that naked flames could issue from a cresset in the bow of a flagship as late as the fifteenth century (fig 12d).⁸³
