## Puddled or Forged? A Steel Bar in The Cathedral of Mexico, from the XVIII Century

M. E., Noguez\*, D. Mojica\*, R. Sánchez\*\*, T. Robert\*

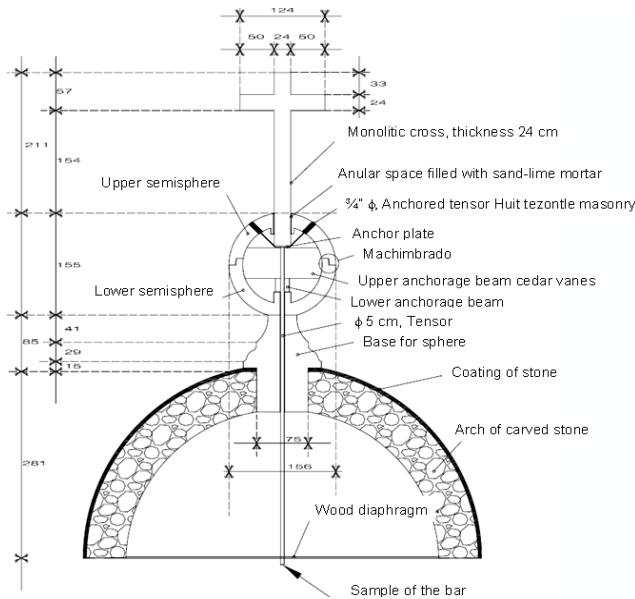
FIG. 1. a) Diagram of the tower.

The building of the Cathedral of Mexico began in 1616 and finished in 1813. From 1787 to 1791 the rising of the east tower was made with stone globes and cruises, Fig. 1 a) and b). A metallic bar was introduced, lowering from the center of the globe to the crosspiece of cedar vanes inside the tower, Fig. 2. During the restoration works, a small segment from this bar was cut (about 5 -5.3 cm diameter and 0.5-0.8 cm thickness), Fig. 3, and analyzed. Chemical analysis, hardness tests and optical and electrical microscopy were used. There are two ways of knowing the origin of this bar: historically and by laboratory evidences.

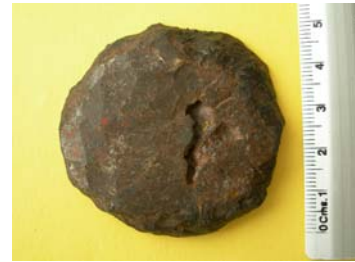
FIG. 2. Sample cut from the bar.

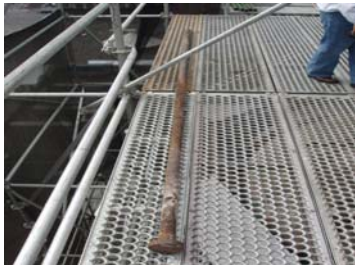
FIG. 3. Holding bar.

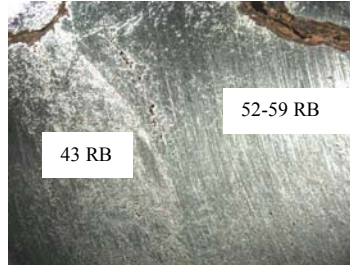
FIG. 4 Different hardness in the bar.

From laboratory observations the following characteristics are indicated. The length of the bar is 469 cm, with a very homogeneous diameter, unless the end, where the sample was cut. The head of the bar was definitely forged to a larger diameter, Fig. 4. The sample cut from the bar had indications of having being struck, with a small oxidation and fractures apparently produced by union by the masses near the center. The chemical composition was determined by an Emission spectroscopy, Spectro M-8; the average analysis is: 0.229% C, 0.126 % Si, 0.027% Mn, 0.002% P, 0.006% S, 0.206% Cu, Fe bal. Moreno Revilla [4] reported that puddled iron have an average of 0.47% P and 0.20% Si, while forged steels have 0.03% Si and 0.08% P, therefore the above analysis is not conclusive for any process. Hardness tests show different values, indicating at least two microstructures, Fig. 5. Optical microscopy analysis shows at least two different carbon content steels, Fig. 6, this condition has been reported by Picasso et al. [5] as characteristic of puddle steel. Besides, it can be seen silicate inclusions in the transversal section, Fig. 8, corresponding to the rolling direction. This evidence points in the direction of puddle rolled steel.

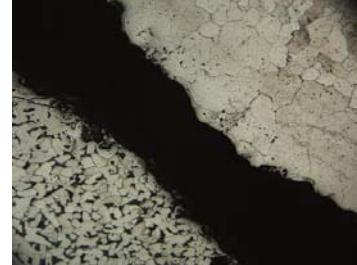
FIG. 5. Different microstructures, 100 X

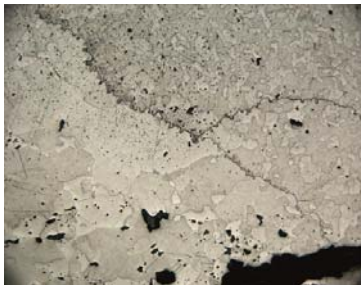
FIG. 6. Different grain sizes. 100 X

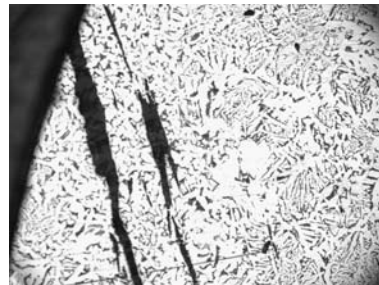
FIG. 7. Oriented aligned silicates. 100 X

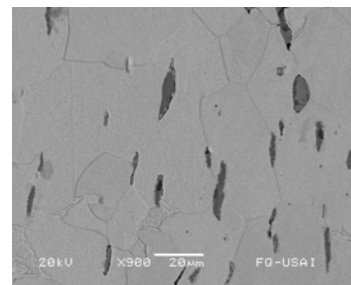
FIG. 8. Aligned silicates, SEM.
