2D Junction Profiling on Semiconductor Device Reliability Fail

Y.Y. Wang¹, J. Nxumalo¹, A. Katnani¹, D. Ioannou¹, J. Brown¹, K. Bandy¹, M. Macdonald¹, J. Bruley²

1. Globalfoundries Inc. Hudson Valley Research Park, 2070 Route 52, Hopewell Jct., NY, USA

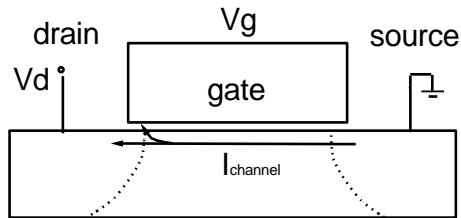
Figure 1.

Electric circuit diagram for hot carrier stress

In this report, electron holography is carried out on a dual lens holography system with 200kV (1-4) and sample is prepared by focused ion beam (FIB) method to about 400 nm thick. An NFET SOI device is stressed by applying high voltage (3.1V) from source to drain for approximately 10,000s as shown in fig.1. The drive current of the device changes (reduces) about 7.3% after stress as shown in fig.2.

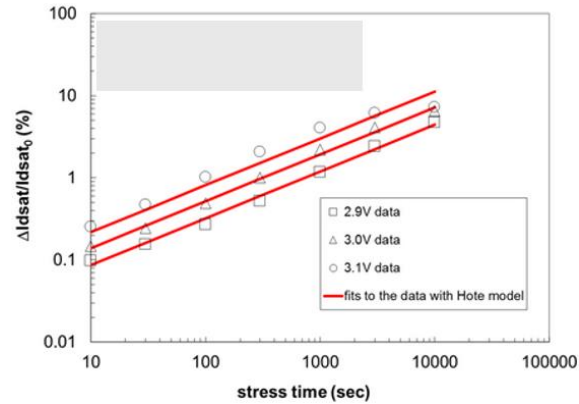
Figure 2.

Device drive current change vs stress time with different stress voltage

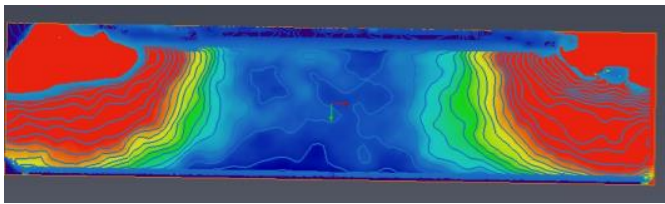
Figure 3.

Junction profiling by dual lens electron holography

Figure 3 shows electric potential measured by dual lens electron holography. The colored map in Si shows asymmetry of junction profile from left to right. The left side junction is more abrupt and right side junction is less abrupt. Figure 4 show the electric potential profile in the channel region (top part of Si) from left to right, which indicates the similar asymmetry between left and right. The device without stress has a symmetric junction.

In conclusion, both electron holography and scanning capacitance measured on the same defective device shows junction asymmetry, with the junction on drain side to be more abrupt than one on the source side after the 10,000 second device reliability stress.

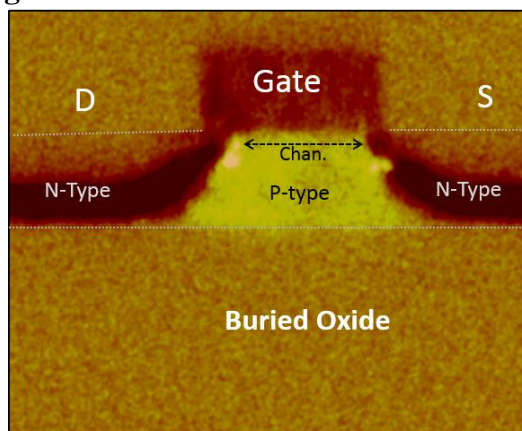
Figure 5.

Scanning capacitance map on stressed device

Scanning capacitance measurement on stressed sample is shown in (fig.5). The color contrast shows an asymmetric junction profile between drain side and source side of the channel. A lateral 1D profile taken through the channel (fig.6) clearly shows a large SCM signal at the left junction compared to the right junction. The signal difference indicates a carrier concentration difference between the two ends of the channel after device stress.

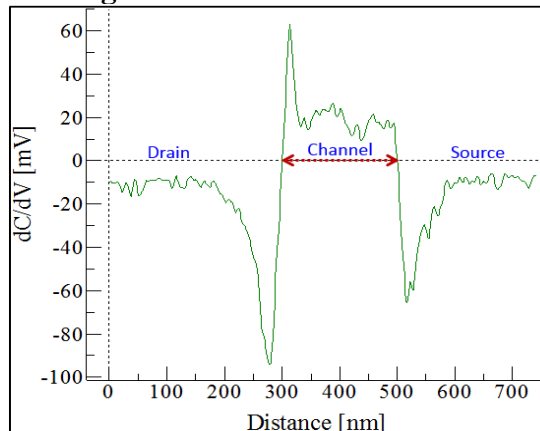
Figure 6.

Profile of SCM near the top of the channel.
