Crystal Park, Bottisham: The Construction Materials of a Roman Villa Complex – A Cambridgeshire Case Study

By KEVIN HAYWARD and CHRISTIANE MECKSEPER

Keywords: Cambridgeshire; bath-house; red-slipped tile; rural; geological analysis; box-flue tile; villa; fabric

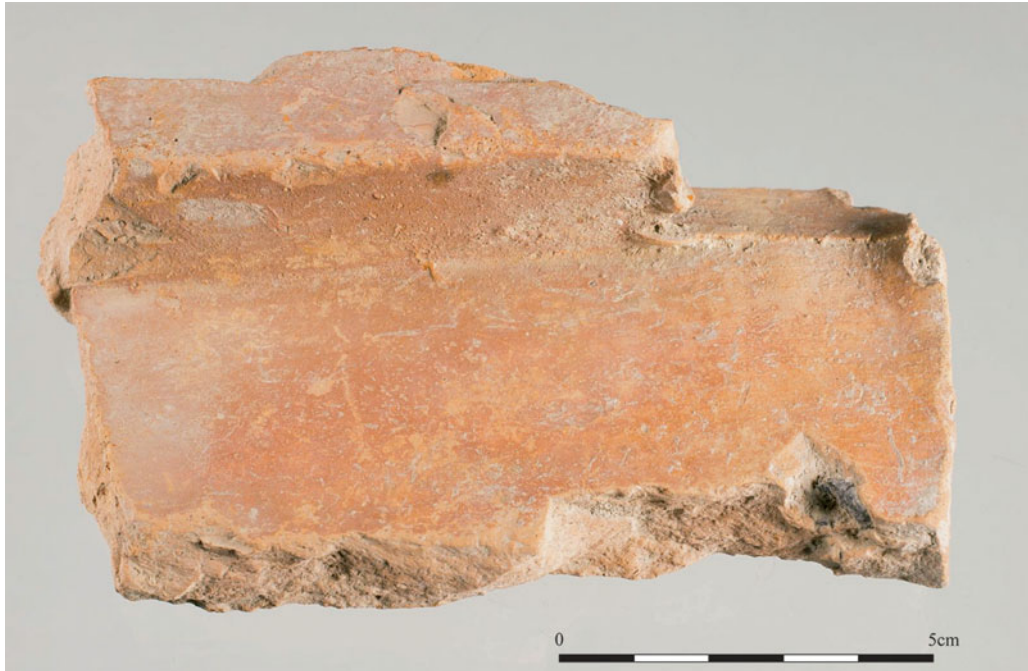
FIG. 5. Red slip on tegula. (© Pre-Construct Archaeology Ltd)

Detailed visual analysis of the ceramic building material assemblage has shown the identification of red pigment in a group of *imbrices* and *tegulae* from the demolition debris of Building 2, also dumped into adjoining Ditch 18 and Ditch 47. The red slip appears all over the flanged *tegulae* and curved *imbrices* but is especially prominent along the flange edges and top of the *tegulae* (FIG. 5) and the point of maximum curvature along the apex of the *imbrices*, as if meant to be seen. The decision to dip these different yellow-clayed roofing materials into a red-coloured solution may have been an aesthetic choice in keeping with the pre-existing red roof skyline for the bath-house and outhouse buildings (Building 1 and Building 3) of a possible courtyard area. Associated with the yellow Gault-rich *Bottisham 3 and 4* fabrics (TABLE 2), nearly all the *tegulae* were also found to have nail-holes.

The tile (both *imbrex* and *tegulae*) had been treated with a red slip, which may have been an aesthetic choice in keeping with the pre-existing red roofs of Building 1 and Building 3, suggesting that Building 2 was a later addition. Other evidence for a later construction date of Building 2 is shown by the fragmentary condition of the 70 kg of Barnack stone in the foundation walls of both the rectangular room and curved wall. It has been shown that large blocks of Barnack stone were used in the earlier bath-house Building 1. Here, however, in the foundation of Building 2, they appear as reused rubble in walls (5002), (5006) and (5009), and as post pad (5060), and were clearly brought over as robbed stone to construct this building.

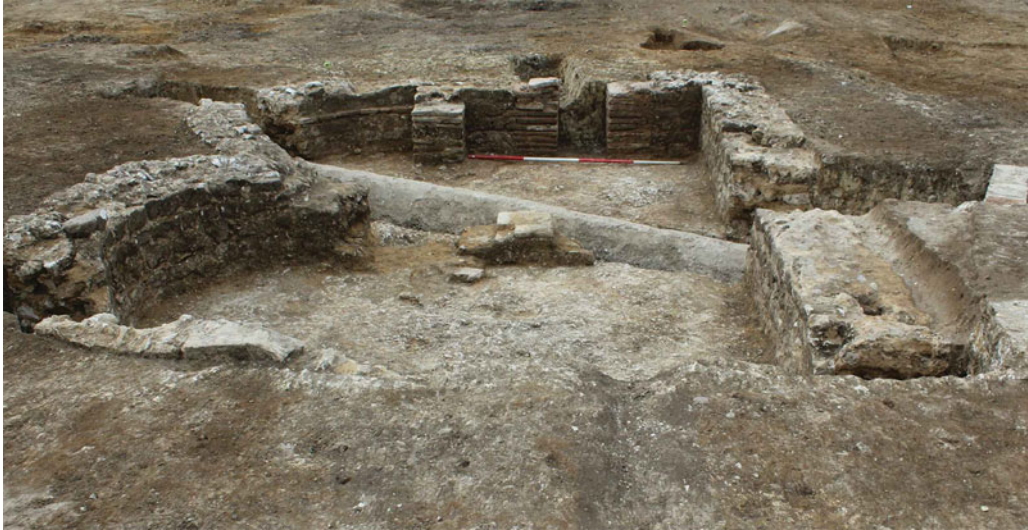
FIG. 8. Building 1. (© Pre-Construct Archaeology Ltd)

The sunken double-apsed Building 1 was a substantial masonry structure, 6.6 m long x 5 m wide x 0.9 m deep consisting of lacing courses of lydion brick made from *Bottisham 5* and *Bottisham 6* brick fabrics, used in conjunction with large structural blocks of Barnack stone (FIGS 7 and 8). Elsewhere, precisely worked *petit appareil* sub-rectangular blocks of clunch and chalk were used to define the outlines of two apsidal features [2012]/[2050] and [2015], each 2.15 m in diameter, as well as a rectangular section of wall [2044] that demarcates the north-east–south-west side of the building. The overall impression is of a sub-structure constructed with thought to aesthetics using fresh and carefully chosen brick and Barnack stone structural elements, the latter brought in over distances of 60 km from north-west Cambridgeshire. Two different mortars, the loose earthy-brown flint chalk mortar M2 and a very high-quality low-density pale orange pink mortar and render M3 define the apsidal and north-east–south-west side sections of wall from the south-west side and buttress, respectively. What is immediately apparent is how intact and pristine all these surviving subterranean elements are, completely undisturbed by subsequent robbing.

There are some elements in this building that are typical of a bath-house building. One is its apsidal plan. A very similar double-apsidal configuration of rooms, used as a *caldarium* and *tepidarium*, was found at the Truckle Hill bath-house in Wiltshire.³² Structural elements supporting the function of the building as a bath-house are a small fragment of surviving *opus signinum* floor in the easternmost apsidal structure, a single coursed ledge or rim of 13 horizontally placed *opus spicatum* paving bricks encircling the apse and some relict *opus spicatum* or herring-bone flooring in the westernmost apsidal structure.³³

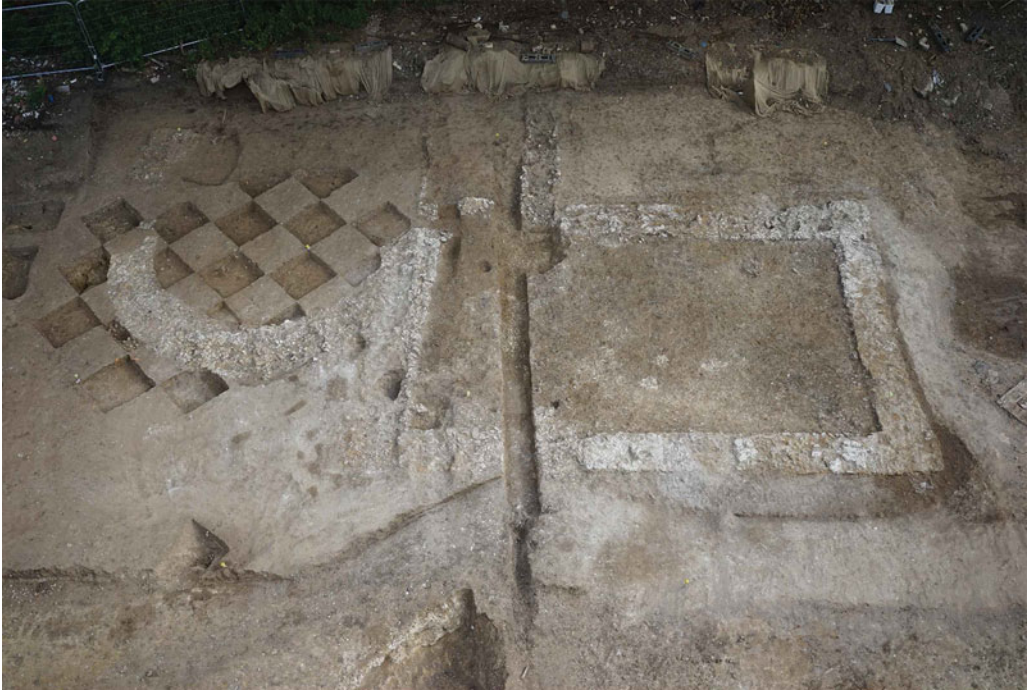
FIG. 10. Building 2. (© Pre-Construct Archaeology Ltd)

The northernmost structure (Building 2) consists of a rectangular room and part of an external curved wall section, both defined by the surviving foundations of a heavily mortared thick (0.9 m) wall containing tile and Barnack stone fragments (FIGS 9 and 10). The walls that delineate the 8 × 4.5 m rectangular building and the curved wall are made in the same very hard concretionary flint mortar M1, or *opus caementatum*, suggesting a single build. This mortar, which was also identified in Building 3, is applied liberally both as a rammed foundation and as a construction material *per se*, making up perhaps for a dearth of recyclable stone and brick from other structures.

A limited quantity of brick (48 kg or 15 per cent by weight) was recovered, which may suggest that Building 2 was a timber-framed construction on stone footings or that the brick had simply been robbed.

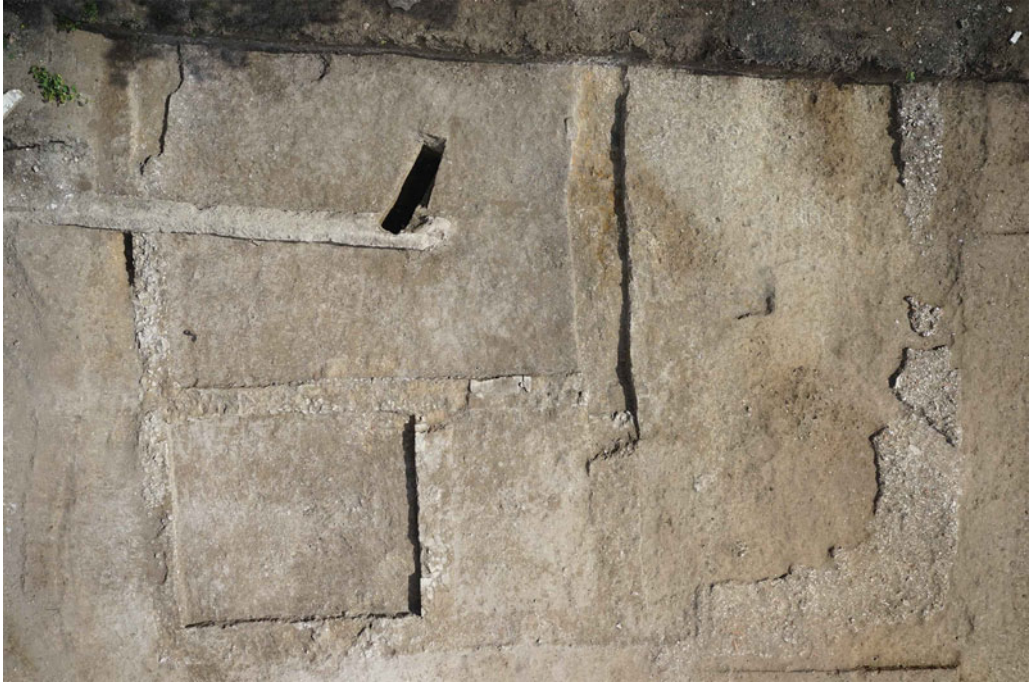
FIG. 12. Building 3. (© Pre-Construct Archaeology Ltd)

It is in R1 and R2, too, that 376 kg of fragmentary combed box-flue tile was present in the demolition fills forming approximately 50 per cent of all building material (by weight) for Building 3, and 85 per cent of all box-flue tile from the entire site assemblage. These small ($220 \times 170 \times 21$ mm) box-flue tiles or *tubuli* have a standardised fabric (Horningsea very fine sandy *Bottisham 1*) and combed form (deep chevron or two inward facing circles) with large 50–70 mm sub-ovoid circular vents with the venting sometimes infilled with the same low density pink mortar M3 seen in the brick from walls [3018] [3021] [3024] and Building 1. The fills (3051) (3052) of robber cuts in other parts of Building 3, for example in the south-eastern corner of R4, also contained quantities of box-flue, most probably from these rooms too.

Such a concentration, albeit accentuated by subsequent robbing of the square and rectangular-shaped brick elements from these rooms, can only mean that the walls of R1 and

R2 were lined with vertically stacked *tubuli* to circulate heat around the rooms. Accounting for the enormous quantities in such small rooms is easy as it has been calculated that 190 box-flue tiles are needed for a single room.³⁸ The thick mortar M3 attached to one side only, and sometimes as vent infill, would have insulated the circulated hot air for use as either a sweat room, *laconicum*, or the heated opulent *caldarium* of a bath-house. There is a notable lack of sooting on the *tubuli* from Building 3, but this could be the result of the distance of the box-flue from the heat source rather than a sign of complete non-use. The calcareous residue seen on some examples certainly suggests some exposure to heat, but the absence of *pilae*, as in Building 1, again calls into question how these two rooms were heated. However, only the southern part of R1 has been excavated and it is possible that the heat source (from the *prae-furnium*) was situated in a part of the building located outside the area of excavation.
