Characterization of VLSI Processing Defects Using STEM-EELS Tomography

Frieder H. Baumann¹, John Miller¹, Bryan Rhoads¹, Anne Friedman¹, Bianzhu Fu²

¹Globalfoundries, 2070 Route 52, Hopewell Junction, NY 12533

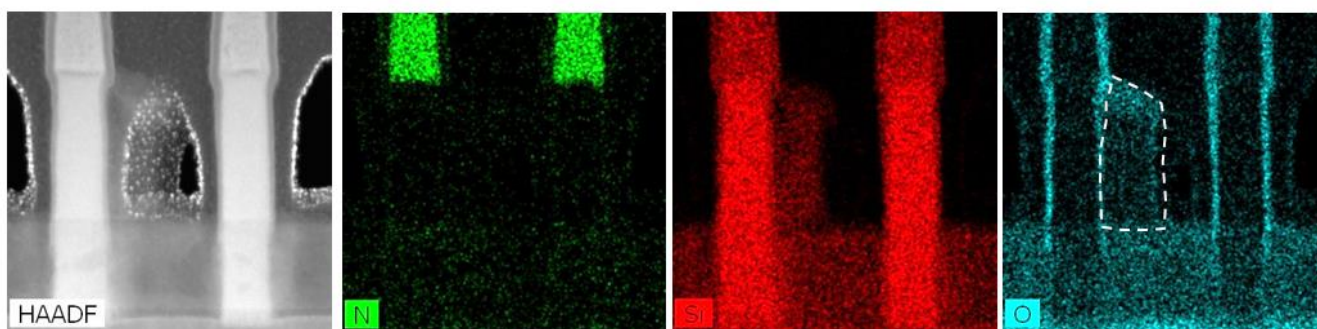
EDX (FEI Osiris) mapping of a typical defect between two α -Si lines is shown in Fig. 1. A faint Si signal can be seen on the right shoulder of the left line. It is believed that a micro-masking effect during the etch left some α -Si standing between the lines. The O-map indicates that a thin oxide layer seems to cover the top of the defect. All in all, imaging and x-ray mapping is barely able to characterize the defect.

Figure 1. X-ray mapping of defect between two a-Si lines. The Si map (red) shows a faint signal at the right shoulder of the left line. The perceived outline of the defect is shown in the O map. Imaging and X-ray mapping are barely able to give insight to the nature of the defect.

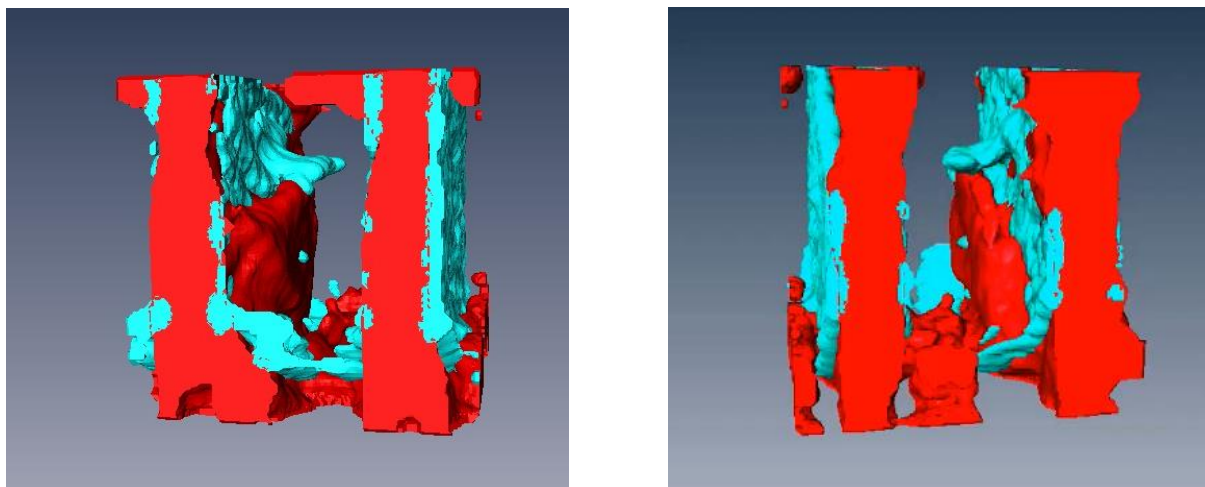
The result of the STEM-EELS tomography is shown in Fig. 2, clearly showing a block of silicon left standing between the α -Si lines. In addition, the oxide cap on top of the un-etched Si block can easily be spotted. For the tomography, a total of 23 EELS maps, with tilt angle ranging from -55° to +55° in 5° steps, were acquired in a probe-corrected FEI Titan microscope operating at 200 kV. Each map consisted of 100x100 pixels and required about 5 min to acquire. Total acquisition time of the data was ~5 hours. Data analysis consisted of noise filtering using principal component analysis for both the Si and the Oxygen edge, followed by reconstruction using the SIRT algorithm for Si and weighted back-projection for O (Inspect3D, FEI). For visualization, the Amira software suite was employed using segmentation.

Figure 2. Two snapshots of the micro-mask defect, reconstructed from a total of 23 EELS maps. The reconstruction shows Oxygen (blue) and unbound Si (red). The oxide cap on top of the un-etched Si block is clearly resolved, as well as a thin SiO₂ layer on the sides of the α -Si lines.
