## Observation of Substructure in Steels and Ni200 Using Electron-Channeling Contrast Imaging

James H. Steele Jr.

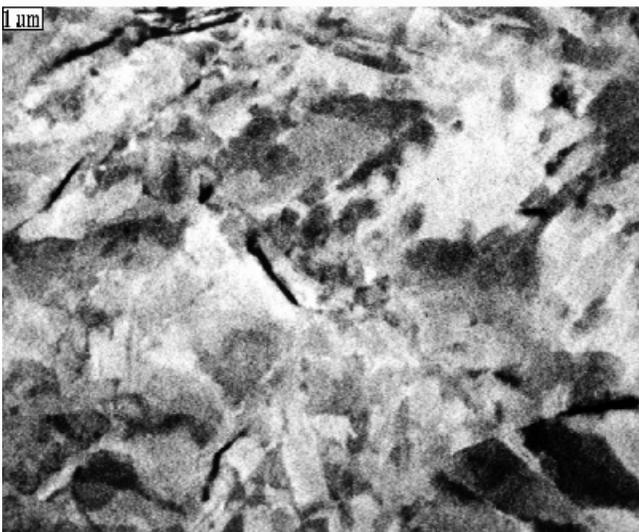
**Fig. 5. IF Steel - Drawn Cup Sidewall.**

Figures 5 and 6 show the dislocation cell structure generated during cold drawing of an interstitial free, drawing quality, low carbon steel[3]. The sidewall of the cup was electropolished to provide the image shown in Figure 5, which shows a dislocation cell size of approximately 1 micron. The deformation in the sidewall was estimated to be about 70 to 80% in the drawing direction, which is horizontal in the micrograph. Figure 6 shows the cell structure developed in the bottom of the cup, which undergoes a biaxial stretching of only about 10-15%.

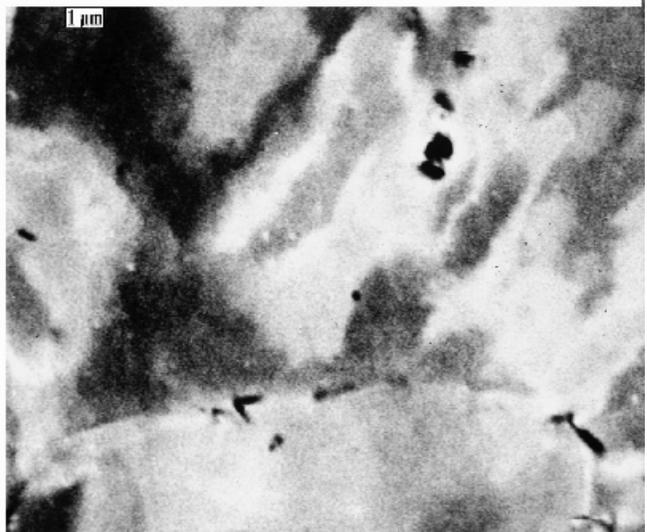
**Fig. 6. IF Steel - Drawn Cup Bottom.**
