Water Supply Facility Damage and Water Resource Operation at Disaster Base Hospitals in Miyagi Prefecture in the Wake of the Great East Japan Earthquake

Matsumura T, Osaki S, Kudo D, Furukawa H, Nakagawa A, Abe Y, Yamanouchi S, Egawa S, Tominaga T, Kushimoto S. Water supply facility damage and water resource operation at disaster base hospitals in Miyagi Prefecture in the wake of the Great East Japan Earthquake. *Prehosp Disaster Med.* 2015;30(2):193-198.

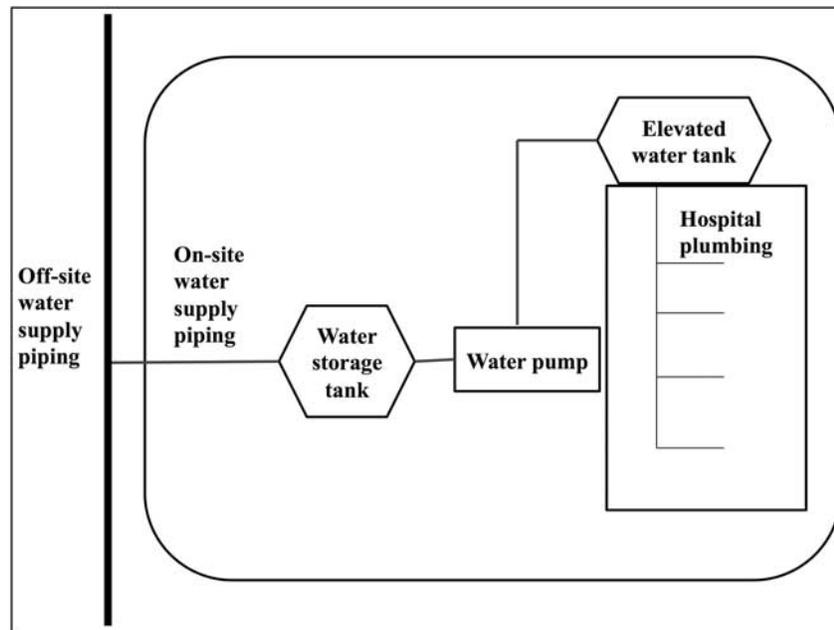
Figure 1. General Water Supply System of a Hospital.

A water-storage-tank-style water supply facility is composed of water supply piping, water storage tank, water pump, elevated water tank, and hospital plumbing.

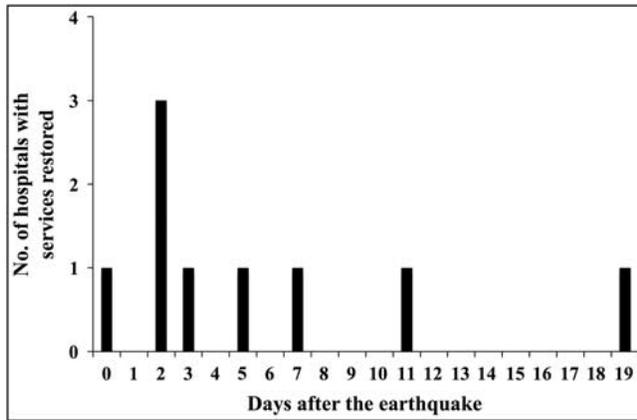
Figure 2. Trend in Recovery from Water Supply Interruption.

Median value for number of days for recovery was three, with a minimum of one day and a maximum of 20 days.

In relation to the supply of water resources, water supply was interrupted to nine out of 14 hospitals following the disaster, with a median value of three days (range = one to 20 days) for service to be restored (Figure 2). For the nine hospitals that experienced water supply interruptions, the volume of water supplied per day under normal conditions was compared with the water volume

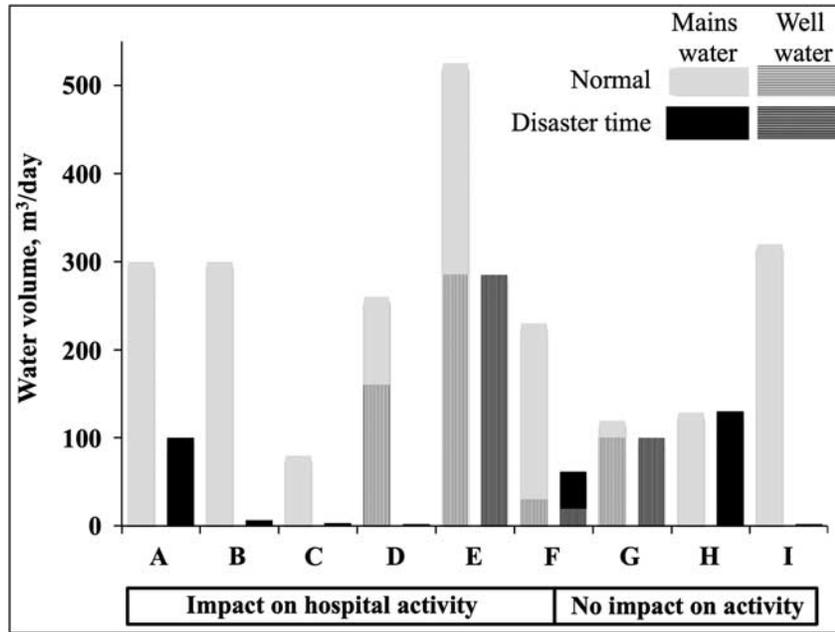
Figure 3. Water Volume by Water Source During Normal Operation and Water Supply Interruption. Left: water volume by water source in normal operation. Right: water volume by water source during water supply interruption. At hospitals where medical care activities were impacted, total water volume was greatly reduced. At Hospital I, water service was recovered on the same day as the disaster. The water supply was greatly reduced, but there was hardly any change in the volume of well water. There was no data on well water for Hospital D.

supplied in the wake of the Great East Japan Earthquake (Figure 3). At hospitals where water supply was interrupted, the main water supply source was fed with an emergency supply of water, transported by truck; however, at Hospitals A, B, and C, where the available water supply service amounted to less than 10 m³ per day, due to insufficient emergency water supply, the only available water supply after the disaster was the water remaining in water storage tanks and elevated water tanks. Hospitals D, E, F, and G, which had well water supply facilities, were able to obtain water from their wells after the disaster, and apart from Hospital D, which did not make any detailed records, the volume of water supplied from the well was quite comparable to the volume supplied under normal operating conditions.

At the six hospitals that responded that their medical care activities were impacted, total available water was reduced. On the other hand, at the three hospitals that reported no impact to their medical care activities, Hospital I was able to restore water service on the day of the disaster, while Hospitals G and H managed to maintain approximately the same level of water as normal, by accessing well water and through frequent deliveries of emergency water.
