A multiscalar approach to survey of military and trade architecture in Jordan: the case of Khirbet al-Khalde

This article reports on the archaeological survey of a (military) fort and (trade) caravanserai at Khirbet al-Khalde in southern Jordan, along the eastern Roman frontier. The results reveal the site's resilience and destruction up until the present day and the need for monitoring of threats to its preservation.

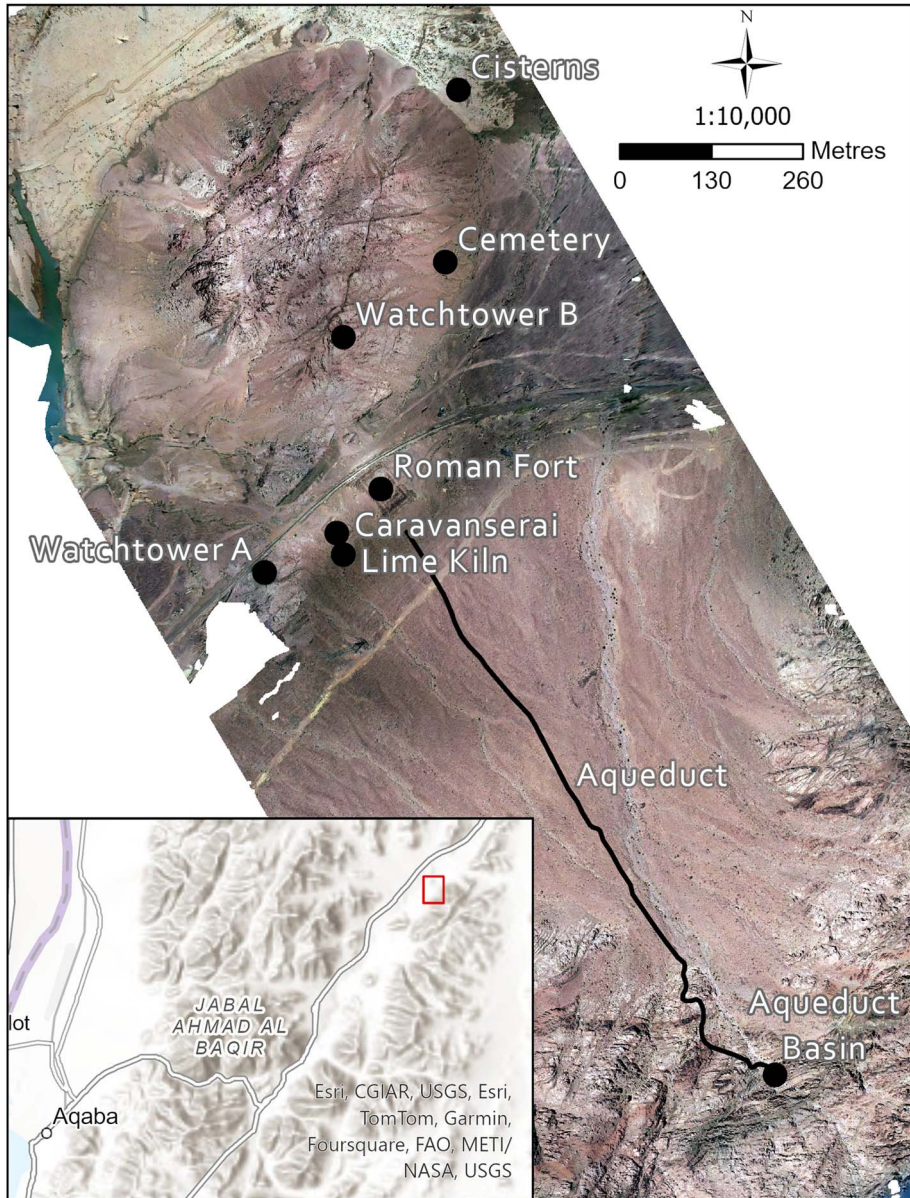
Figure 2. Drone imagery of site with important features highlighted (image from the Khirbet al-Khalde Archaeological Project).

The site at Khirbet al-Khalde, 26km north-east of Aqaba in the Wadi al-Yutm, encompasses a fort, a caravanserai, two watchtowers, cisterns, an aqueduct and cemeteries (Figure 2).

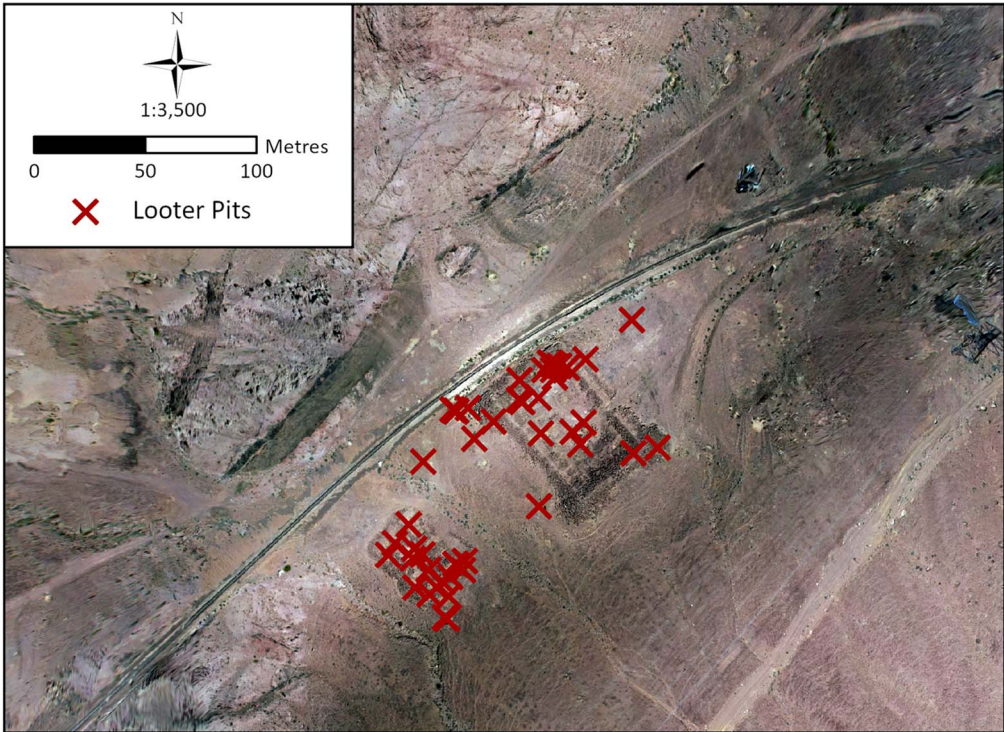
Figure 6. Drone imagery of main site showing locations of disturbance (image from the Khirbet al-Khalde Archaeological Project).

observation, but also assessed that the entire area north-east of the fort had been heavily bulldozed on several occasions. One bulldozing event occurred during the construction of the railroad, which runs alongside the north-west wall of the fort and comes within 10m of its remains. The area in front of the fort carries traces of bulldozing and the find-rich surface shows that archaeological material has been moved around extensively to create a level surface for constructing the railroad. During this process, the tower was probably partly bulldozed.
