# Radiological Demonstration of Choroid Plexus Causing Proximal Shunt Dysfunction

Can J Neurol Sci. 2019; 46: 346–347

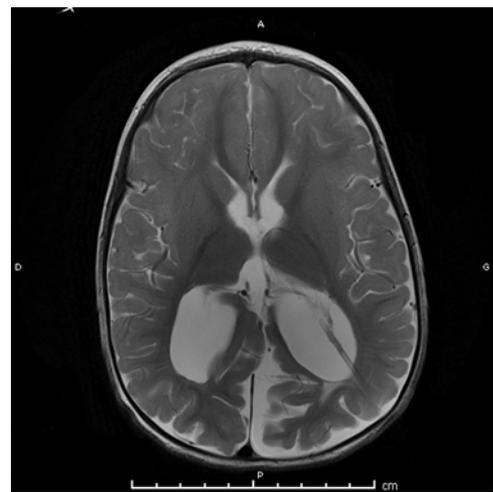
**Figure 1:** T2-weighted axial cerebral MRI demonstrating CP obstructing an otherwise clear proximal catheter tip in the occipital horn of the left lateral ventricle in an 18-month-old boy.

to these findings, demonstrating the radiological appearance of CP causing CSF shunt dysfunction on MRI (Figure 1). The intraventricular hemorrhage which occurred in this patient despite coagulation of the plexus highlights the importance of its preoperative recognition and/or intraoperative identification.

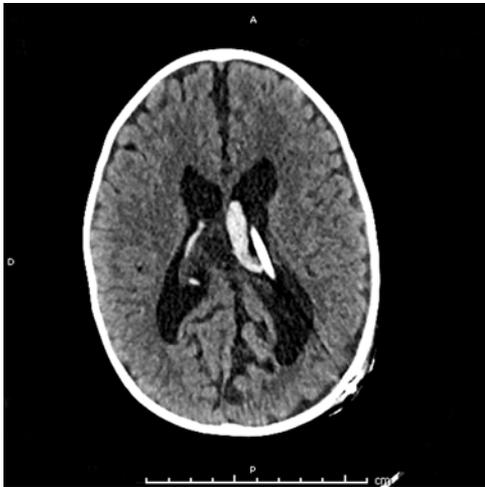
**Figure 2:** Post-operative non-contrast axial CT showing intraventricular hemorrhage surrounding the newly placed catheter located in the left lateral ventricle.

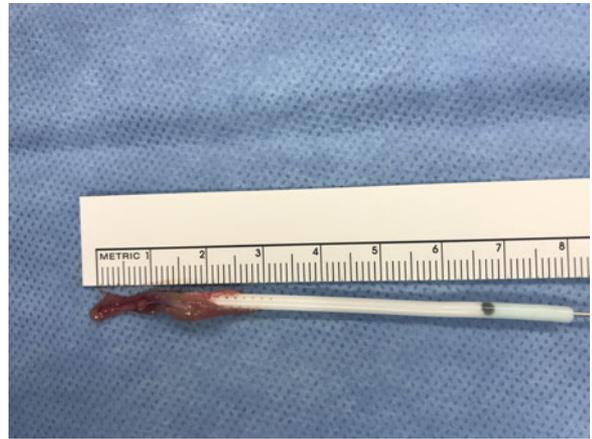
**Figure 3:** Gross view of CP (after operative catheterization) enveloping and entering the orifices of the obstructed proximal ventricular catheter tip.
