2818
doi:10.1017/S1431927622010625
Microsc. Microanal. 28 (Suppl 1), 2022

Failure Analysis of Conformal Cooling Inserts Fabricated by Additive Manufacturing

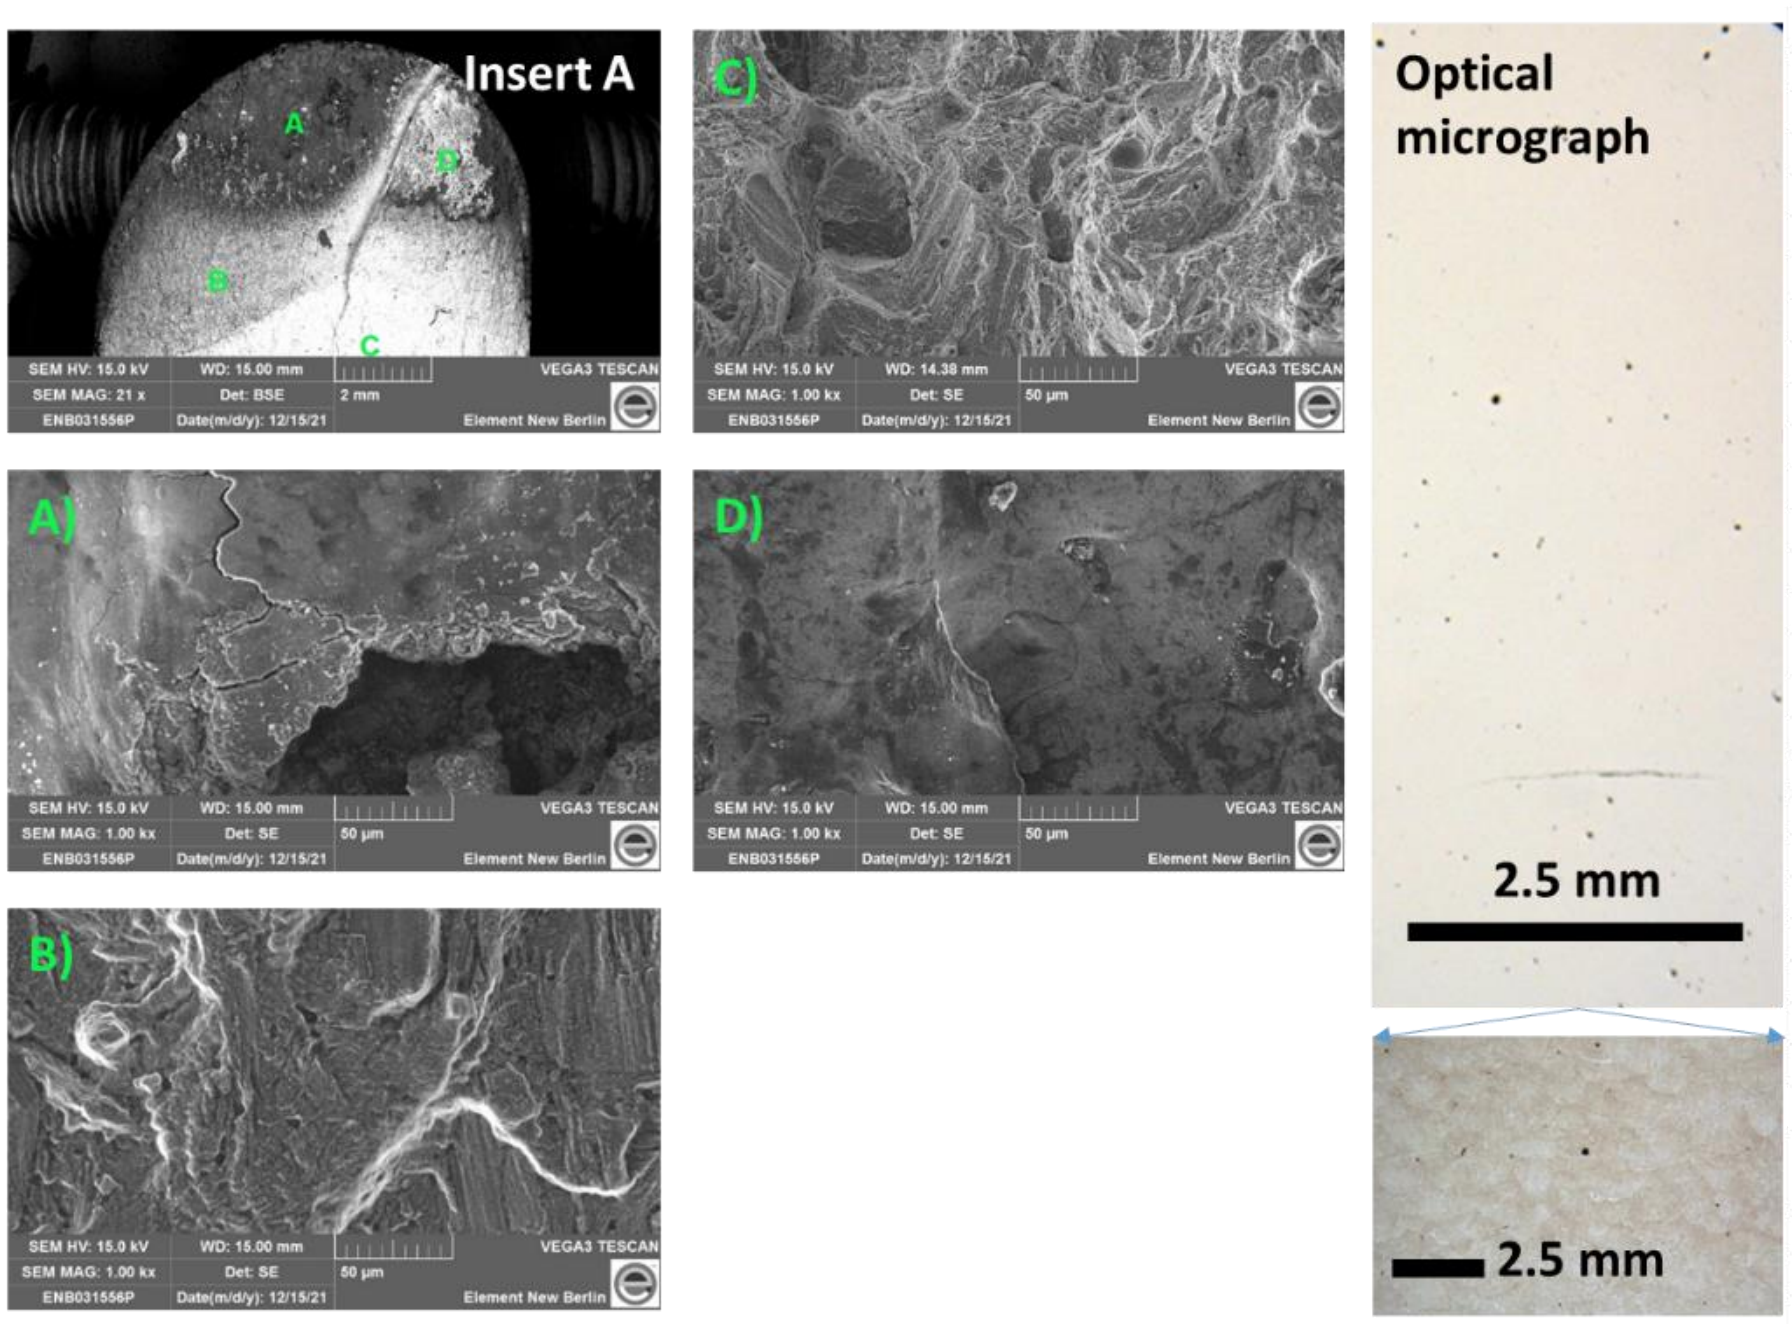
Figure 1. Microstructural and mechanical results of insert A

Microstructural and mechanical results of insert A are presented in Fig. 1. Analyzes were carried out around the fracture of the insert. A different chemical composition is observed in each analyzed zone. An aluminum and oxygen rich-zone is presented in zone A, due to the exposition of the aluminum casted to the oxygen through the fracture. A high concentration of oxygen is also observed in zones B and D respectively, due to the corrosion of the alloying elements of the Maraging steel. On the other hand, insert B, shown in Fig. 2, present a low-concentration of aluminum near to the fracture as observed in the chemical analysis, however higher present of oxygen is observed in the areas surrounding the fracture (zones C and D), which analyses were carried out in the closer areas to the fracture.

Insert A				
Element	Zone A	Zone B	Zone C	Zone D
O K	38.89	19.62	1.14	20.96
AlK	34.46	2.61	0.16	12.65
C K	8.79	14.5	2.72	5.14
FeK	5.75	42.98	66.21	37.24
SiK	4.88	1.81	0.1	2.83
CaK	2.39	1.36	0	1.67
MgK	1.44	1.48	0	2.12
CuL	1.36	0	0	0
NiK	0.9	7.39	15.36	8.98
P K	0.46	0.8	0	0.44
CoK	0.46	4.53	8.35	4.23
ClK	0.22	0.52	0	0
MoL	0	1.99	3.55	2.39
TiK	0	0.42	1.88	0.47
CrK	0	0	0.51	0
CuK	0	0	0	0.88

Tensile test	Insert A (4000 Shots)
Diameter, (in)	0.252
Original area, (in²)	0.0499
Gage length, (in)	1
Tensile strength, (psi)	214000
Yield strength, 0.2% offset, (psi)	188000
Elongation, (%)	9.5
Reduction in area, (%)	26

Specimen No.	Test temperature (°F)	Insert A (4000 Shots) Energy, (ft-lbf)
1	68	9
2	180	10
3	300	11

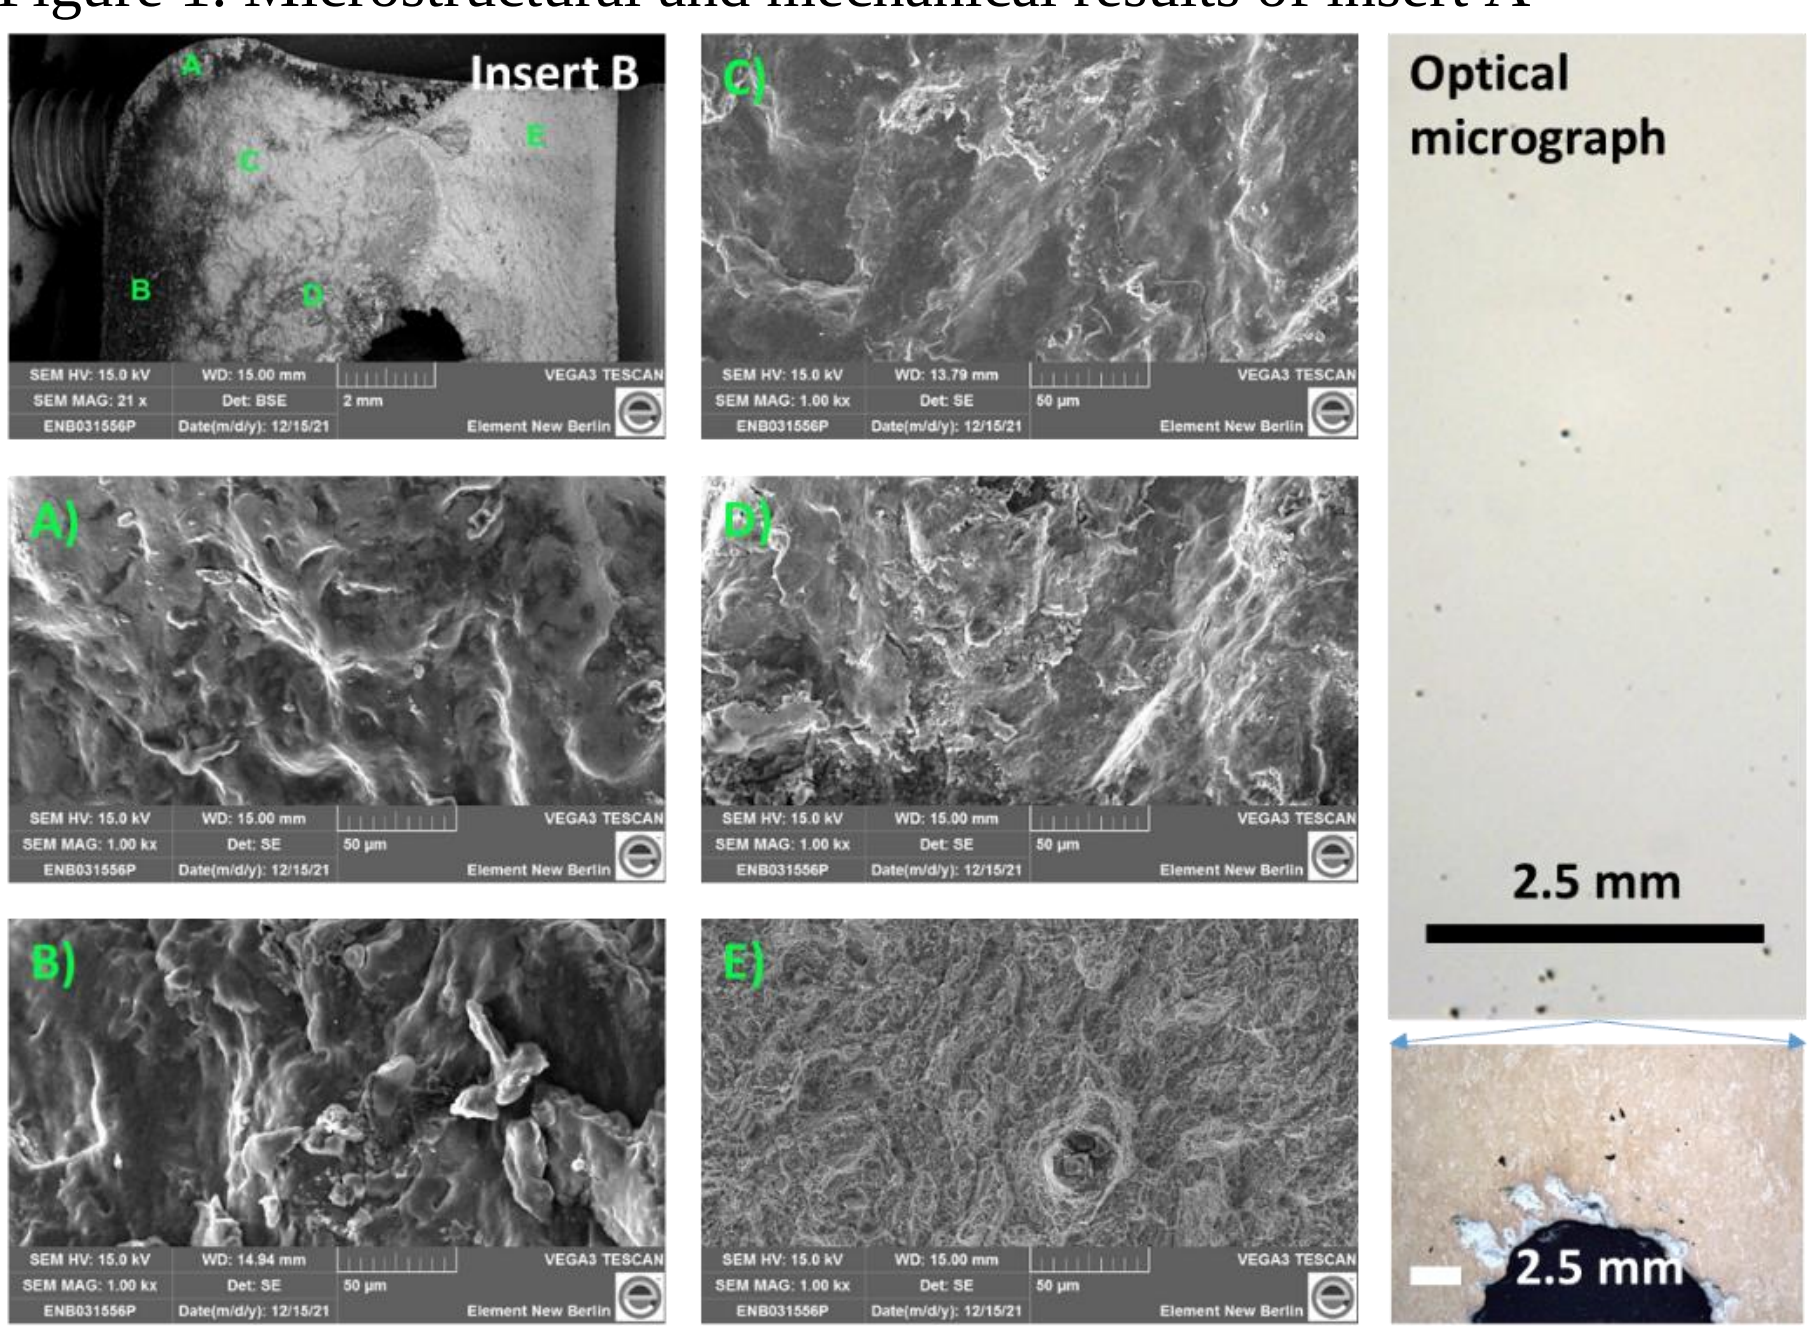
Figure 2. Microstructural and mechanical results of insert B

It is observed the presence of small ruffles corresponding to each point where the laser hit the material during the additive process. An evident and considerable number of porosities generated during the additive manufacturing process is also presented. This defect can considerably affect the mechanical properties and even generate stress concentration points. On the other hand, the porous distribution on insert B is lower that the observed in insert A and the fracture can be observed in the surrounding to the conformal cooling channel. The microstructure does not present the typical additive manufacturing mark [3.4], which suggest a subsequent heat treatment carried out in the insert B after its additive fabrication. The different in microstructures and well as the difference in the mechanical behavior of the inserts observed in Figs 1a and b, are directly related with the mechanical performance of the inserts under working conditions, allowing an increment in the life service of insert B of 4000 shots in the parts production in comparison with insert A.

Insert B					
Element	Zone A	Zone B	Zone C	Zone D	Zone E
O K	19.12	29.62	21.45	25.65	0.94
AlK	8.88	8.17	0	1.16	0.07
C K	14.57	33.56	4.7	8.67	2.55
FeK	31.31	11.43	54.7	45.2	69.01
SiK	3.2	4.81	0.88	1.24	0
CaK	1.14	3.63	0.5	2.4	0
MgK	3.55	3.82	0	0.38	0
NiK	9.77	2.01	10.57	8.81	15.18
P K	0.2	1.06	0	0.34	0
CoK	4.76	1.12	6.57	5.22	8.19
ClK	0	0.32	0	0	0
MoL	2.45	0	0.62	0.93	2.96
TiK	0.43	0	0	0	0.97

Tensile test	Insert B (8000 Shots)
Diameter, (in)	0.251
Original area, (in²)	0.0495
Gage length, (in)	1
Tensile strength, (psi)	300000
Yield strength, 0.2% offset, (psi)	292000
Elongation, (%)	5
Reduction in area, (%)	22

Specimen No.	Test temperature (°F)	Insert B (8000 Shots) Energy, (ft-lbf)
1	68	7
2	180	7
3	300	7
