e-Beam Detection of Buried Open Defects in Semiconductor Device

[1.] Samsung Austin Semiconductor, LLC, Austin, TX, USA.

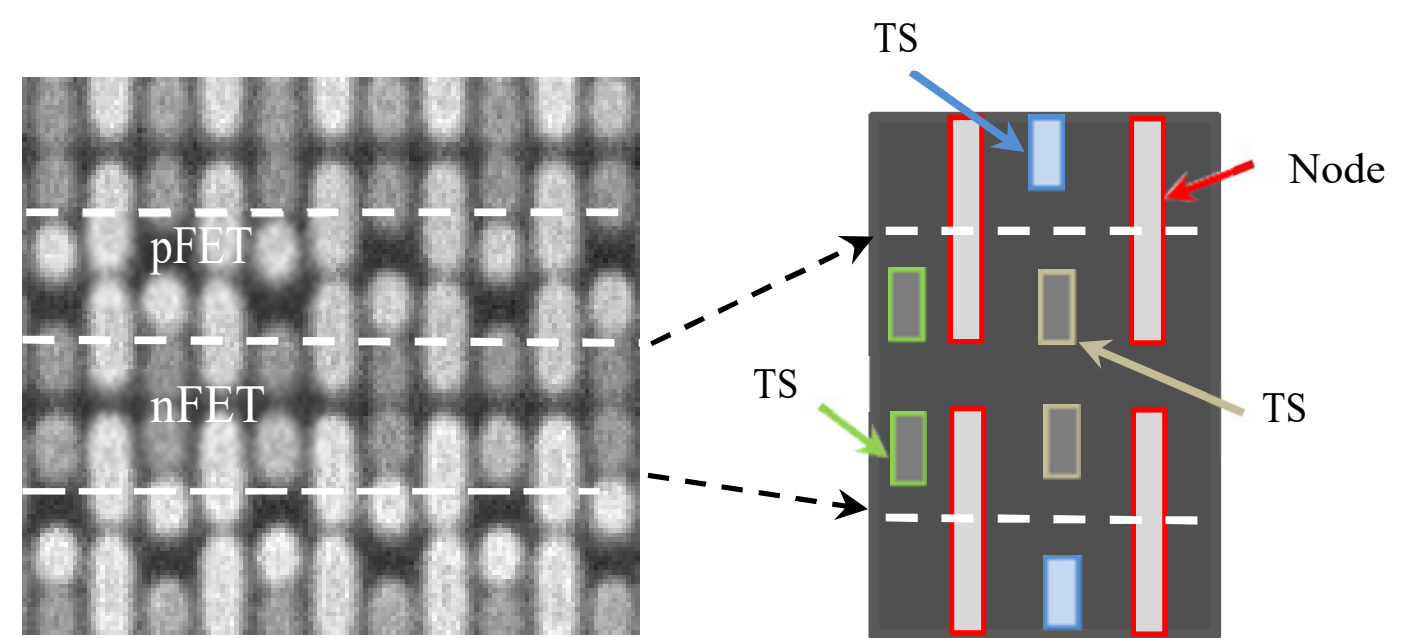
Under "extracting" beam conditions an open or floating defect would appear as dark voltage contrast (DVC) and in this inspection several DVCs were detected on the wafer in nFET regions. TEM analysis is used to gain more information on the defect and determine defect mechanism. Analysis of defective sites shows a wide gap between the TS and eSD. EDX map of the TS-eSD interface reveals the presence of high levels of Florine (F). Excess process gas can react with other materials during metallization process to form compounds that prevent electrical contact between TS and eSD. This leads to device fail and can cause significant yield loss. e-Beam inspection uses this lack of conductivity between TS and eSD to flag the defective structure as the defect of interest.

Figure 2. Live image of n/p structures on wafer surface under inspection conditions. TS structures within nFET are prone to opens.
