Structural health monitoring of 52-meter wind turbine blade: Detection of damage propagation during fatigue testing

Keywords: Damage; fatigue testing; structural health monitoring; wind turbine blades

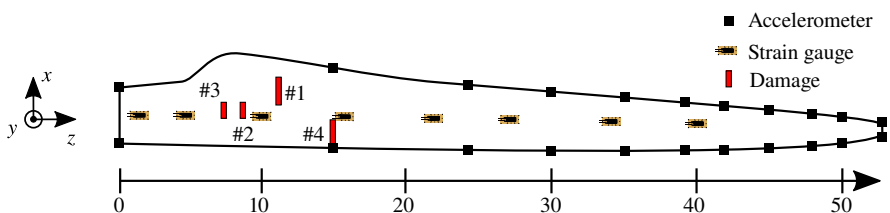
Figure 3. Spanwise and edgewise placements of investigated damage cases, including global unidirectional SG and triaxial accelerometer placement. All dimensions in meter. At positions marked with SGs, SGs are placed on the suction side, pressure side, leading edge, and trailing edge, respectively.

Damage case	Description	Spanwise position [m]	Manually induced crack length [mm]
#1	Crack in PS shell, toward TE	11	70
#2	Crack in web start	7.5	30
#3	Crack in web start	6.5	100
#4	Crack in LE shell	15	200

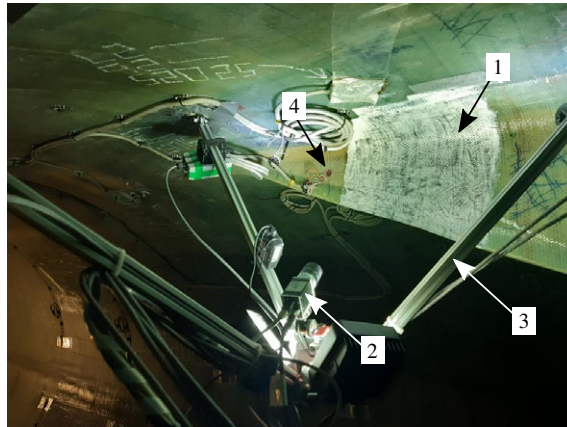
Figure 5. Sensing systems near damage #3. DIC system 1: Black-and-white speckle pattern; 2: Digital camera; 3: Tripod fixture with LED lights. 4: Strain rosette on the web start near damage #3.

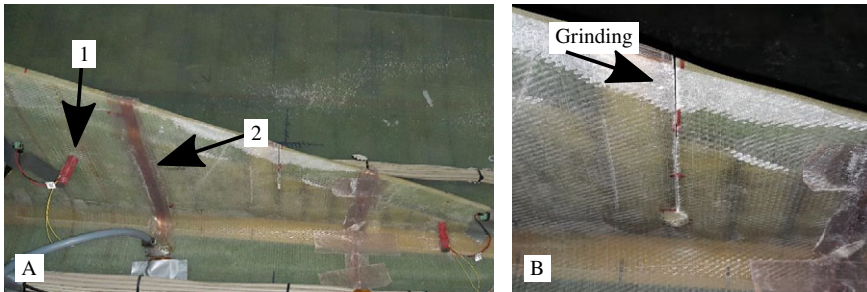
Figure 8. *A: Web start toward suction side (SS) with GW pitch–catch system installed near damage #3; 1: GW actuator; 2: GW sensor patch with eight individual sensors. B: Damage #3 on the SS part of the web start after the test was stopped with this damage case. The damage was initially introduced through grinding of the laminate on February 5, 2021. A delamination formed at the crack tip, but it propagated significantly slower than the damage on the pressure side part of the web start.*

Damage #3 was desired to be crack in the laminate, transverse to the spanwise direction of the blade. A first attempt at initiating the damage was made by grinding down the laminate on both the LE and TE sides of the web start, which reduced the laminate thickness. This can be seen for the SS in Figure 8b, and a similar grinding was made toward the PS. The grindings resulted in a thinner laminate, which lead to larger strain magnitudes in the laminate, based on which the likelihood of damage initiation would increase. However, no visible damage initiated at the grinding in the laminate. Consequently, the damage was initiated by manually cutting through the laminate, which resulted in a crack, as shown in Figure 8b. Damage #3 was a transverse crack in the web laminate, placed close to the web start (see Figures 3 and 9). The damage was introduced in the web start toward both the PS and the SS. Starting from the web, the crack was initiated by cutting all the way through the web laminate. This resulted in the crack shown in Figures 8a and 10a, showing the web start toward the SS and the PS, respectively. Both artificial cracks had an initial length of approximately 100mm transverse to the spanwise direction. The width of the cracks corresponded to the width of the saw blade used to cut through the laminate. The crack toward the SS did not propagate significantly during fatigue testing, which is attributed to mean strains being of lower magnitude compared to those on the PS. Due to the loads induced by the self-weight of the blade, the SS and the PS are subjected to a negative and positive offset in mean load, respectively. Thus, the crack on the PS is loaded in tension–tension fatigue, which is more likely to propagate the crack than the compression–tension fatigue load on the SS. Since the crack in the PS web start propagated most, analysis of local sensor data in Section 4 is limited to the PS part of damage #3.

Figure 8a shows damage #3 on the SS part of the web start. No significant damage propagation occurred with the initial damage length of 100 mm, after which the damage length was increased to a total of 150 mm. A delamination formed at the crack tip after additional fatigue testing (see Figure 8b), but the delamination propagated significantly slower than the delamination in the PS web start. From the initial length of damage #3 toward the PS, as shown in Figure 10a, the crack propagated between approximately 45 and 60° toward the tip and the PS spar cap (see Figure 10c). Once the crack had propagated close to the spar cap, the damage propagated further as a delamination (see Figure 10c). With subsequent fatigue

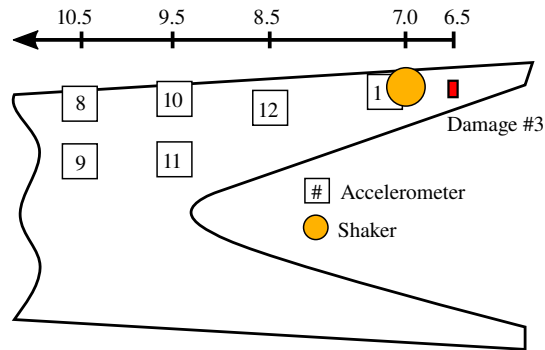
Figure 15. Accelerometer placement near damage #3. Accelerometers #2–7 are placed along the LE and TE between spanwise positions 8 and 14 m. This work investigates measurements from accelerometers #9 and #12.
