## Steel Corrosion Mechanisms during Pipeline Operation: *In Situ* Characterization

Katherine L. Jungjohann<sup>1</sup>, Steven C. Hayden<sup>2</sup>, Jeremy T. O'Brien<sup>2</sup>, Timothy J. Kucharski<sup>2</sup>, William M. Mook<sup>1</sup>, Claire Chisholm<sup>1</sup>, Anastasia Ilgen<sup>3</sup>, Dan Bufford<sup>4</sup>, Khalid Hattar<sup>4</sup>, and Michele L. Ostraat<sup>2</sup>

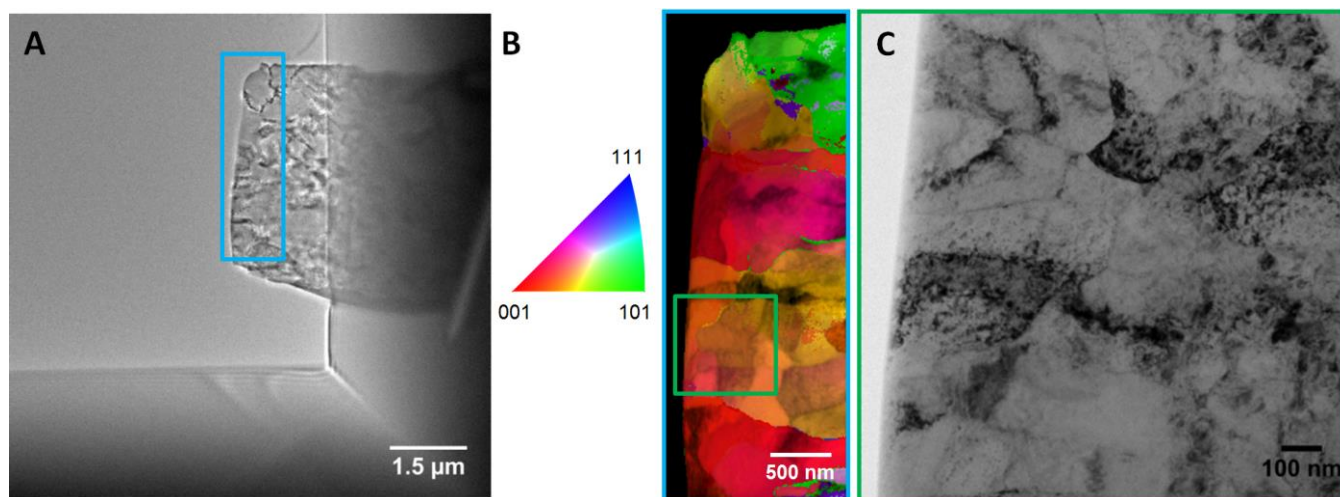
**Figure 1.** FIB lift-out thin-film of 1018 low-carbon steel, prior to *in situ* exposure to the corrosive environment. A) TEM image at the corner of a SiN membrane window. B) Precession electron diffraction mapping of the grain orientation of highlighted region in (a). C) Nanoscale features at the center-edge in sample of highlighted region in (b).

Pipeline steel coupons (1018 low-carbon steel) were sectioned for initial characterization, after which lift-out TEM samples were fashioned by cutting out thin foils using a focused ion-beam (FIB). The samples were then characterized using grain orientation mapping (Figure 1b) and EDS to determine the texture of the grains and to generate elemental compositional maps. Comparison to bulk surface characterization identified direct correlation in the chemical composition, although the thinning process did lead to a thin (1-2 nm) amorphous surface layer in the thin FIB foil samples. The outer thinned section of the samples was placed onto the edge of a SiN membrane window (Figure 1a), and corrosion analysis was undertaken using a microfluidic liquid-cell holder by Hummingbird Scientific [2-4]. Thin-film sections were initially mapped in vacuum to identify the locations of defect regions or interesting nanoscale features where corrosion processes were expected to occur (Figure 1c).
