Fracture Surface Morphology of Cracked Organic Matters in Kerogen-rich Source Rock Observed in Electron Microscope

Mohammad Haque

Aramco Americas, Katy, Texas, United States

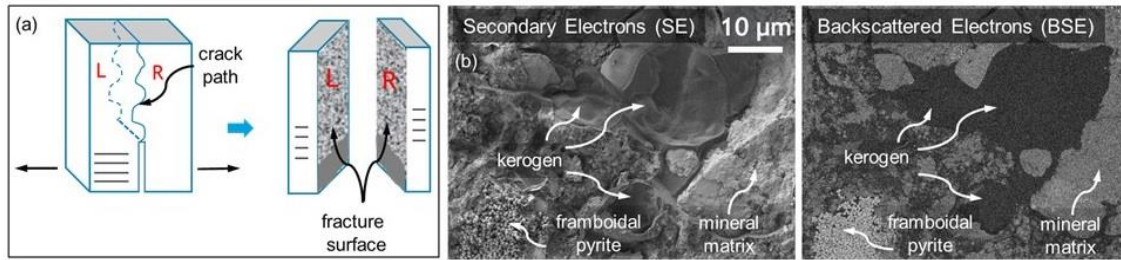
Figure 1. Schematic of prepared samples (a). SE and BSE electron microscopy of a fracture surface showing the presence of kerogen (b).

In this work, millimeter size single edge notch beam (SENB) were prepared from source shale (Woodford, a source rock from the Texas basin). The fracture surface morphology of the trapped kerogen, after a controlled crack propagated across the bedding plane (Fig. 1a), were imaged by scanning electron microscope (SEM) - both in secondary (SE) and backscattered (BSE) electrons modes. The naturally created fracture surfaces of the cracked kerogen under study had the most preserved fracture morphology. The track of the crack propagation was also remained in its most original state after fracturing the rock matrix. This is because traditional sample preparation techniques for SEM imaging utilizes mechanical polishing or ion milling of the rock surface which alter or damage the exposed kerogen diminishing the surface morphology originated during fracturing process. Unique feature such as obsidian fracture, commonly observed in glassy/brittle minerals like quartz, is reported to be observed in kerogen geopolymer. A combination of BSE and energy dispersive X-ray (EDS) were used to identify the kerogen intertwined in the mineral matrix (Fig. 1b), whereas, SE scanning was used for the topography analysis.

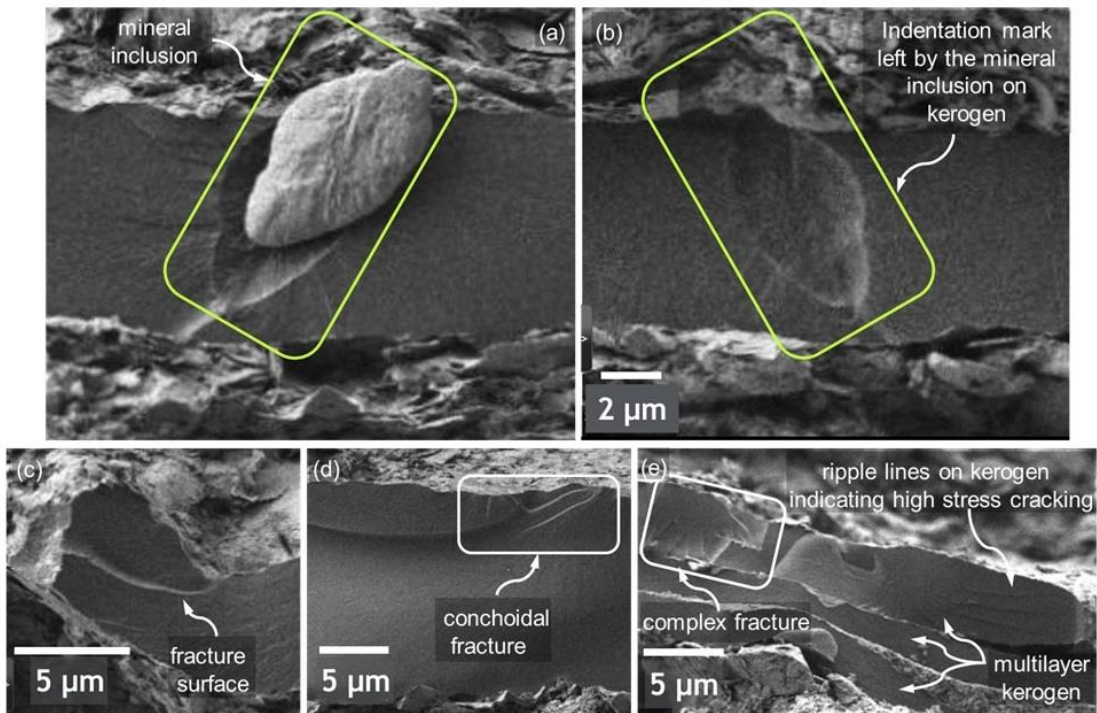
Figure 2. Glassy fracture surface of a single layer kerogen resulting from a pre-existing inclusion (a,b). Fractography of multi-layer kerogen bodies showing fracture surfaces (c, d, e), and obsidian fracture (d, e).

Kerogen, a tough natural geopolymer, undergoes extreme aging at a geological timescale leading to maturation (types I, II, and III) and embrittlement as exposed to temperature and high stress. Fractography of kerogen revealed high yield and high tensile strength failure. Depending upon the shape, size, location and orientation of the kerogen body in the matrix, a kerogen body may or may not be cracked when rock matrix is fractured. Fig. 2 shows a series of examples of glassy fractures for fractured kerogen where crack propagated through the kerogen body across the bedding plane. A mineral inclusion occurred to be trapped within the kerogen body, which became exposed after the crack propagated along its interface, leaving the indentation mark on the cracked kerogen surface (Figs 2a, 2b). In other events, obsidian fracture like microstructures (Figs. 2d, 2e) and a complex multibody multi-planar fracture were observed (Fig. 2e) with three parallel ripple lines, indicating high stress failure. In summary, there is not a single kind of fracture morphology that can generalize the kerogen failure. But a strong high yield high tensile behavior with glassy fracture was common in most kerogen samples studied in this work.
