Atom Probe Tomography of Oxidised Grain Boundaries in Highly Irradiated SS316

In this study, Type 316 steel from thimble tubes of the pressurized water reactor (PWR) Ringhals 2 has been characterized. The thimble tubes, used as guide tubes for neutron flux measurements, were in service from the commissioning of the reactor in 1975 until 2009 (205,891 effective full power hours) at a temperature of around 315°C. The accumulated dose during this time is as high as 100 dpa. The irradiated material is compared to reference material that was exposed at a similar temperature for the same time, but without neutron irradiation.

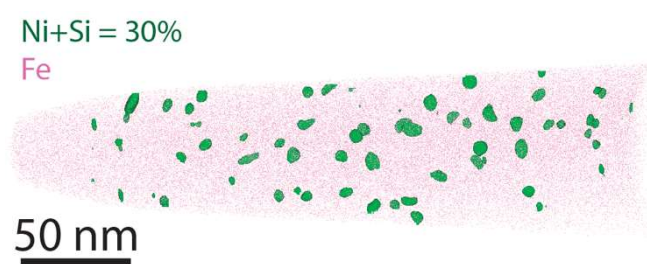
Figure 1. Atom probe reconstruction of the material irradiated to 100 dpa. Green isoconcentration surfaces represent Ni-Si rich precipitates. The extent of the analysis is shown by a small number of the Fe atoms in pink.

After 100 dpa of irradiation, the metal matrix was full of precipitates of Ni and Si that are a few nanometres in diameter, see Figure 1. These precipitates are assumed to be γ' (Ni_3Si) or its precursors, as the Ni/Si ratio was less than 3 in most cases (2.4 ± 0.2 , except one analysis where the ratio was found to be 3.1). The number density of precipitates was $0.9 \pm 0.3 \times 10^{23}/\text{m}^3$. These precipitates are known to increase the hardness of the material [3] and appear as a result of the irradiation, as no precipitates were observed in the reference material.

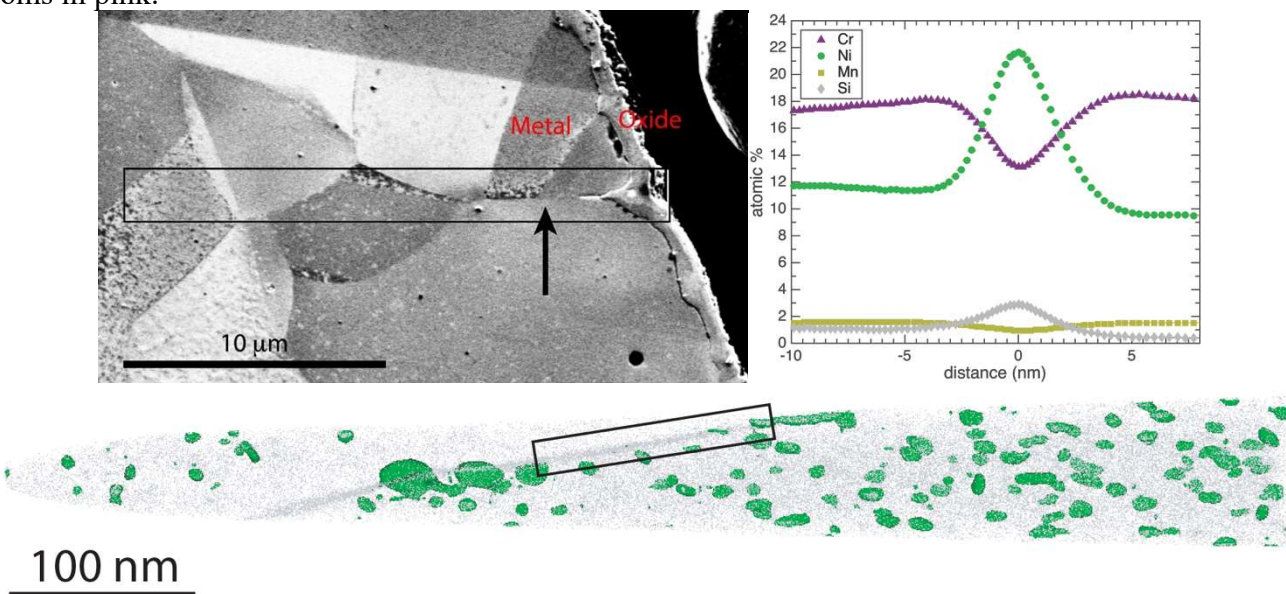
Figure 2. SEM micrograph of the material irradiated to 100 dpa. The box marks the volume that was initially lifted out and made into a number of APT needles. The arrow marks the approximate position of the analysis of the grain boundary. Furthermore, the figure also shows the APT reconstruction of the grain boundary, with Si atoms in grey and Ni+Si= 30% as green isoconcentration surfaces. The profile through the grain boundary (marked with a box) is shown.

An overview (from the FIB/SEM during the sample preparation) of an analysed grain boundary can be seen in Figure 2. The oxide is growing into the boundary. A few micrometres from the outer oxide, the APT needle was prepared (arrow in the SEM micrograph). The reconstruction of the APT analysis can be seen in the same figure. The grain boundary is enriched in Ni and Si, and depleted in Cr and Mn. There is no O detected at the boundary. There are a number of Ni- and Si enriched particles on the boundary. These
