## TEM CHARACTERIZATION OF SINGLE CRYSTAL SILICON FILM ON GLASS SUBSTRATE

S. C. Cheng and K. P. Gadkaree

Science and Technology, Corning Incorporated, Corning, NY 14831

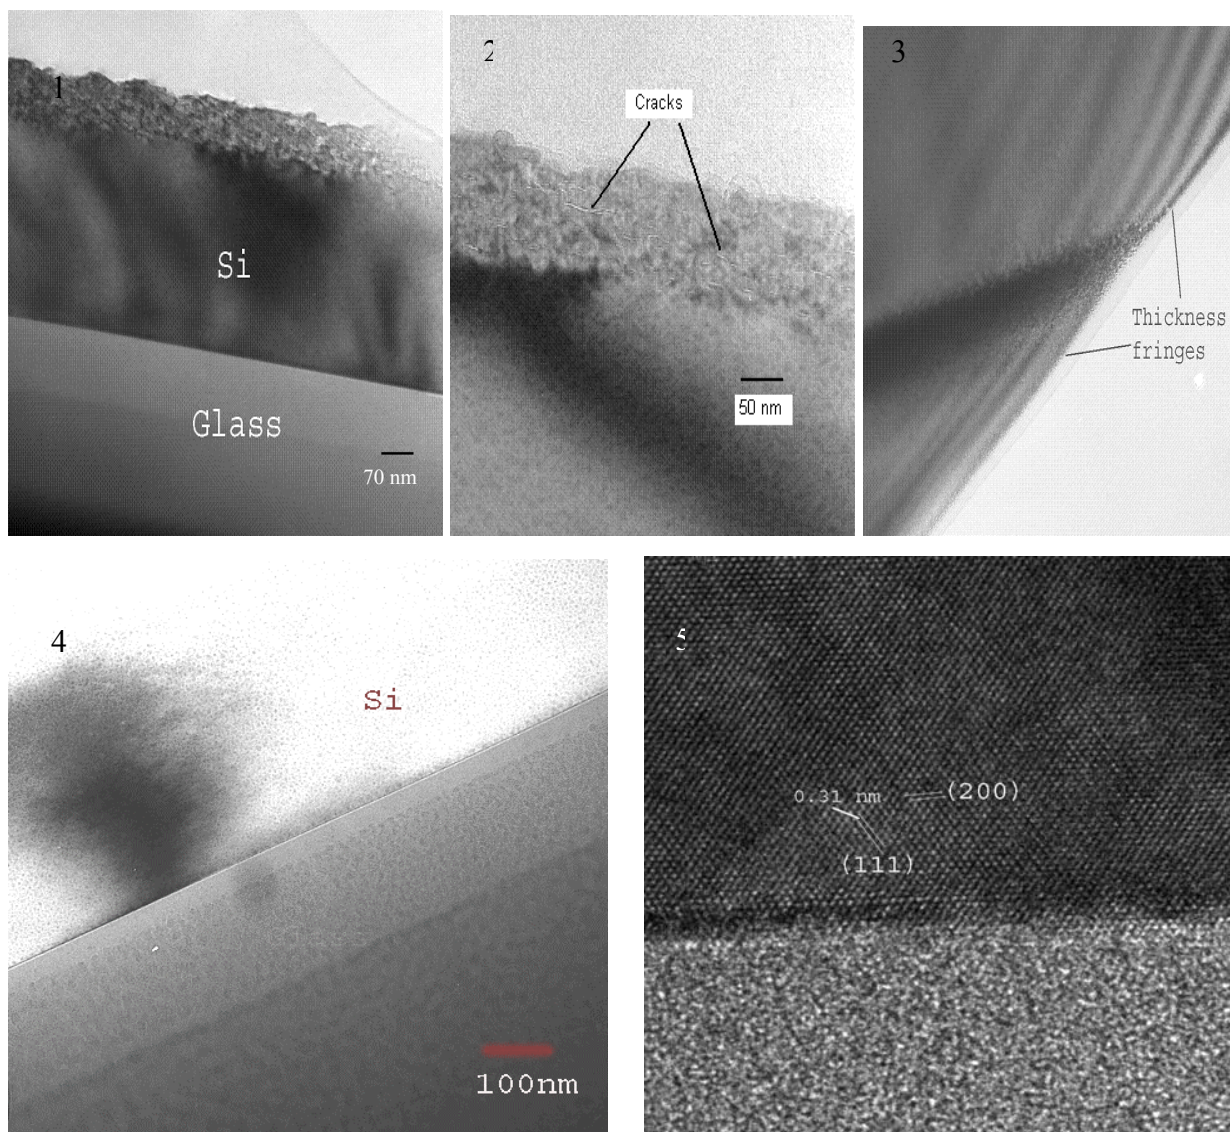
Fig. 1. Bright field image of sample prepared by implant  $H^+$  at 100 keV. The image clearly shows two regions in the Si film.

Fig. 2. Enlarged image of Fig. 1 on the damaged area to show the microcracks.

Fig. 3. Bright field image of the defects in Si wafer before bounded to glass substrate.

Figure 1 is a bright field image, taken from the sample prepared by implant  $H^+$ . The image clearly shows two regions in the Si film. On the top region of the film, the crystal structure is significantly damaged. The exfoliated Si layer containing the damaged layer has bonded well to the glass substrate. Figure 2 is the enlarged image of the damaged area. Many microcracks are observed from the image. It is believed that these cracks were developed during the annealing process from the  $H^+$  related crystal defects, such as Si-H defect in the system or high pressurized  $H_2$  gas bubbles. The Si-H defects were observed in silicon wafer before the bonding procedures. Figure 3 is a bright field image of these defects on Si wafer. The orientation of the specimen was tilted away from (011) to increase the contrast of the defects in the image. The thickness fringes, shown in the image, cross the whole areas of specimen except the damaged layer. No microcracks similar to that, shown in Fig. 2 were observed in Fig. 3. The microcracks in the Si wafer after annealing, shown in Fig. 2, play an important role in separating the film from the Si mother wafer. Figure 4 is a bright field image, which reveals that there are two layers in the interface region between the silicon film and the glass substrate. EDS and EELS techniques were used to analyze the chemical distribution and stoichiometry of the interfacial layers. The first interfacial layer is a silica layer, and the second is a barrier layer, in which mobile ions are not present. Details of the results will be presented at a separated paper [1].
