## **Metallographic Sectioning and Grinding Damage Analysis Through the Use of Color Metallography and Electron Backscatter Diffraction (EBSD)**

G. M. Lucas\*, G. F. Vander Voort\*, P. T. Pinard\*\*, M. Lagacé\*\*\*, P. Hovington\*\*\*

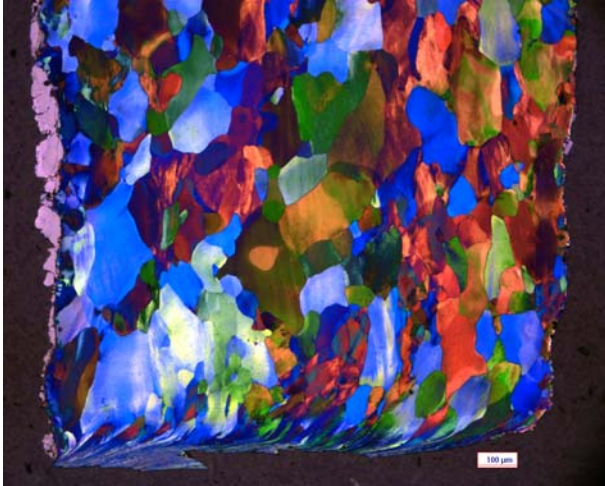
Fig. 1. 99.98 Fe sheared, etched with Klemm's I, 5X objective.

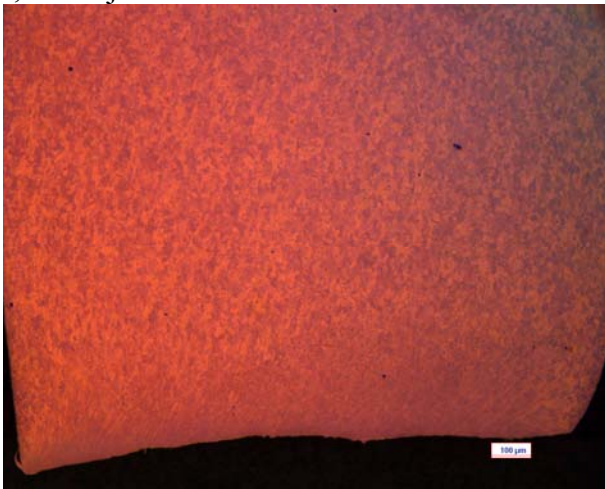
Fig. 3. CP Ti Sheared, as polished viewed in polarized light and sensitive tint, 5X objective
