## **Metallographic Sectioning and Grinding Damage Analysis Through the Use of Color Metallography and Electron Backscatter Diffraction (EBSD)**

G. M. Lucas\*, G. F. Vander Voort\*, P. T. Pinard\*\*, M. Lagacé\*\*\*, P. Hovington\*\*\*

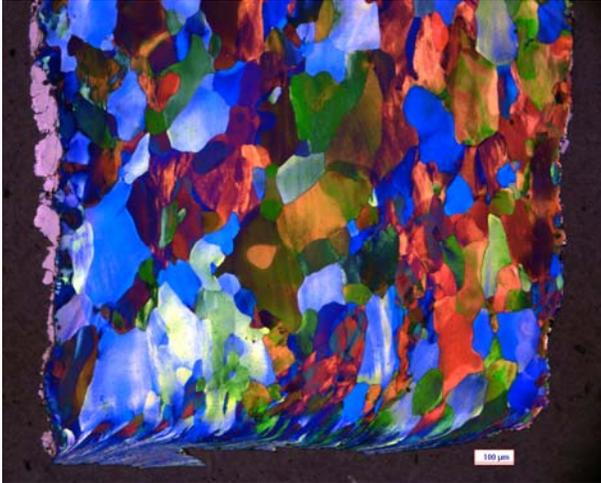
Fig. 1. 99.98 Fe sheared, etched with Klemm's I, 5X objective.

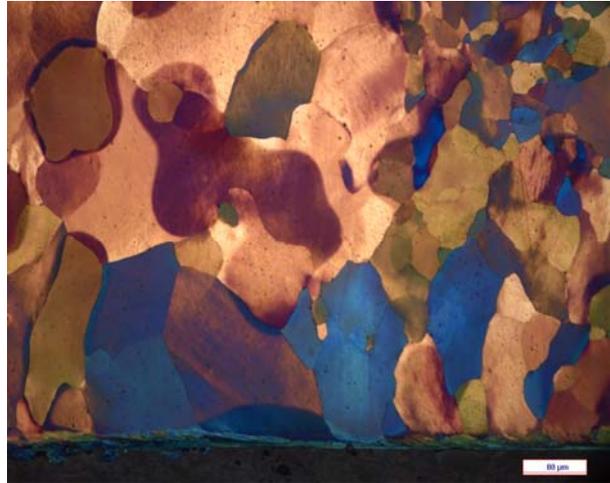
Fig. 2. 99.98 Fe Band saw, etched with Klemm's I, 10X objective.

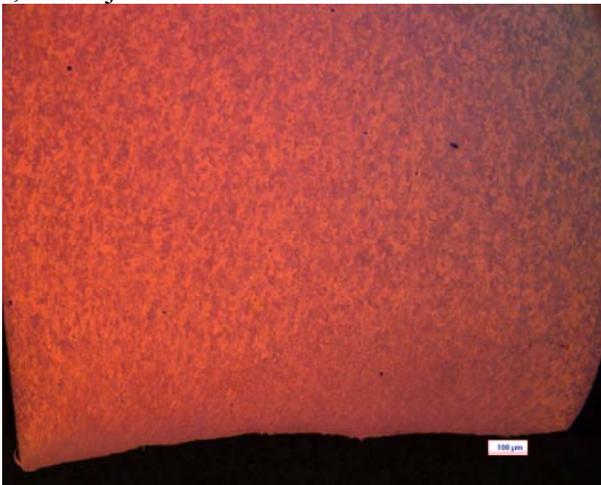
Fig. 3. CP Ti Sheared, as polished viewed in polarized light and sensitive tint, 5X objective

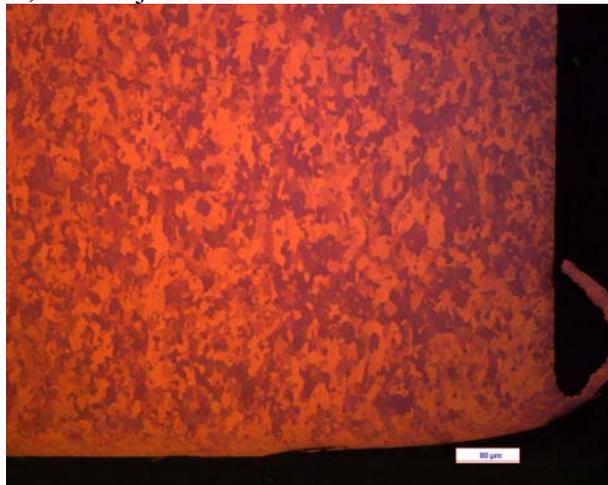
Fig. 4. CP Ti Band saw, as polished viewed in polarized light and sensitive tint, 5X objective

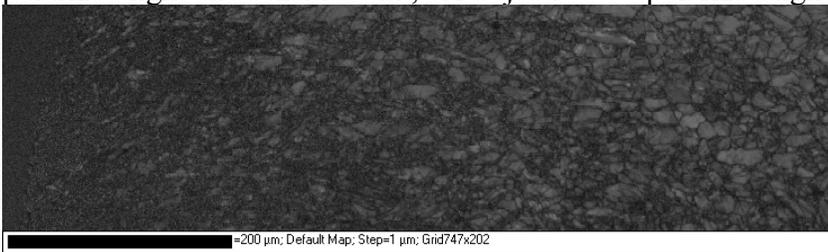
Fig. 5. CP Ti sheared, as polished Grain contrast map plus quality index map.

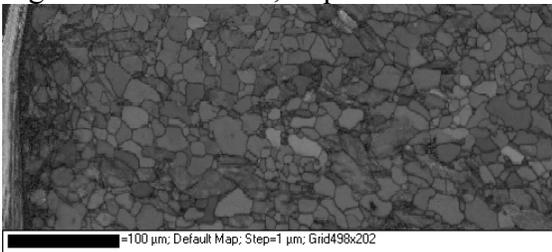
Fig. 6. CP Ti, Band saw cut, as polished Grain contrast map plus quality index map.
