How to Recognize and Avoid AFM Image Artifacts

Paul West and Natalia Starostina
Pacific Nanotechnology, Inc.
pwest@pacificnanotech.com

Images produced by an atomic forces microscope (AFM) often contain spurious features and image distortion that can render accurate imaging and metrology suspect. These "artifacts" are caused by the manner in which the image is produced. Artifacts can originate from the probe tip geometry, scanner non-linearity, image processing software, vibration, sample contamination, electronic noise, and poor sample stability. This article describes and illustrates common AFM image artifacts and suggests means to eliminate or minimize them.

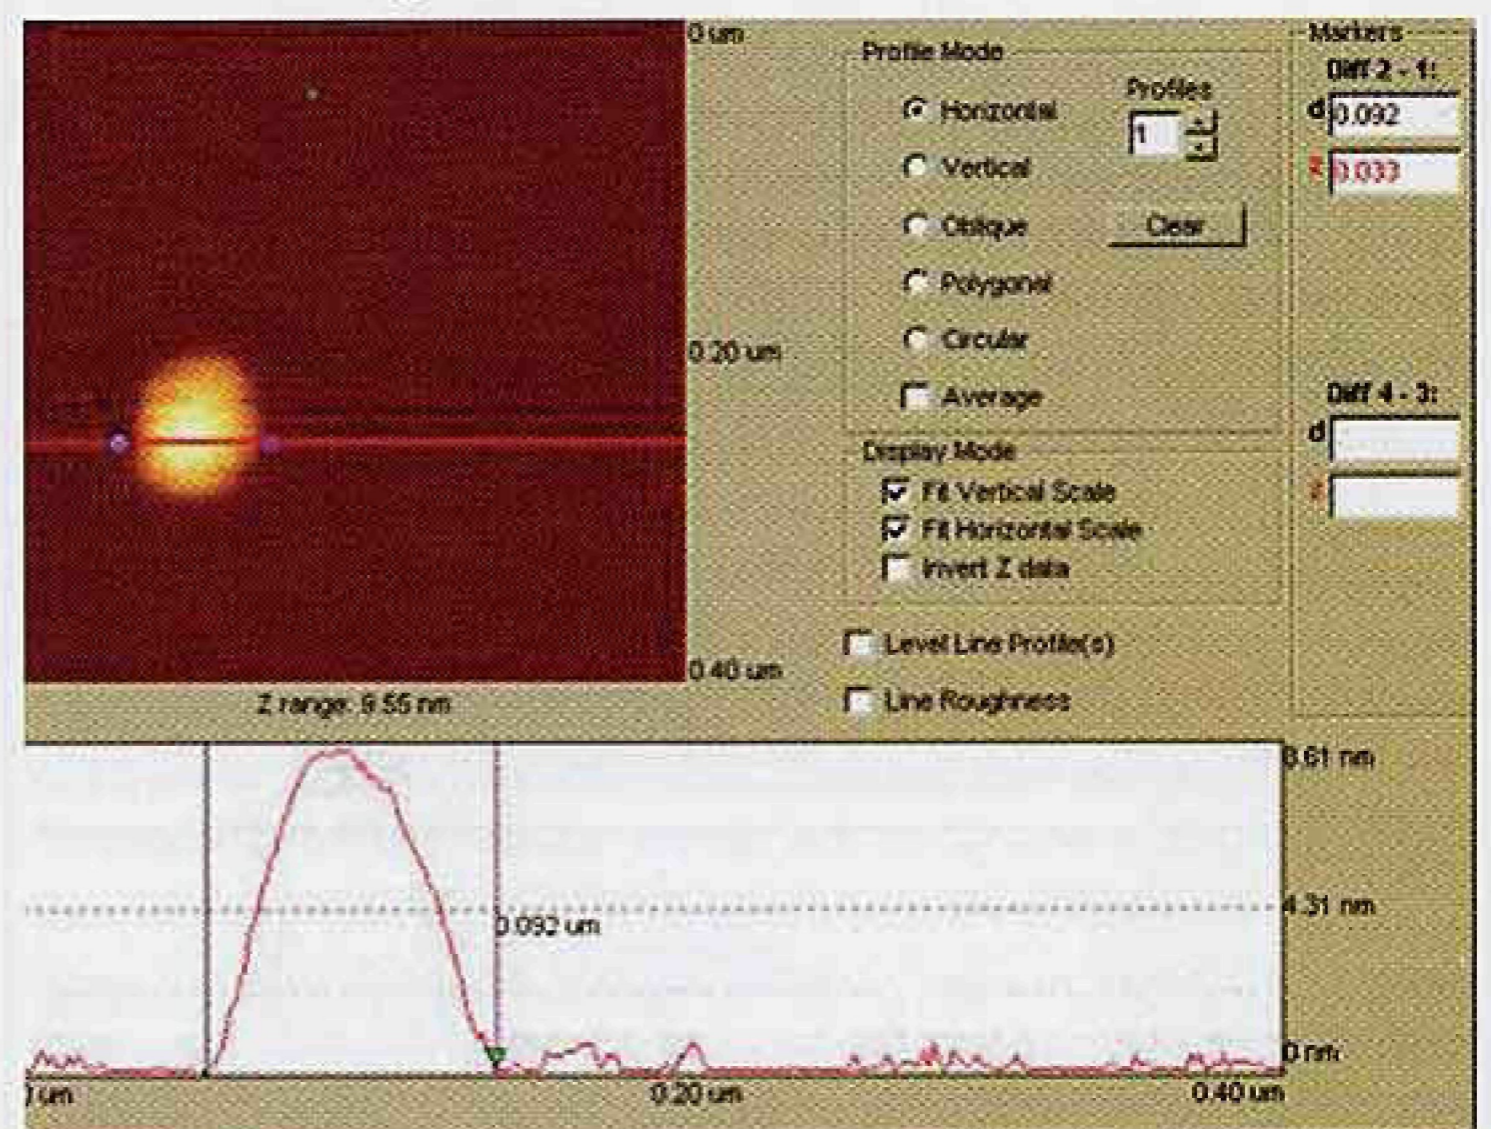
Figure 2. The image (top) of an 8-nm-diameter sphere (field: 400x400 nm) and the resultant line profile (bottom). This probe tip was larger than the feature (Figure 1a) the image shows an incorrect diameter of 92 nm and a height of 8 nm.

Often the size of an extremely small sample such as a nanotube or nanosphere will look larger than expected. However, the height of the feature as measured by a line profile will be correct. This is illustrated in Figure 2, where the image of an 8-nm-diameter sphere is broadened to 92 nm, while the height is accurately represented. If depth is to be measured accurately, the probe tip must be able to touch the lowest point of the feature. Figure 3 is an example of this problem.

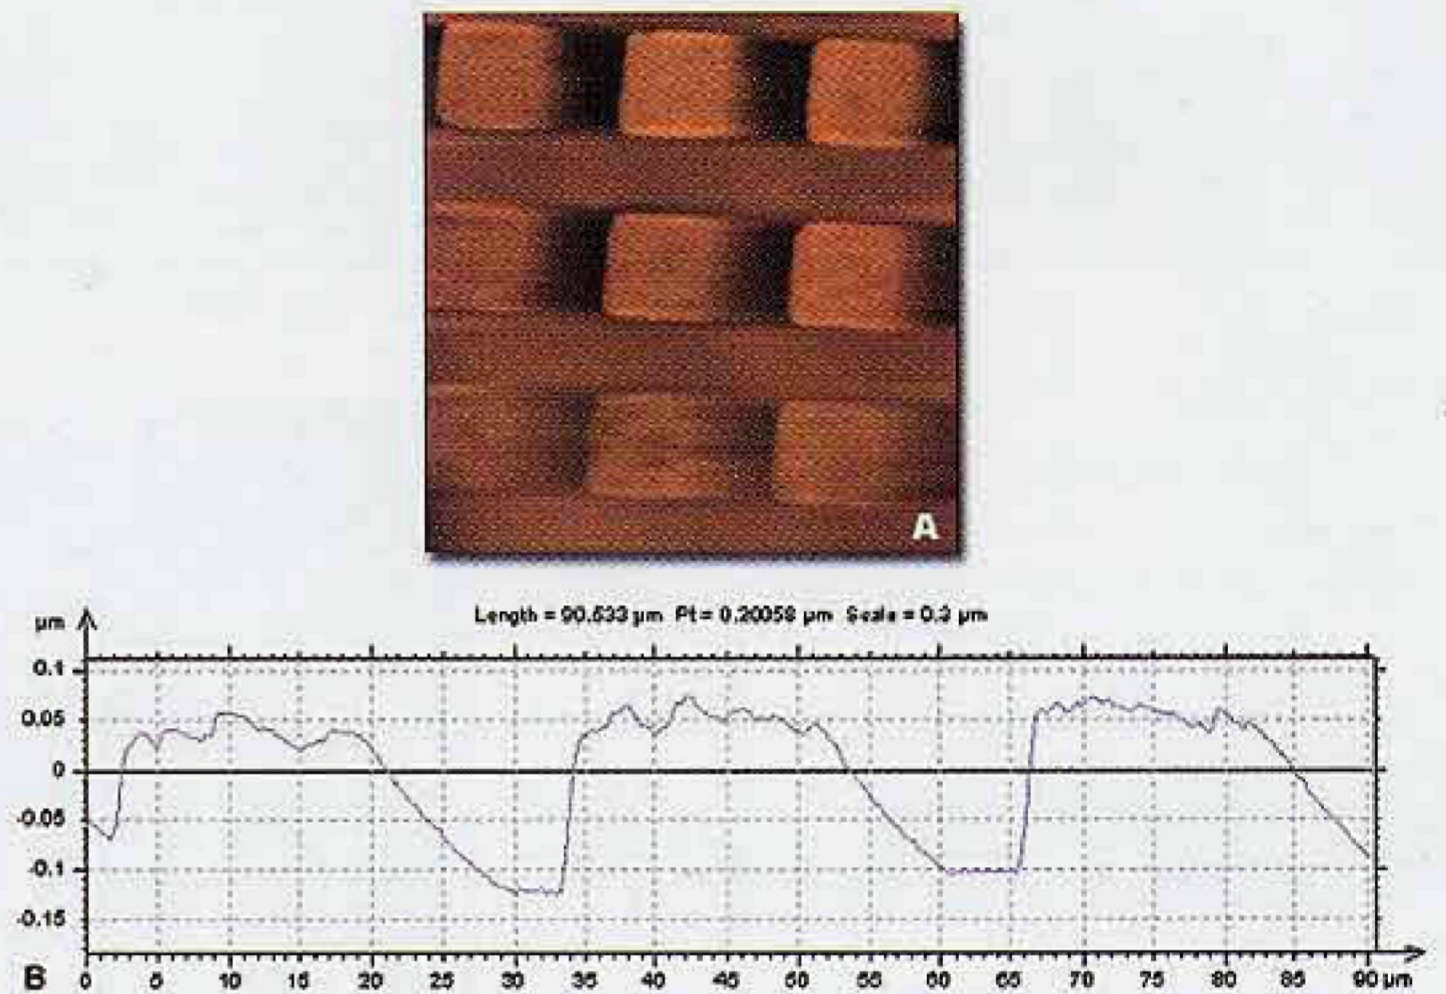
Figure 5. Image distortion caused by a damaged probe tip. A. The image of the functional surface has dark right edges indicating a slope (field: $91 \times 91 \mu\text{m}$). B. The line profile shows the degree of the slope to be too great to be due to a tilted probe.

A damaged probe can also cause image distortion and produce strangely shaped objects that mimic the effect of a tilted probe. Figure 1c illustrates the effect of a damaged or asymmetric probe tip that is too large relative to the feature topography. The image will be significantly distorted. This is illustrated in the image and line profile of Figure 5. Although, this artifact could be caused by a large angle between the probe and the sample surface, the angle as indicated by the line profile is too large (height = 0.16 μm ; width = 10 μm). In this case a damaged tip caused the distortion.

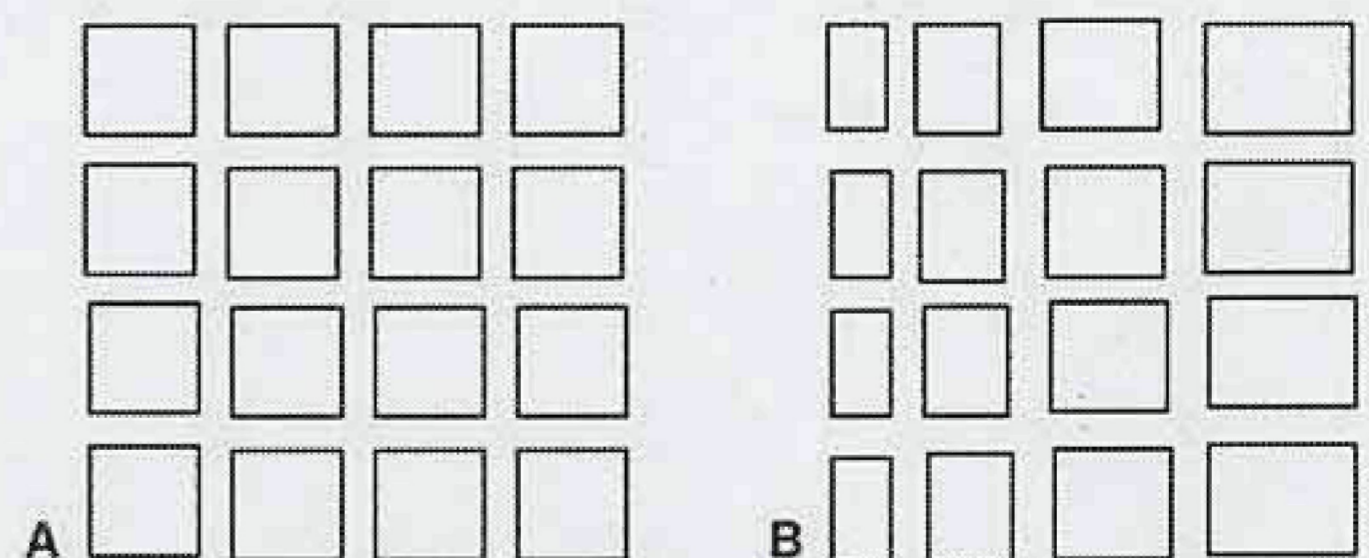
Figure 7. Linearity and x-y calibration. A. Test pattern. B. Image with distortion caused by non-linearity in an uncalibrated AFM.

To compensate for x-y non-linearity in the plane of the scan AFMs must be calibrated. Figure 7 illustrates the difference between a square array test pattern and the image generated by an un-calibrated AFM due to non-linearity. With no correction the features on one side of an image will appear smaller than on the opposite side. Correction for non-linearity (linearization) is typically done by software. For accurate metrology the AFM must also be calibrated using a standard test structure [1] or standard 3D objects such as nanospheres of known diameter. Accurate height measurements also require that the AFM be linearized and calibrated in the z-axis. Non-linearity and calibration can also be accomplished in AFMs that have calibrated position sensors that correct the AFM output in real time.

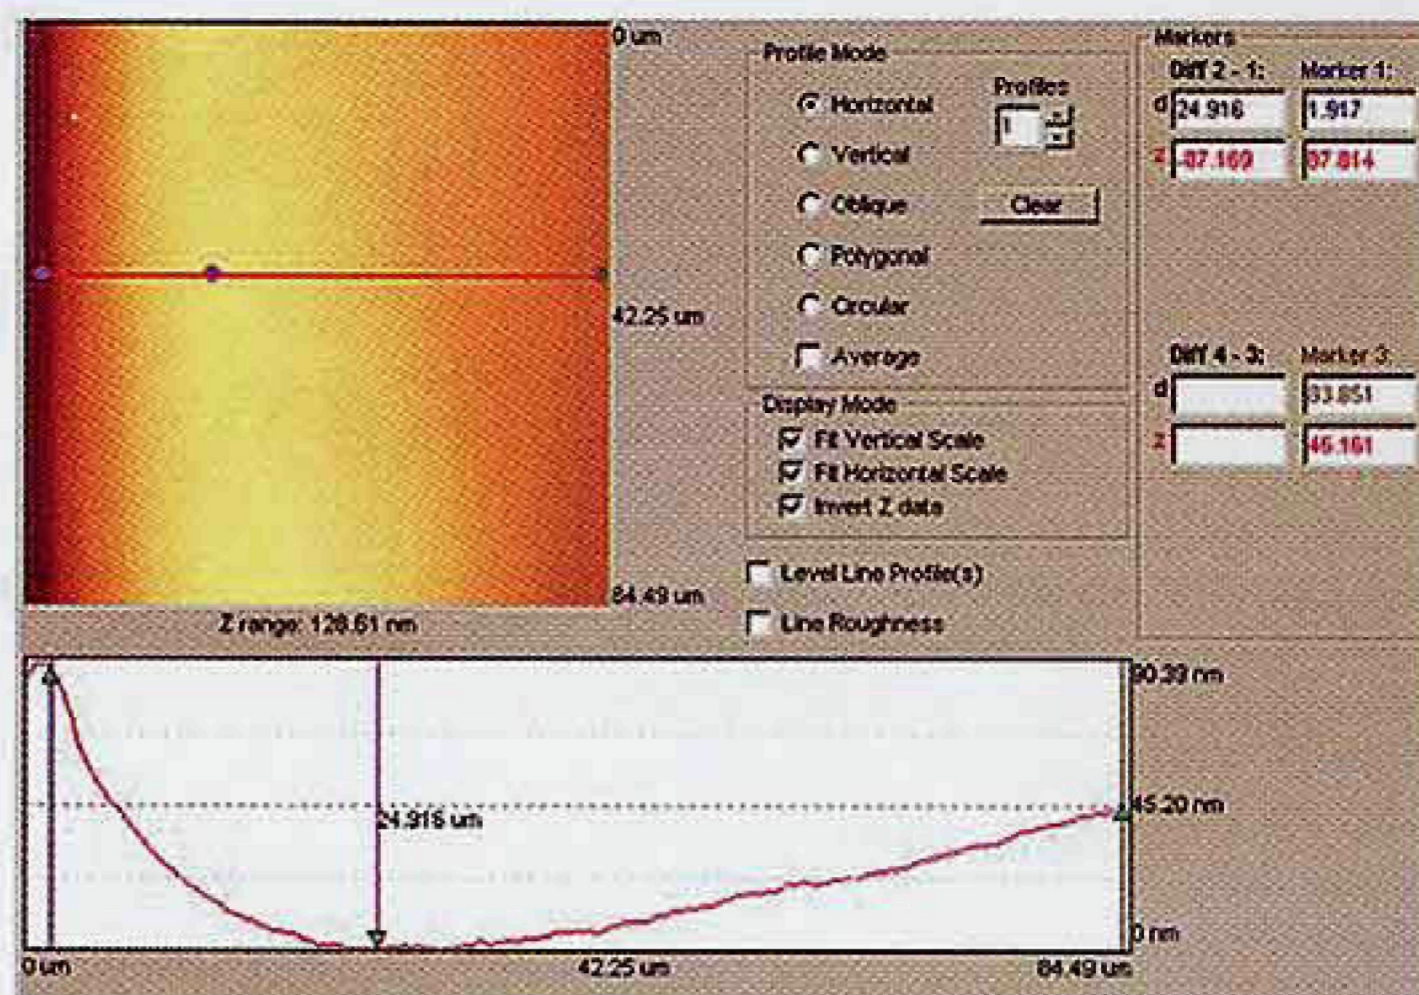
Figure 9. AFM image (field: $85 \times 85 \mu\text{m}$) and line scan of a flat silicon surface. Bow is evident at the edges of the image. A line profile shows the magnitude of the bow. This large amount of bow indicates a damaged scanner.

The scanner motion can introduce two types of background artifacts: bow and tilt. A bow in the AFM image is the appearance of a convex background across the scanned field. Figure 8 illustrates the origin of bow and Figure 9 shows an AFM image and line scan showing the effect. Although some bow is expected in AFM images the extreme bow shown in Figure 9 indicates that the scanner is damaged.

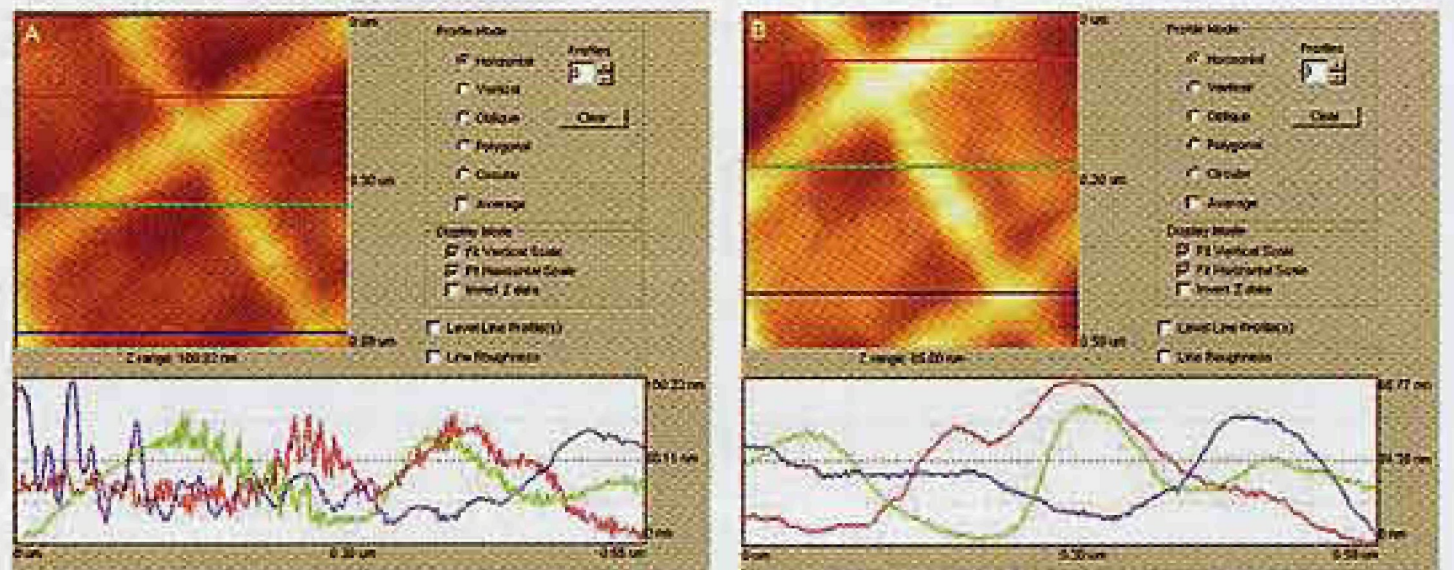
Figure 16. Effect of acoustic noise on a high-resolution image (top) and line scans (bottom) of a diffraction replica AFM standard (TedPella). Left. Noise present. Right. Noise eliminated.

Even acoustic vibrations such as an airplane passing overhead or loud talking can cause artifacts in AFM images. Figure 16 shows the effect of a person talking while the AFM image was being acquired. A quiet vibration-free environment will ensure a clean, noise-free image.

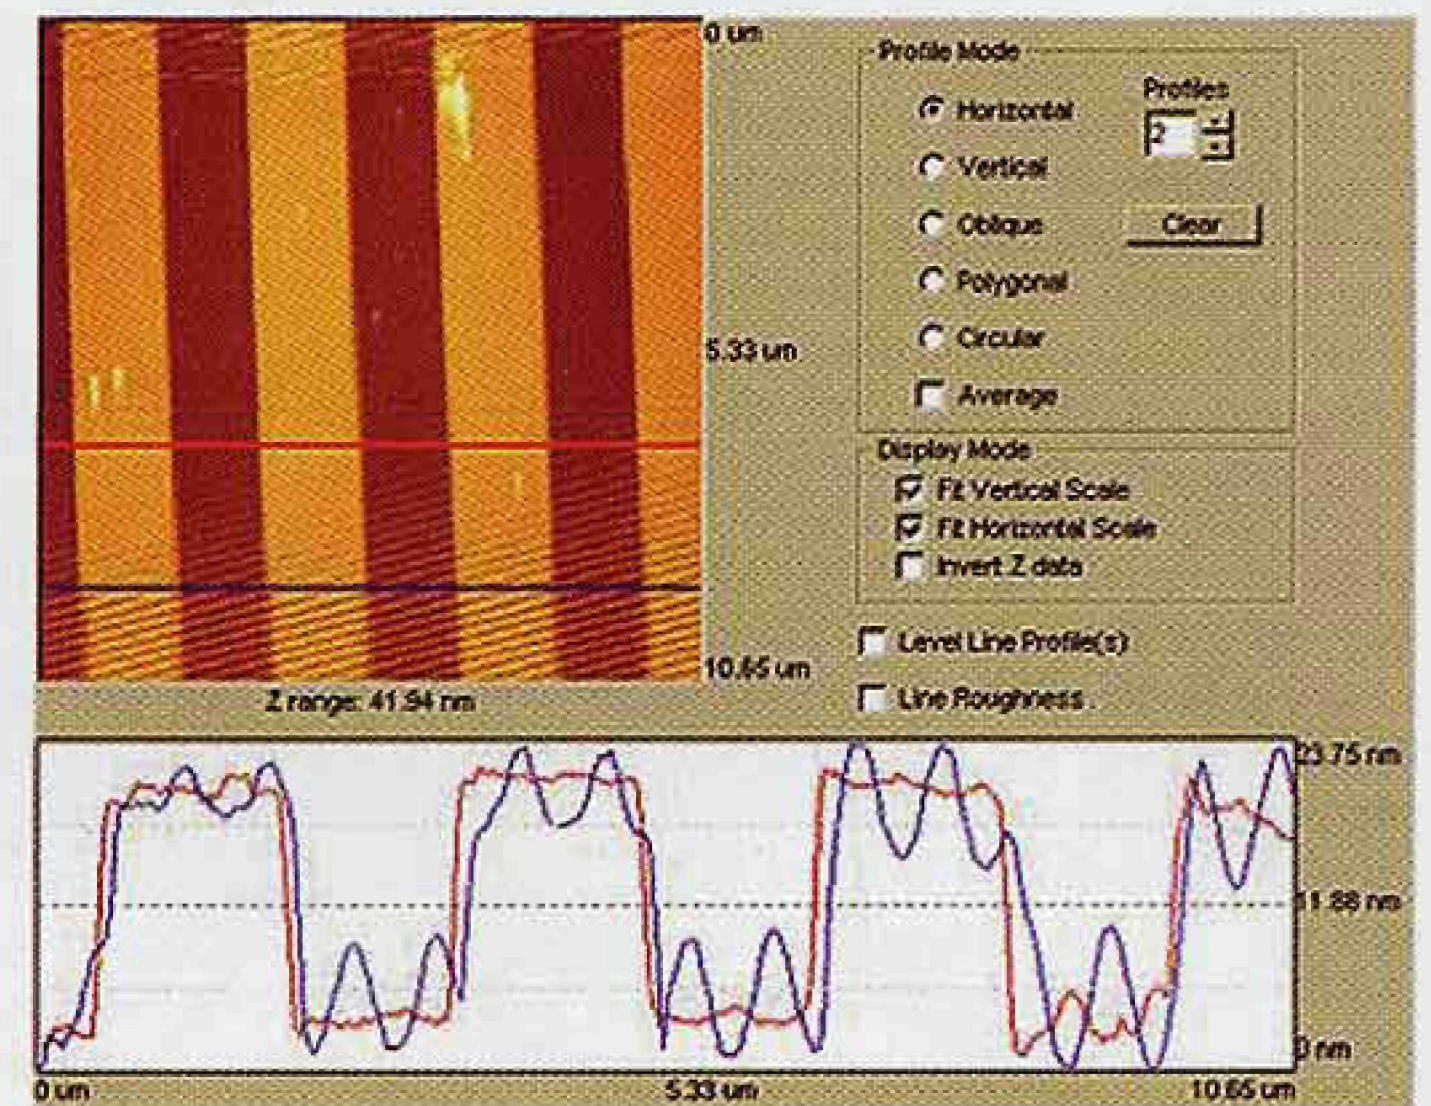
Figure 17. Effect of electronic noise. The effect can be seen in the lower part of the image and in the blue line profile.

Faulty electronics can introduce electrical noise into an AFM image that most often appears as periodic oscillations or repeating patterns. Ground loop currents due to improper electrical grounding of the stage or defective electronic components are the usually sources of electronic noise. Figure 17 illustrates noise introduced by a faulty ground connection to the sample stage. Check that all ground connections are tight and free of corrosion or insulating films.
