Environment-Sensitive Behaviour of Welds: Challenges in Microstructural Characterisation

M. G. Burke, S. Schilling and A. Welbourne

School of Materials, University of Manchester, Manchester, UK

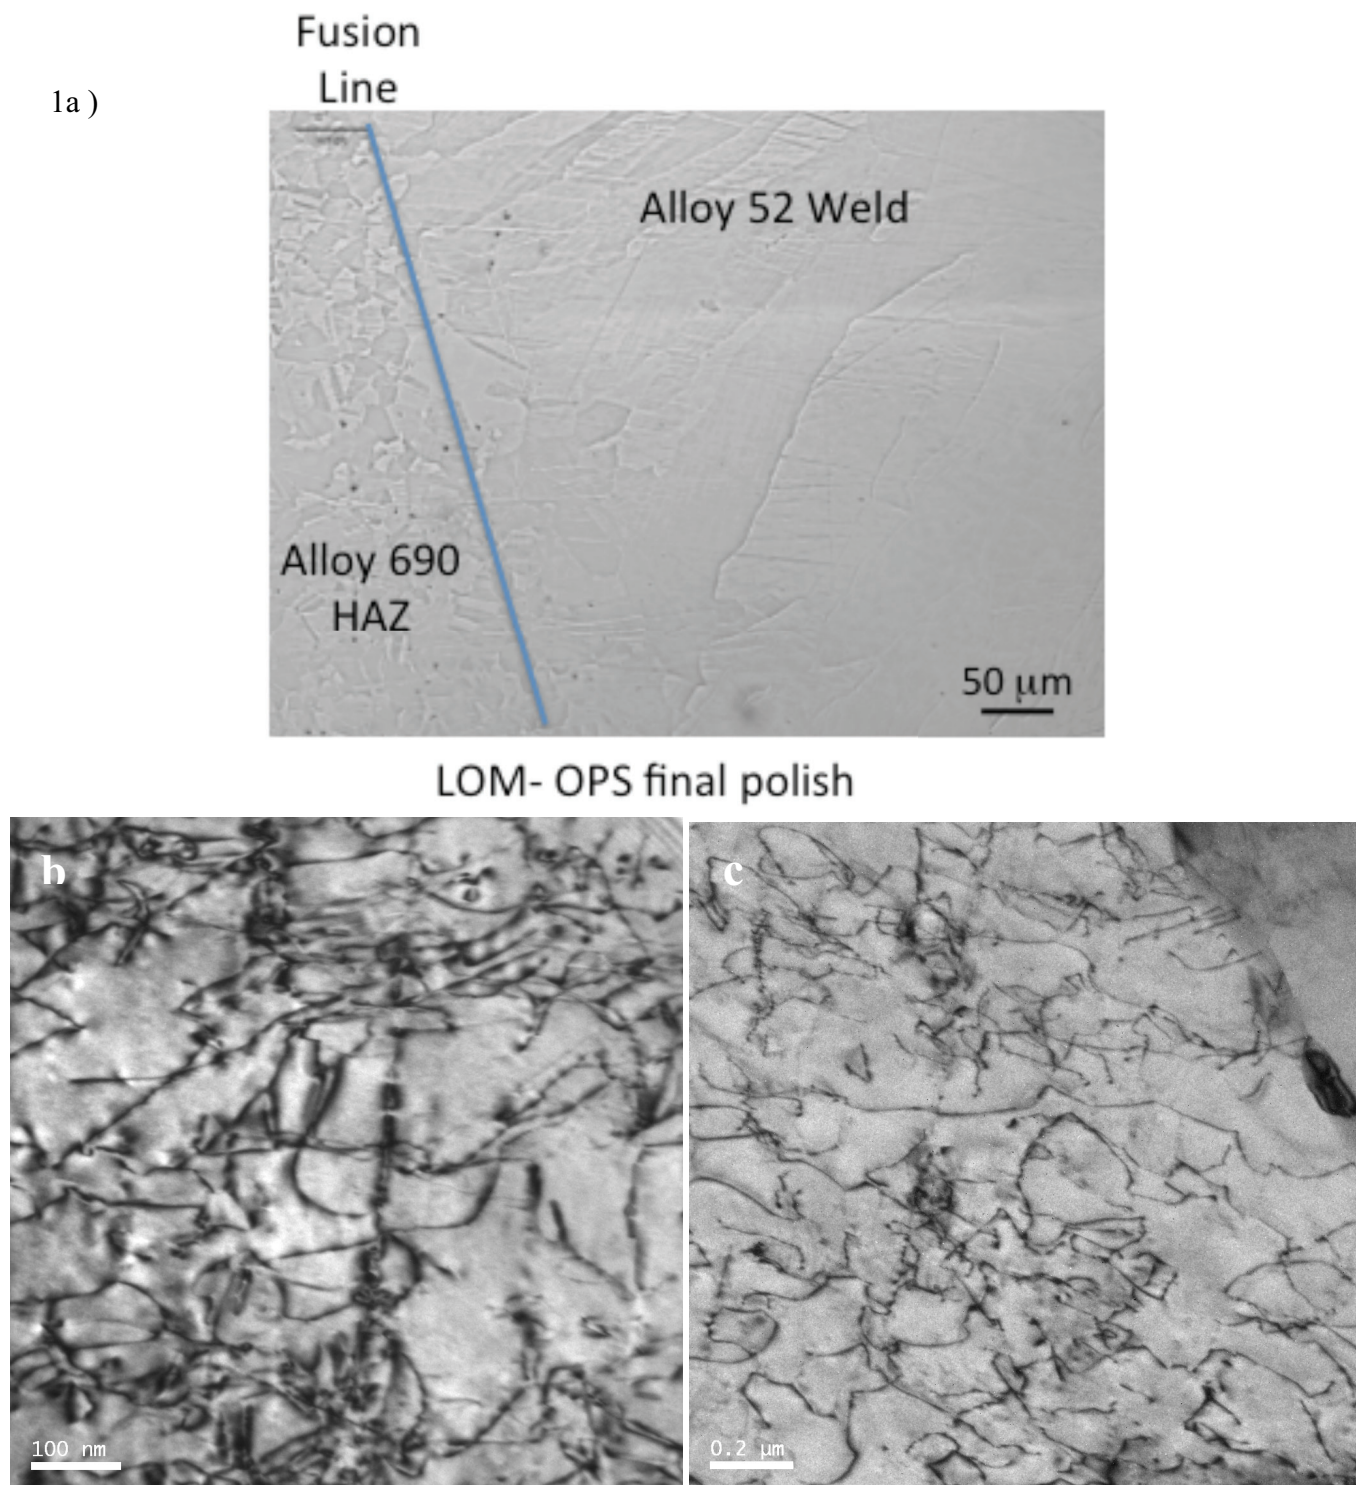
Figure 1. (a) Light optical micrograph of an Alloy 690/Alloy 52 weld; (b) and (c) Bright-field TEM images of the deformation structures in the HAZ. Note that the dislocation structures suggest deformation occurred at elevated temperatures.

Figure 1a shows the light optical micrograph of the Alloy 52 weld with the adjacent Alloy 690 HAZ. TEM analysis of HAZ specimens revealed that the increased hardness of this zone was associated with a dislocated microstructure, as expected. However, unlike the deformation structures associated with room temperature deformation of this face-centered cubic alloy, the HAZ revealed very little evidence of planar slip. In contrast to the presence of numerous slip bands, the deformation structures in the HAZ consisted of numerous dislocations with evidence of cross-slip and climb, as well as dislocation loops. The TEM images of Figure 1b and 1c provide representative examples of the HAZ deformation structures. These structures were inconsistent with low temperature deformation, but indicated that the strain experienced in the HAZ occurred at elevated temperatures. In addition to the deformation structures, particular attention was given to the assessment of intergranular carbide precipitation in the HAZ. However, very little additional intergranular precipitation was observed in the region. This research is continuing, but it demonstrates the importance of detailed characterisation to ensure that the surrogate materials used for the evaluation of the SCC, EAC and CF reflect the relevant microstructures (particularly deformation structures) for a true assessment of the environment-sensitive behavior of the HAZ.
