## AFM / SEM Backscattered Imaging of Slip Bands in Titanium

S. Okerstrom

Medtronic Inc., 7000 Central Ave. NE, Minneapolis, MN 55432

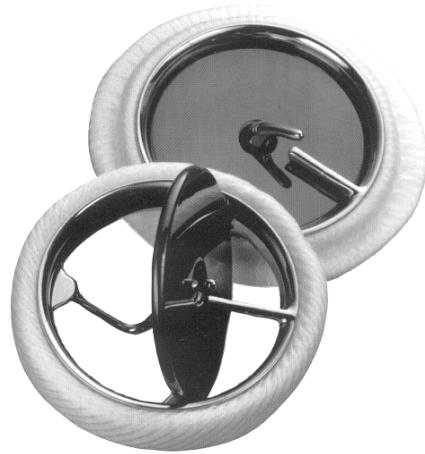
FIG. 1. Prosthetic Heart Valve

Fatigue crack initiation in titanium as a function of surface damage accumulation was the subject of this study. Titanium is commonly found in implantable medical devices. However, mechanical heart valve housings require a highly fatigue resistant grade of titanium. This demanding application is filled by grade 4 titanium. Grade 4 has higher concentrations of iron and oxygen than grades 1 – 3, which substantially increases the strength of the material. Pulsatile blood flow from each heartbeat causes a pyrolytic carbon coated disc to contact the valve housing support members seventy-two times per minute or about 38 million times per year. This makes the housing a candidate for high-cycle fatigue loading. A mechanical heart valve is pictured in Figure 1.
