## EELS Monitoring of Beam-Induced Dynamic Transformation of Lithium Materials at 30 keV

Frédéric Voisard<sup>1\*</sup>, Hendrix Demers<sup>2</sup>, Nicolas Brodusch<sup>1</sup>, Michel L. Trudeau<sup>2</sup>, Karim Zaghib<sup>2</sup>, and Raynald Gauvin<sup>1</sup>

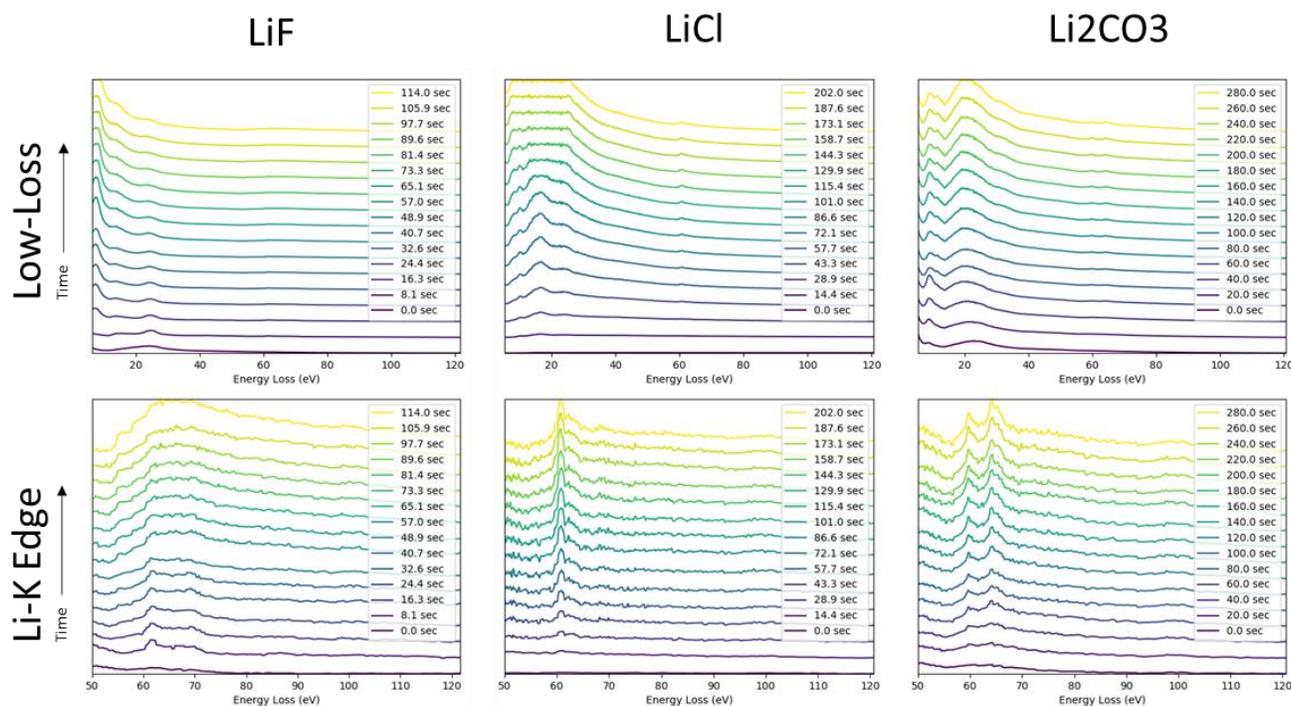
**Figure 1.** EELS time series of lithium fluoride (LiF), lithium chloride (LiCl), and lithium carbonate (Li<sub>2</sub>CO<sub>3</sub>). The spectra are acquired with an incident beam energy of 30 keV, in the 3 to 120 eV range (upper panels). A background subtracted intensity of the lithium K-edge is shown on the lower panels. The three materials exhibit significant beam-induced transformations.

Thus, a 30 keV cold-field emission STEM-EELS instrument, the Hitachi SU9000EA is used. This instrument working energy may exacerbate the transformation mechanisms. The microscope has an estimated probe size of less than 0.5 nm and an energy beam resolution 0.55 eV [7]. Several commercially available lithium compounds were purchased from MilliporeSigma and were inspected in the microscope. EELS time series were collected. Figure 1 shows the beam-induced transformation of three materials: lithium fluoride, lithium chloride, and lithium carbonate. The beam-induced transformations are observed in both the low-loss region as well as in the fine structure of the lithium K-edge. A common trait for the three datasets is loss of mass of the sample. This mass loss reduces the thickness over mean free path ratio ( $t/\lambda$ ). The effect of this shift in  $t/\lambda$  is most visible in the low-loss series of LiCl, where the intensity of the signal increases to the point of saturating the detector. The LiF time series shows a transformation from LiF to lithium metal. The Li<sub>2</sub>CO<sub>3</sub> low-loss series shows a gradual splitting of a peak at 10 eV, also indicating a change in the chemical nature of the material.
