Zigzag Edges in SEM Micrographs

A. F. Yang and M. Kaláb

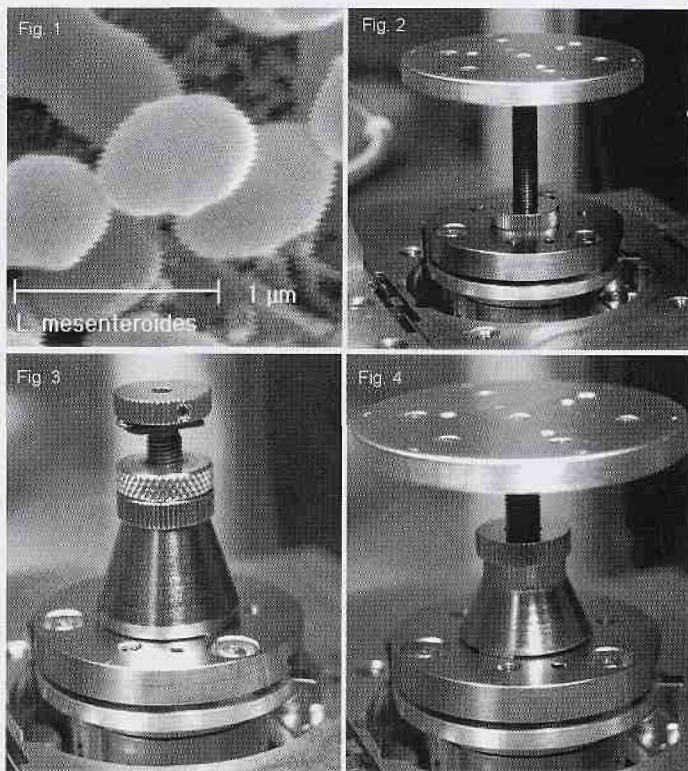
Then, during one session, the ragged edges became so bad (Fig. 1) that the examination had to be terminated. The microscope was vented and the samples were being removed from the multiple specimen holder when it was noted that the holder was somewhat loose. It was re-tightened, the specimens were returned in place and the microscope was started again. The images had a proper appearance and no ragged edges could be found. An examination of the multiple specimen holder (Fig. 2) and its comparison to the single-specimen holder (Fig. 3) indicated that the former would be more susceptible to loosening while the motor-driven stage was moved in order to examine the next specimen. A new stem for the multiple specimen holder was developed (Fig. 4) and the zigzag, ragged edges in the images of bacteria are a defect of the past. ■
