## Chemical Processing of an Early Salt Print Photograph Revealed with X-ray Fluorescence Elemental Mapping

Daryl L. Howard<sup>1,\*</sup>, Martin D. de Jonge<sup>1</sup> and David Paterson<sup>1</sup> and David Thurrowgood<sup>2</sup>

<sup>1</sup>. Australian Synchrotron (ANSTO), Clayton, Australia.

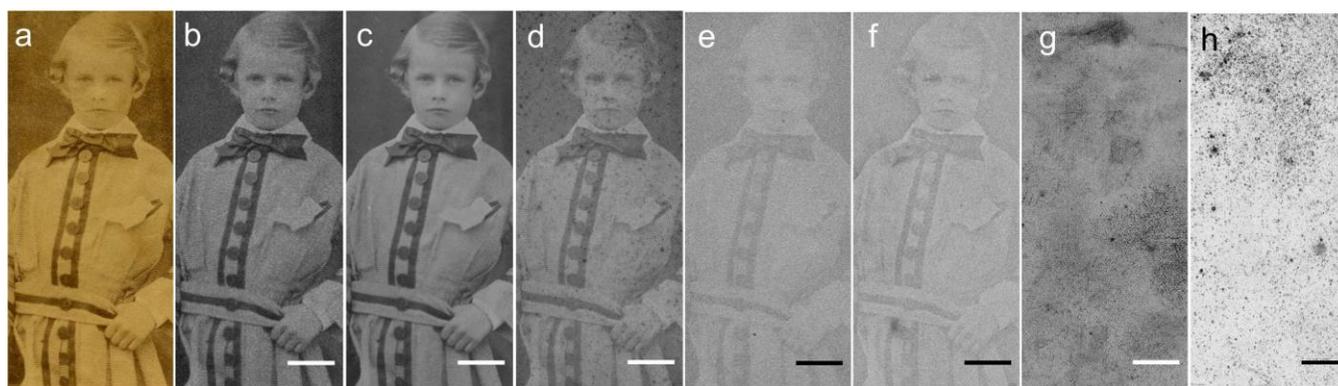
**Figure 1.** a) Visible light image of a salt print photograph, circa 1850, photographer unknown. Scanning XRF elemental maps of: b) silver, c) gold, d) mercury, e) chlorine, f) bromine, g) lead and h) copper. Scale bar = 10 mm. Darker areas indicate higher concentrations.

The salt print photograph (Fig. 1a) was scanned at the XFM beamline with a Kirkpatrick-Baez microprobe using the Maia detector array with an incident energy 18.5 keV, 15 micron pixel size, 5 ms dwell time, and 3 mm/s scan velocity for overall scan time of 17.8 h [2]. The event-mode data was processed into 12.8 Mpixel elemental concentration maps with GeoPIXE software [3].

The silver distribution map (Fig. 1b) reveals the portrait as would be expected from a salt print. The gold map (Fig. 1c) yields the clearest image of the original photograph of all the elemental maps observed. This is partly due to the greater sensitivity to Au-L detection versus Ag-L at the XFM beamline. Gold was used to tone photographs and to improve image stability [4].

Mercury (Fig. 1d) is an interesting find, as it is typically considered to be absent from salt prints [1]. Mercuric iodide or mercuric chloride was sometimes used by photographers to chemically intensify the original silver image via the addition of optically denser mercury to silver [4]. The mottled appearance of mercury warrants further investigation, as the Hg spots do not collocate with other elements observed.

The halogens chlorine and bromine (Fig. 1e and 1f) are common in the many salts used in photographic processes, and both are observed to slightly contribute to the image chemistry. Iodine was observed in several spots of approximately 0.3 mm diameter, which appear to be part of the paper support rather than the photographic image and is not presented.

Lead was present on the photograph (Fig. 1g), but does not appear to be part of the photographic processing. Interestingly, fingerprints containing Pb were observed on the right side, below centre of the print. This observation would not be possible with conventional XRF point analysis. The source of lead is unknown, but this finding is evidence to its widespread use in the past.

The dotted copper distribution (Fig. 1h) appears to be part of the paper support. Zinc and trace nickel are highly collocated with copper and are not shown. The Cu : Zn concentration ratio varies from spot to spot, but is generally 2 : 1. This suggests brass inclusions are present in the paper. Metal inclusions in paper can result from particles abraded from the metal equipment or and/or contaminated water used in the papermaking process [5].
