Classifying the Severity of Grain Boundary Corrosion in CoCrMo Biomedical Implants

Alex Lin¹, Emily Hoffman¹ and Laurence D. Marks¹

¹Department of Materials Science and Engineering, Northwestern University, Evanston, IL

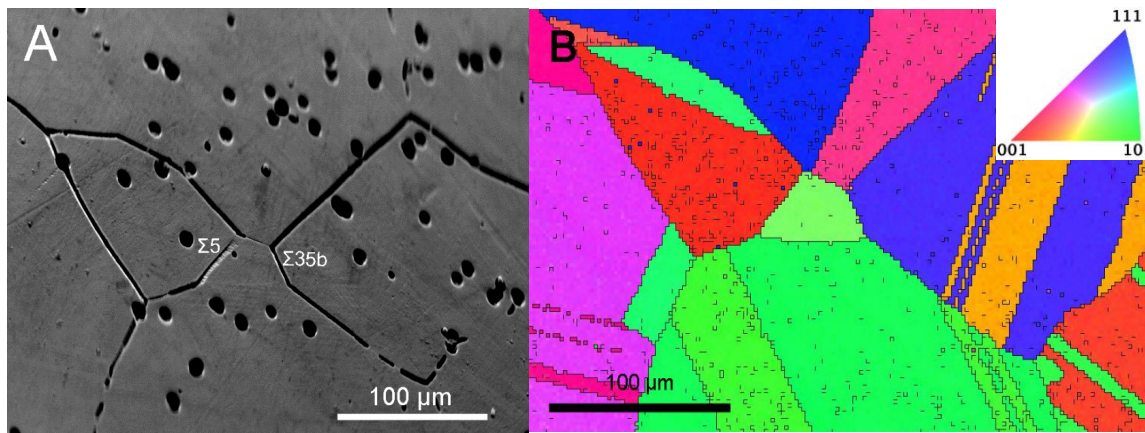
Figure 1: (A) A SEM image showing preferentially corroded grain boundaries and different grain boundary geometry. (B) The corresponding EBSD map showing the crystallographic orientations of the grains in order to determine grain boundary geometry.

Solution-annealed high carbon CoCrMo hip implants are imaged using scanning electron microscopy (SEM) to investigate the grain boundaries in the retrieved sample. As shown in Figure 1 (A) and (B), the SEM images containing the grain boundaries at varying degrees of corrosion are classified via electron backscatter diffraction (EBSD) in order to index the crystallographic misorientations of the grains. The grain boundaries identified as special CSL boundaries ($\Sigma 3$ -49) are then analyzed using a 3D optical microscope for their depth profiles.

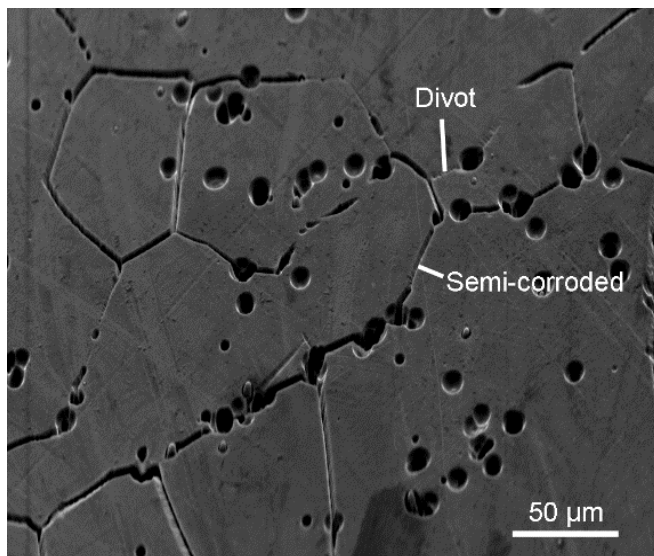
Figure 2: A SEM image showing the semi-corroded boundaries and asymmetrical divot-like features.
